REPORT BMS94

Water Permeability and  
Weathering Resistance of  
Stucco-Faced, Gunite-Faced,  
and "Knap Concrete-  
Unit" Walls

# Water Permeability and Weathering Resistance of Stucco-Faced, Gunitite-Faced, and "Knap Concrete-Unit" Walls

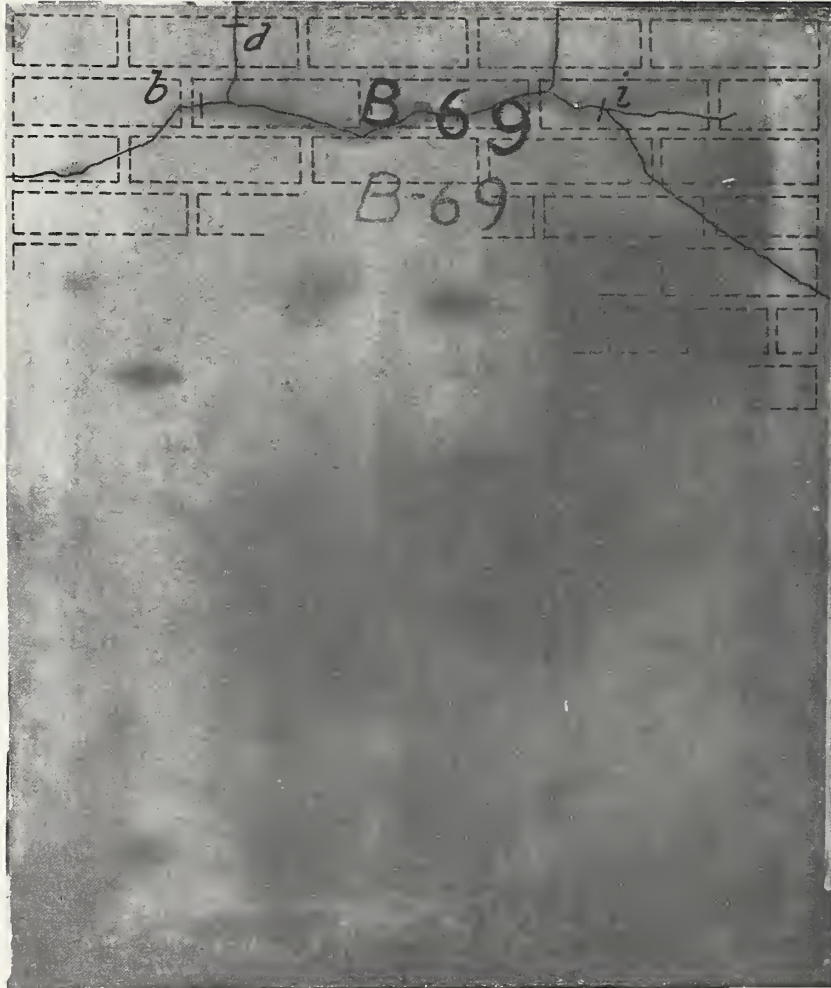
FIGURE 3.—Wall B69 SACN after weathering.

The wall was wetted daily and cured in damp air at a temperature of 37° F for 1 week. The jagged lines at top of the wall indicate the extent of cracking observed on the dry wall. The width of cracks measured at *b*, *d*, and *i* (indicated by transverse lines) was about 0.012 in.

<sup>b</sup> No cracks noted except at top of the wall, see figure 3. Width of crack about 0.04 in. when observed in spring of 1942.

After the walls had been tested for permeability, they were placed outdoors until April 1942, when the width of the cracks in some of them was again measured. Little or no change was noted in the width of cracks in any except wall B69, and the maximum width of cracks in the top of this wall had increased from about 0.012 in. to 0.04 in.; the large increase in crack width indicates a structural failure not common to the other walls.
