NIST Technical Note 1794

**The Performance of Concrete Tile
and Terracotta Tile Roofing
Assemblies Exposed to
Wind-Driven Firebrand Showers**

Samuel L. Manzello

March, 2013

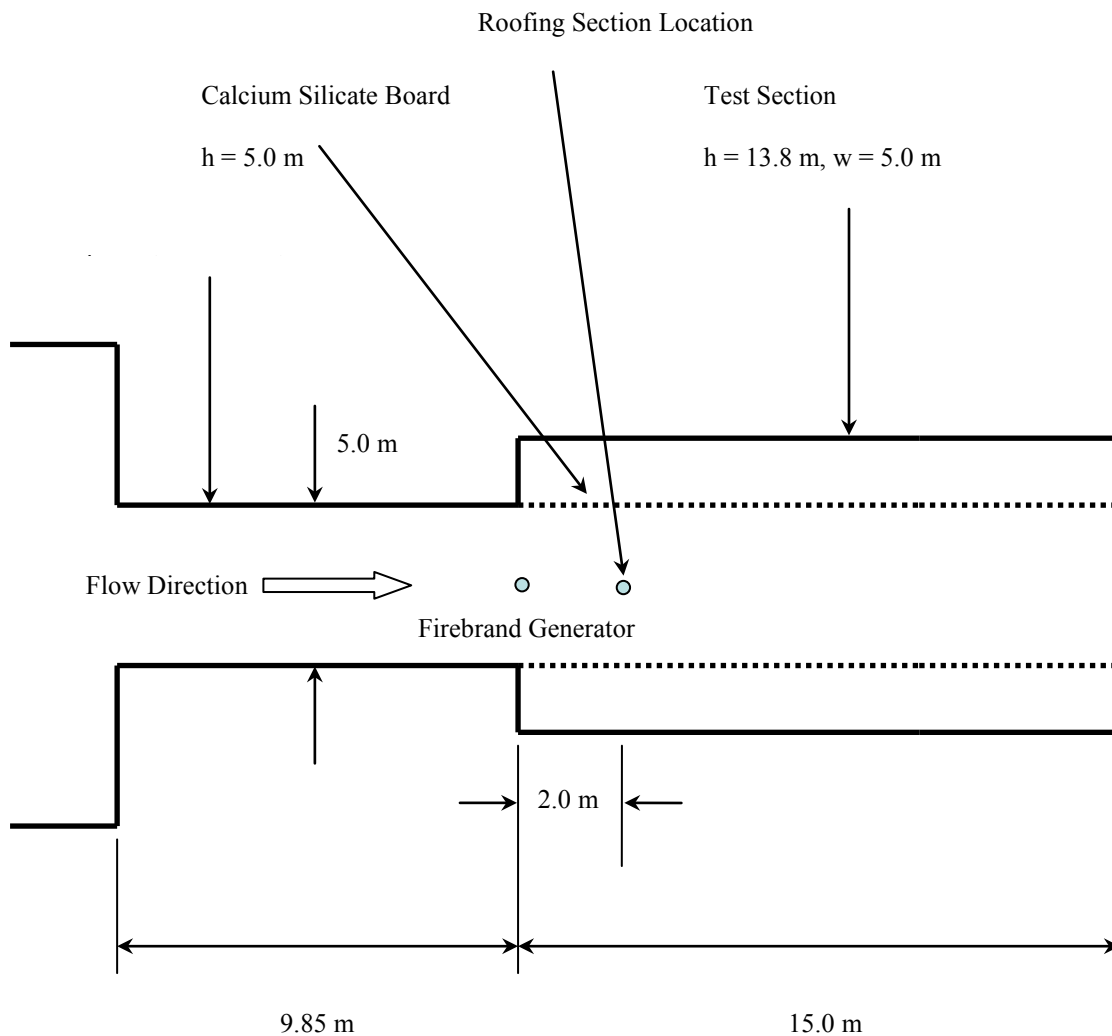
Figure 2. Schematic of BRI's Fire Research Wind Tunnel Facility (FRWTF).

The NIST Firebrand Generator was installed inside the test section of the FRWTF at BRI (see Figure 2) in Japan. The facility was equipped with a 4.0 m diameter fan used to produce the wind field and was capable of producing up to a 10 m/s wind flow. The uniformity of the wind flow velocity distribution was verified using a 21 point hot wire anemometer array. The array was translated across the entire 15 m test section to map out the flow distribution. The flow was uniform (within 10 %) across the entire length of 15 m test section [3].

A custom assembly was constructed to mount the tile roofing assemblies. In all experiments, the tile roofing assemblies were mounted 2.0 m downstream of the NIST Firebrand Generator (see Figure 2); the same location as used by Manzello *et al.* [5]. In these experiments, no decking was included in the supporting structure as these experiments were intended to replicate Australian construction details. Underlayment (sarking) in the form of a layer of aluminium foil laminate bonded with a fire retardant adhesive to a polymer fabric, was placed under the tile battens. The batten spacing was adjusted depending on the type of ceramic or terracotta tile roofing assembly being tested. A photograph of the custom assembly for the experiments is shown in Figure 3. The sarking (green material) as well as the battens used to support the tiles are clearly visible in the figure. Figures 4-8 display the four types of tile roofing assemblies tested, including two concrete tile roofing assemblies (flat and profiled tiles) as well as two terracotta tile roofing assemblies (flat and profiled tiles). The differences between the flat and profiled tiles are obvious in the images. A 25 degree pitch was used for all roofing assemblies. The overall dimensions of each roof assembly were 1.2 m by 1.2 m. The flat terracotta tiles had an interlocking design. The tile roofing assemblies were constructed in an attempt to have uniform gaps across the tiles.

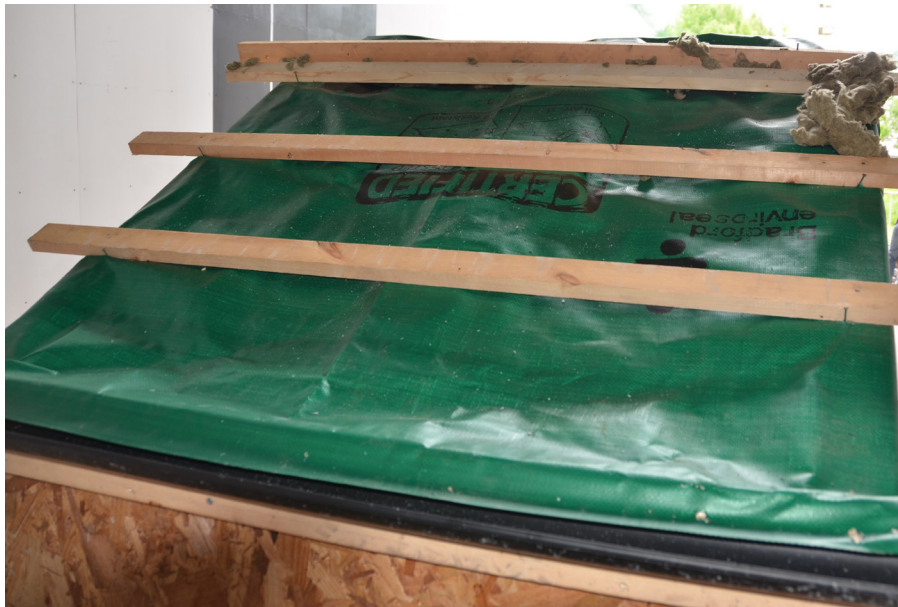
Figure 3. Custom Assembly used to Mount the Various Tile Roofing Assemblies. The Sarking (green material) as well as the Battens used to Support the Tiles are Clearly Visible. In this Picture the Batten Spacing was Adjusted for Terracotta Tiles (flat tiles).

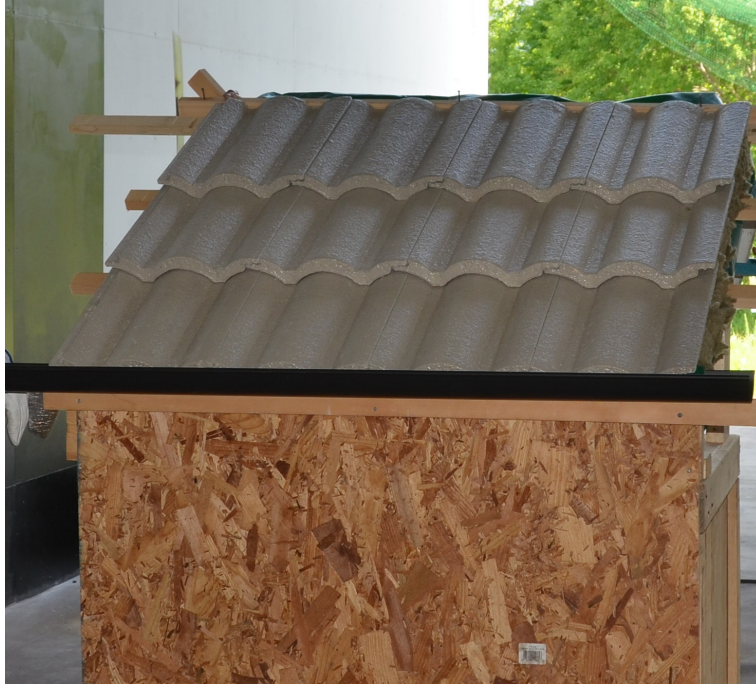
Figure 4. Concrete Tile Roofing Assembly (profiled tile) Exposed to Wind-Driven Firebrand Showers. The dimensions of each tile were 420 mm long by 320 mm wide. The Height, from the Wind Tunnel Floor to the Base of the Gutter of Roof Deck was 1250 mm.

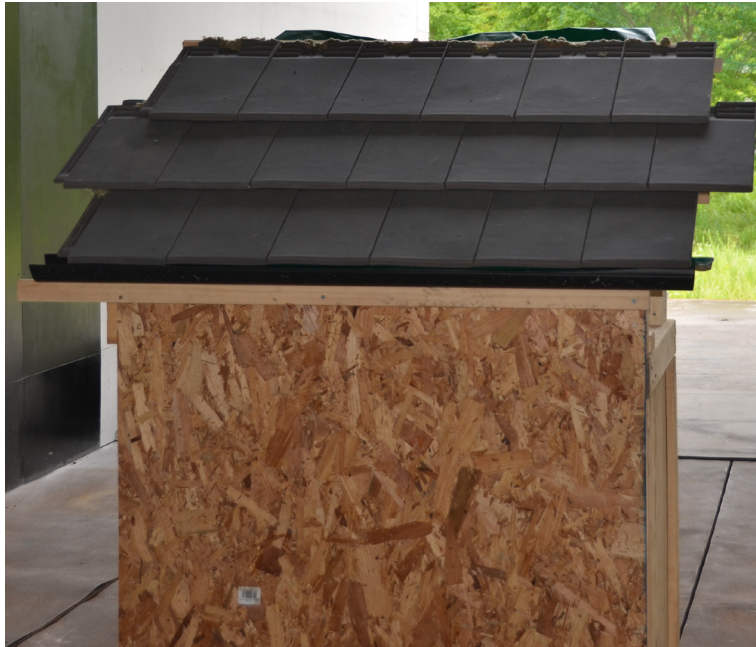
Figure 6. Terracotta Tiles Roofing Assembly (flat tile) Exposed to Wind-Driven Firebrand Showers. The Dimensions of Each Tile were 425 mm long by 265 mm wide. The Height, from the Wind Tunnel Floor to the Base of the Gutter of Roof Deck was 1250 mm.

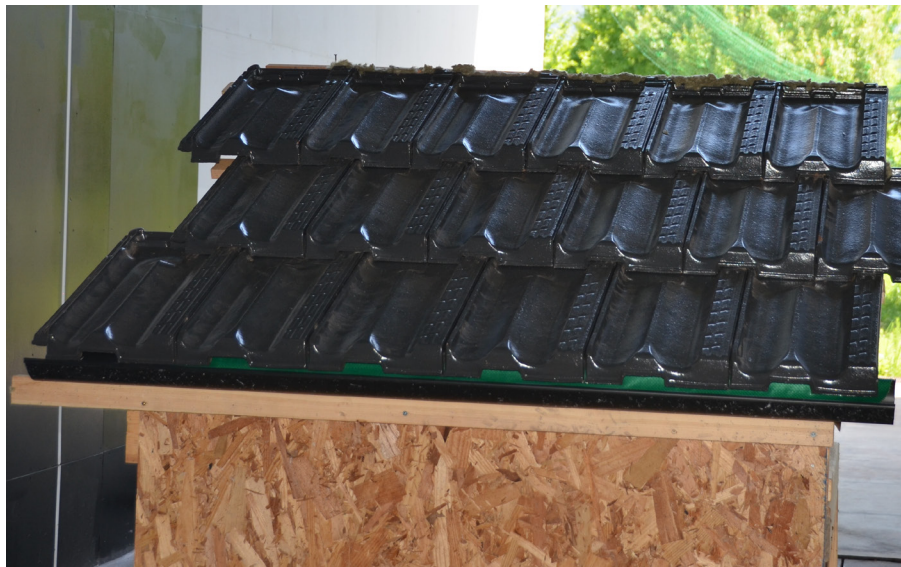
Figure 7. Terracotta Tile Roofing Assembly (profiled tile) Exposed to Wind-Driven Firebrand Showers. The Dimensions of Each Tile were 423 mm long by 265 mm wide. The Height, from the Wind Tunnel Floor to the Base of the Gutter of Roof Deck was 1250 mm.

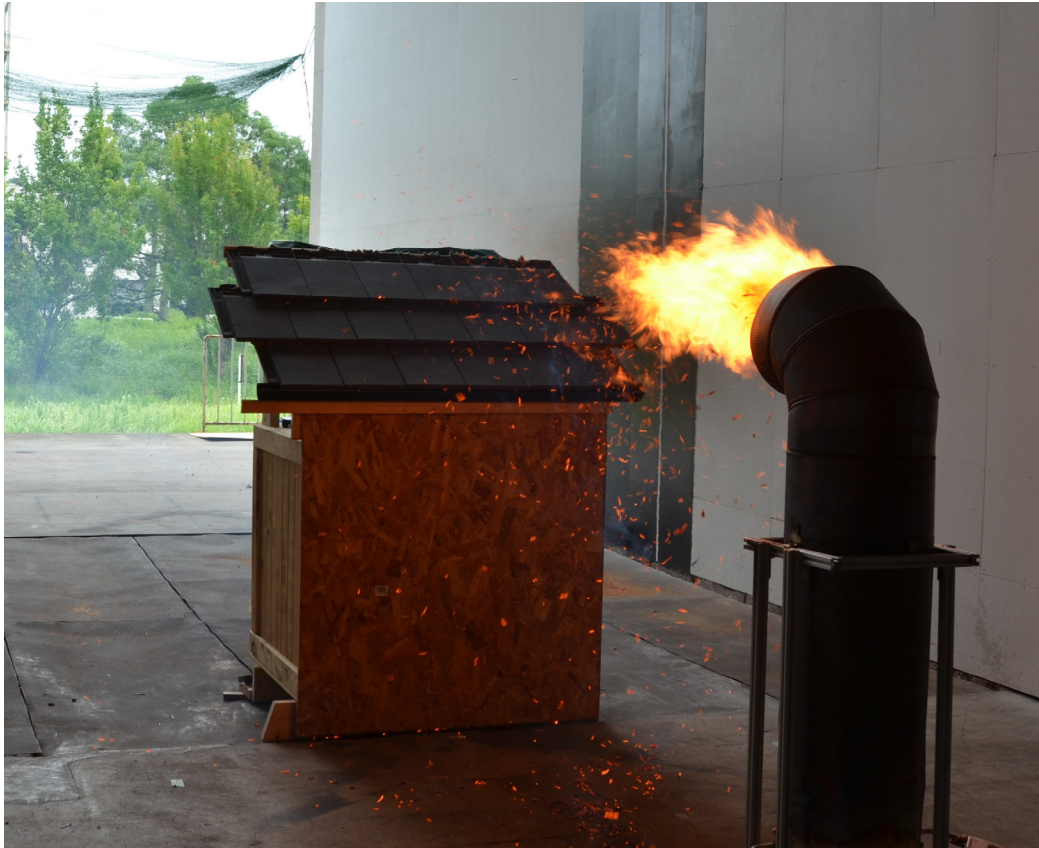
Figure 8. Typical Experiments Exposing Terracotta Tile Roofing Assembly (flat tiles in this image). The Wind Tunnel Speed was 9 m/s and the Roofing Assembly was Located 2.0 m from the NIST Dragon. The Average Total Firebrand Mass Flux was $10 \text{ g/m}^2\text{s}$.

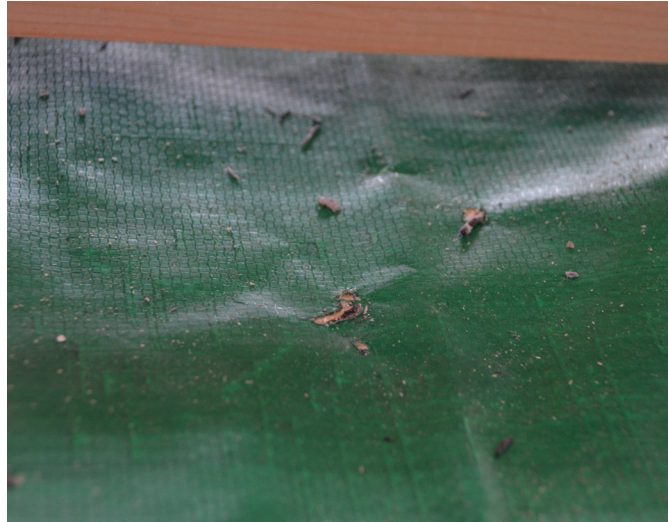
Figure 9. Images of Sarking Placed Under Concrete Tiles (profiled tile) Taken Immediately after the Experiment was Completed. The Tiles have been Removed.

The terracotta tile roofing assembly constructed of profiled tiles (no interlocking) performed similarly to both types of concrete tiles used; namely firebrands were observed to penetrate the tiles and melt the sarking. For the terracotta tile roofing assembly (flat tile), these tiles are interlocked, and it was observed that, after the firebrands penetrated the tile gaps, the firebrands were trapped within the interlocking between the tiles so essentially no penetration was observed onto the underlayment (sarking – see Figure 10).

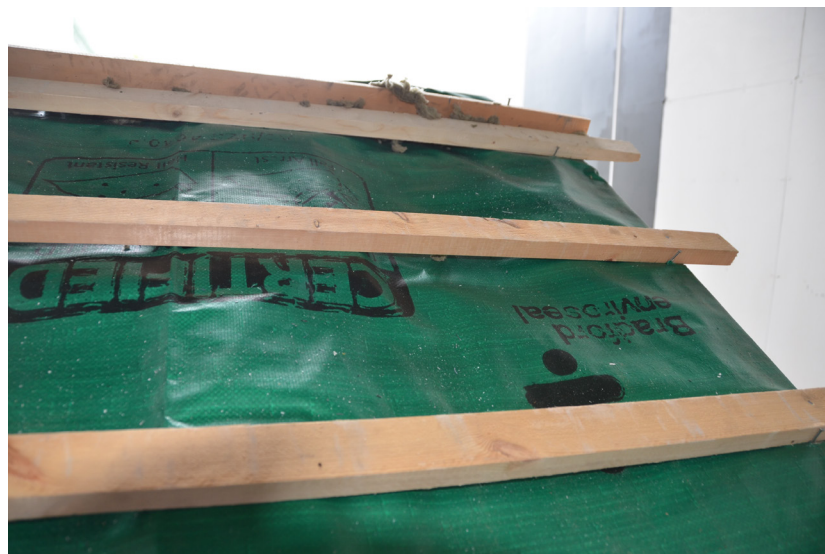
Figure 10. Photograph of sarking placed under terracotta tiles (flat tiles) taken immediately after the experiment was complete. The tiles have been removed. No firebrand penetration was observed.
