REPORT BMS101  
Strength and Resistance to  
Corrosion of Ties for  
Cavity Walls

ISSUED JULY 1, 1943

# Strength and Resistance to Corrosion of Ties for Cavity Walls

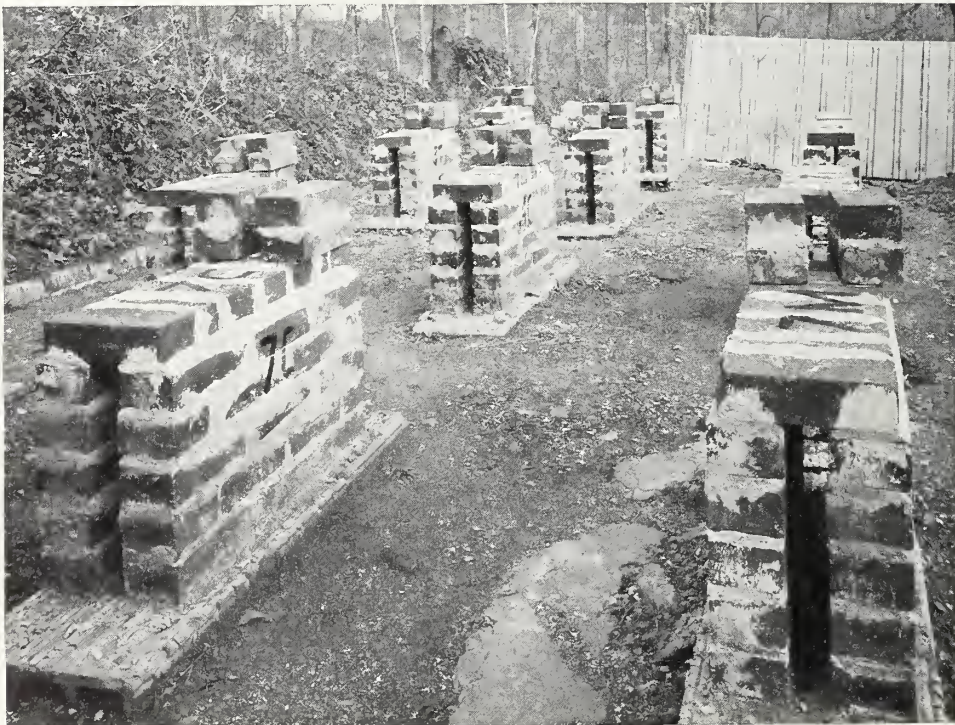
FIGURE 3.—Outdoor-weathering specimens.

The outdoor-weathering specimens, figure 3, were cavity-type wallettes. These specimens were three stretcher brick in length, five stretcher courses high, and were topped with a covering course of header brick. The cavity was 2 in. wide. Mortar *H* was used in all but the covering courses, which contained mortar *L*. Two ties were placed near the ends of the specimens in the bed joint between the first and second courses, and one tie was placed at midlength of the wall between the fourth and fifth courses. The joints were cut flush with the surfaces of the brick. The ties were of the same kind and were given the same protective coatings as those represented in the indoor-weathering specimens.

The small (indoor) weathering specimens were placed above the wallettes after the indoor tests were completed.
