NBSIR 81-2191 (DoE)

The Use of the Slow Strain Rate Technique for the Evaluation of Structural Materials for Application in High-Temperature Gaseous Environments

C. E. Johnson and G. M. Ugiansky

Final Report

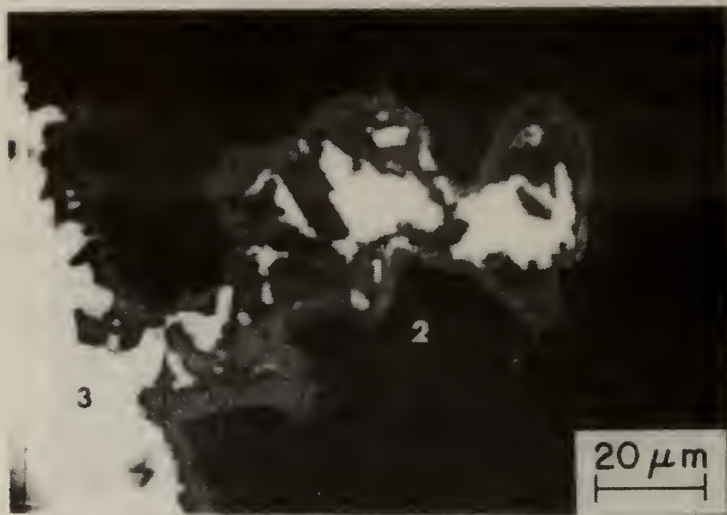
Fig. A-2. (a) Area of target current image for microprobe analysis.
(b) X-ray scan of crack showing sulfur distribution.
(c) X-ray scan of crack showing oxygen distribution.

The microprobe analysis has revealed that the duplex corrosion products on the surface of the specimen and in the cracks are mixed oxides and sulfides with the lighter colored corrosion product next to the bulk metal, rich in oxygen.

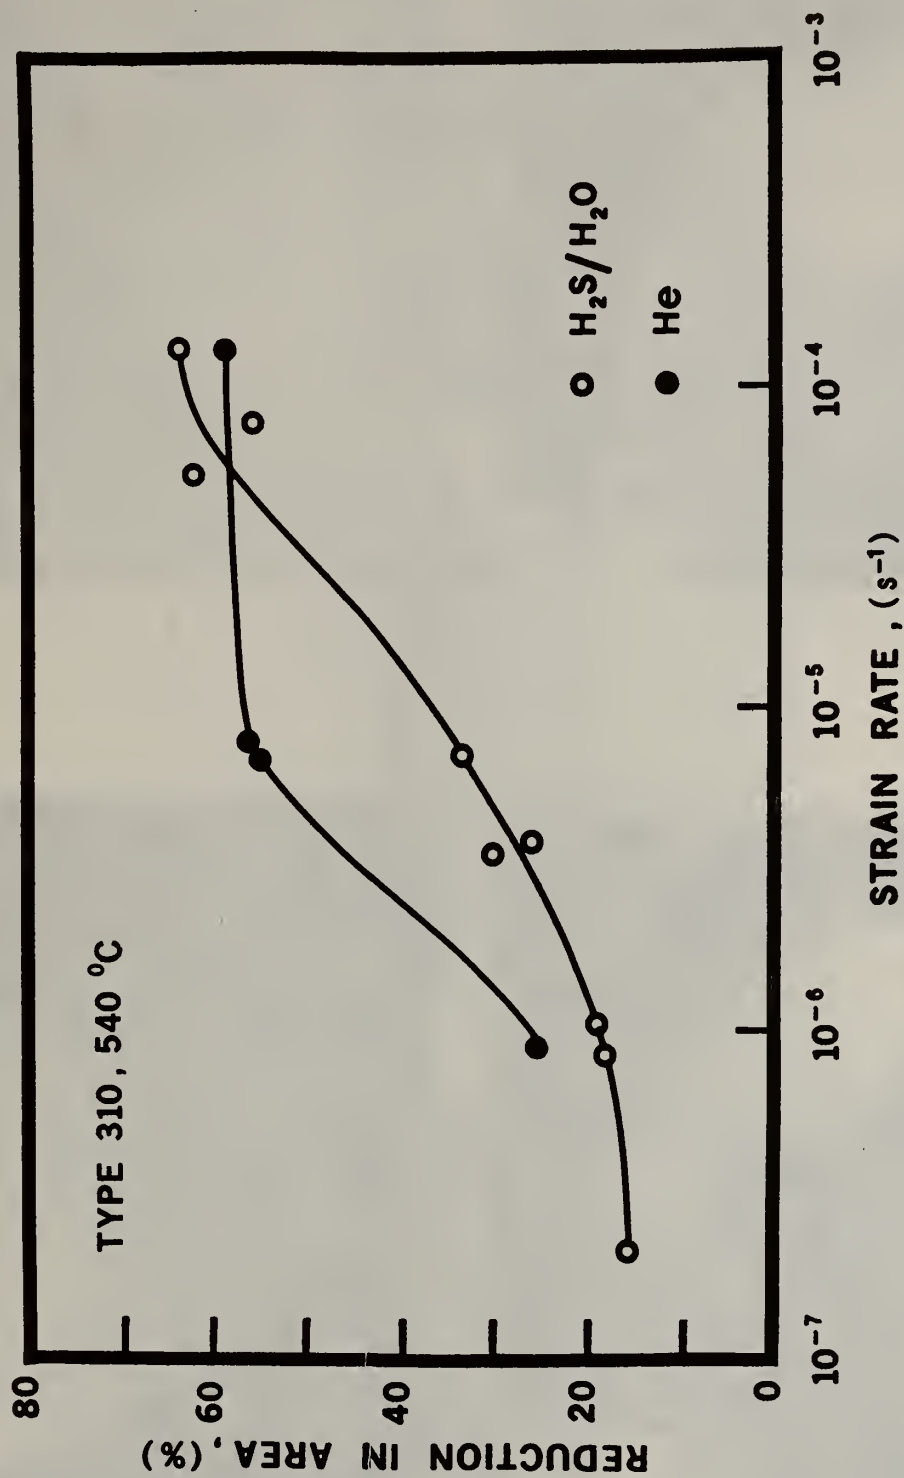
Fig. 5. Ductility as reduction in area versus strain rate for Type 310 specimens tested in gaseous H₂O/H₂S and He at 540 °C (1000 °F).

Type 310: Specimens were initially tested at 540°C(1000°F) in the H₂S environments. Typical stress-strain curves are shown in Fig. 4, and the various fracture parameters are presented in Fig. 5 and Table 3. It can be seen that the UTS, elongation and % reduction in area (RA) are markedly reduced at strain rates of 7.2×10^{-6} /s and slower. SEM examination indicated that the reduction in the tensile parameters was associated with the appearance of large numbers of surface cracks, Fig. 6. These formed throughout the gauge section and were approximately perpendicular to the stress axis, e.g., Fig. 6(d). In the case

For comparison purposes, specimens were also tested in He at 540°C(1000°F). The results, Fig. 5, indicated that the RA was again decreased at the lower strain rates, and SEM examination revealed the presence of intergranular cracks. A visible oxide film was observed, raising the possibility that this was responsible for the reduced RA. The supplier's analysis of the He gave a value of O₂ content of 0.1 to 0.5% while H₂O was listed at 2-250 ppm. Accordingly, further testing was carried out at a strain rate of 10⁻⁶/s in He which was first passed through heated Ti filings, phosphorus pentoxide, and a liquid-nitrogen trap; tests were also carried out in Ar and vacuum (2 x 10⁻² Torr). Intergranular cracking occurred in each case, Fig. 7. However, a visible oxide film was detectable in each case, so that the environments cannot be regarded as inert. A hard vacuum test cell probably would have prevented the oxide on the specimens, but equipment and time were not available to test this idea.

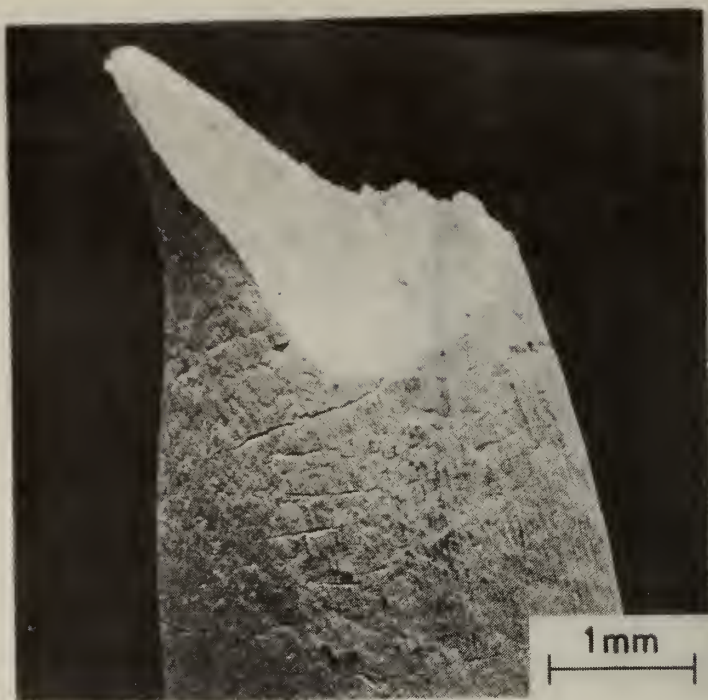
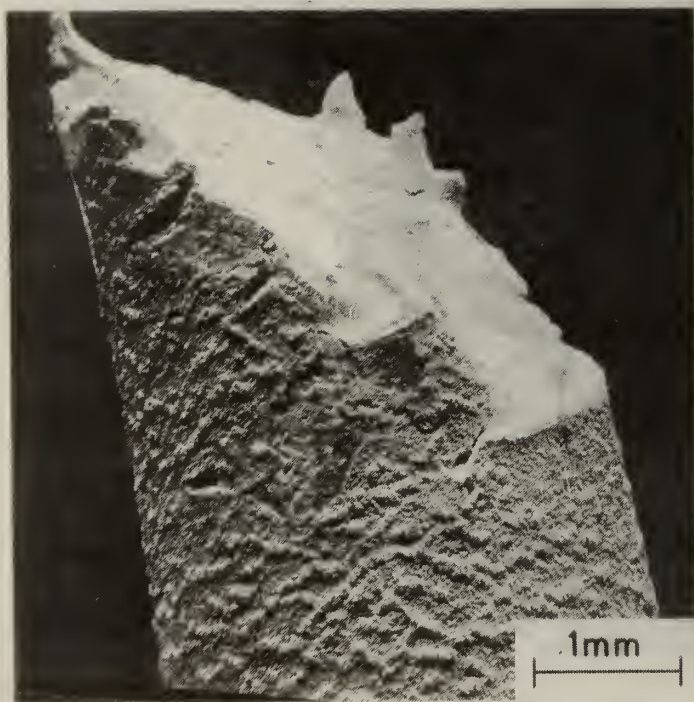
Fig. 6. Scanning electron micrographs indicating the effect of strain rate ($\dot{\epsilon}$) on the fracture of Type 310 specimens when tested in H_2O/H_2S at 540 °C (1000 °F).

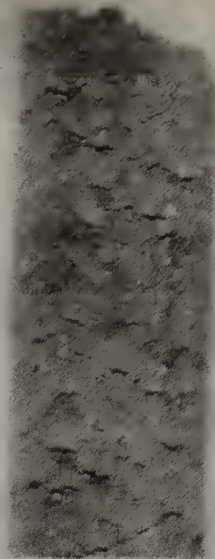
Fig. 7. Cracking of Type 310 specimens in various "inert" environments when tested at 540 °C (1000 °F) at a strain rate of 10^{-6} /s. Original magnification 7 X.

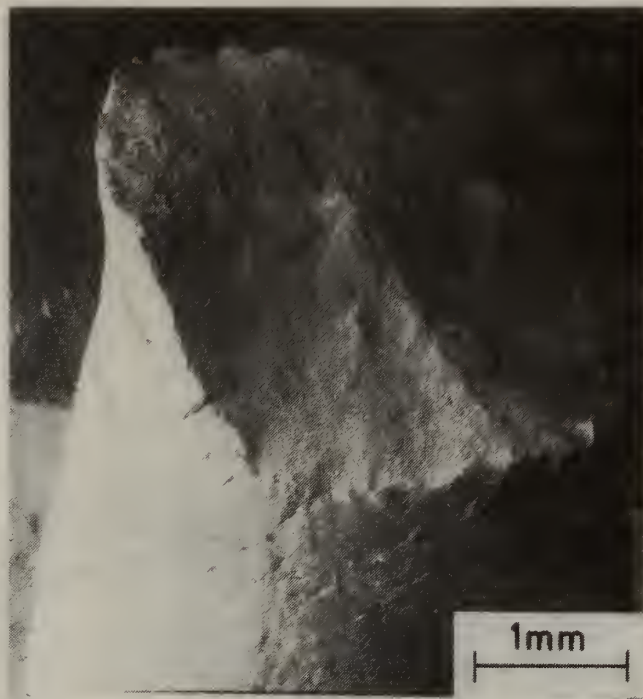
Fig. 11. Scanning electronmicrograph and photomicrograph of Type 310 specimen showing the ductile fracture and partially sensitized grain boundaries after testing in H_2 at $450\text{ }^\circ\text{C}$ ($840\text{ }^\circ\text{F}$) at a strain rate of $10^{-6}/\text{s}$.

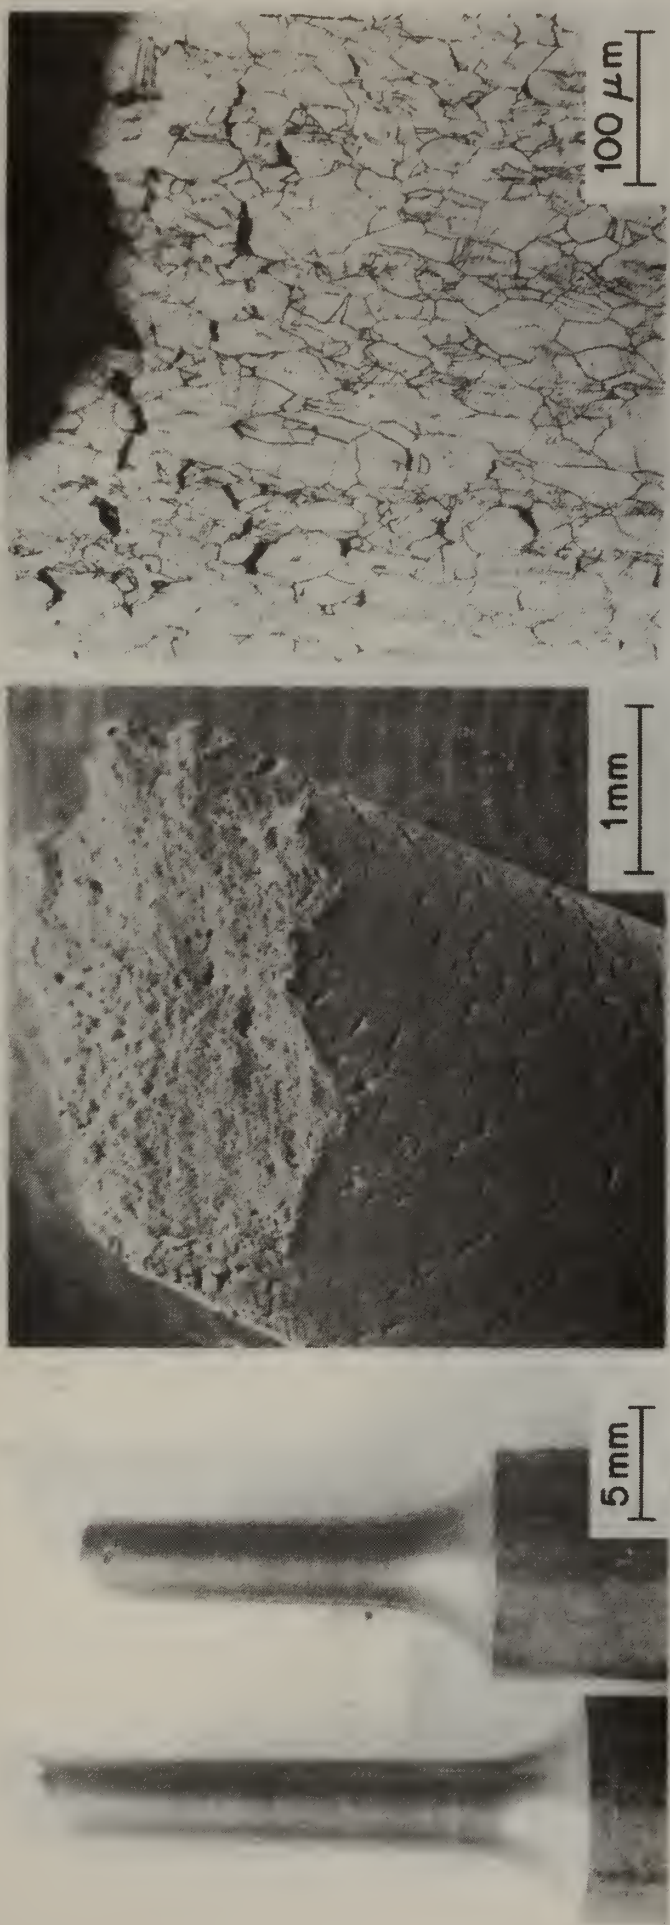
Fig. 17. Type 310 specimen tested in dry He at 600 °C at a strain rate of 1×10^{-6} /s.
 (a) Photomicrograph of fractured specimen.
 (b) Scanning electron micrograph at the region of fracture.
 (c) Photomicrograph of the sectioned specimen near the fracture.

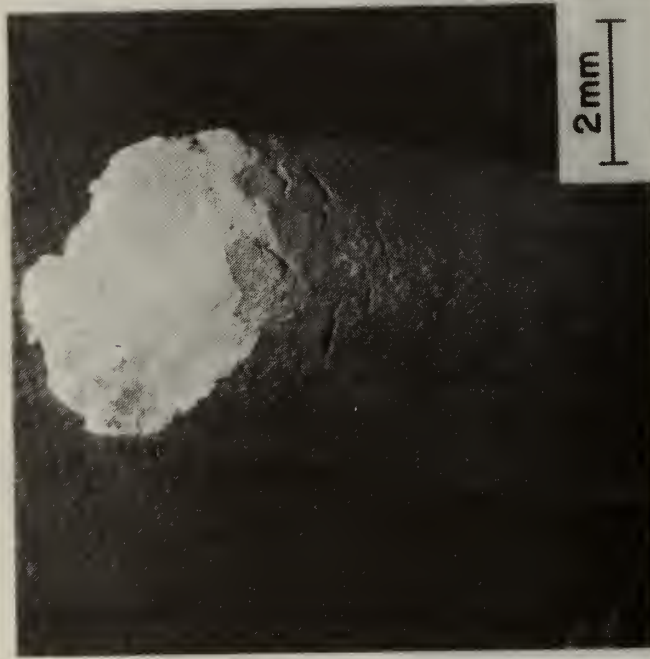
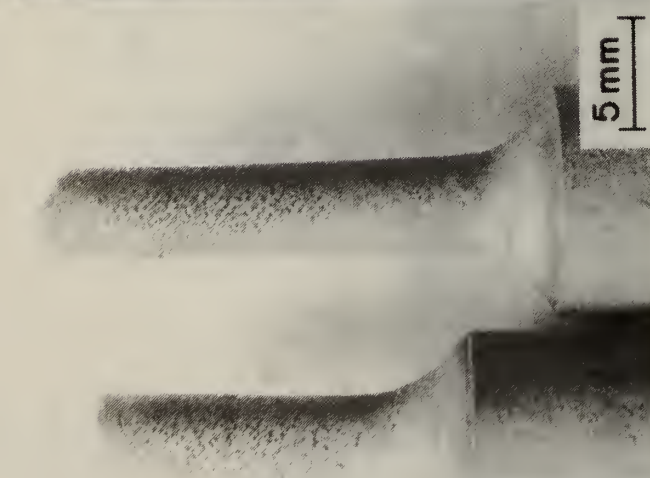
UTS — 347 MPa (50,300 psi)
 Elongation — 14.0%
 RA — 21.6%

Fig. 18. Type 310 specimen tested in the oxidizing-sulfidizing environment at 600 °C at a strain rate of 1×10^{-6} /s. (a) Photomicrograph of fractured specimen. (b) Scanning electron micrograph at the region of fracture. (c) Photograph of the sectioned specimen near the fracture.

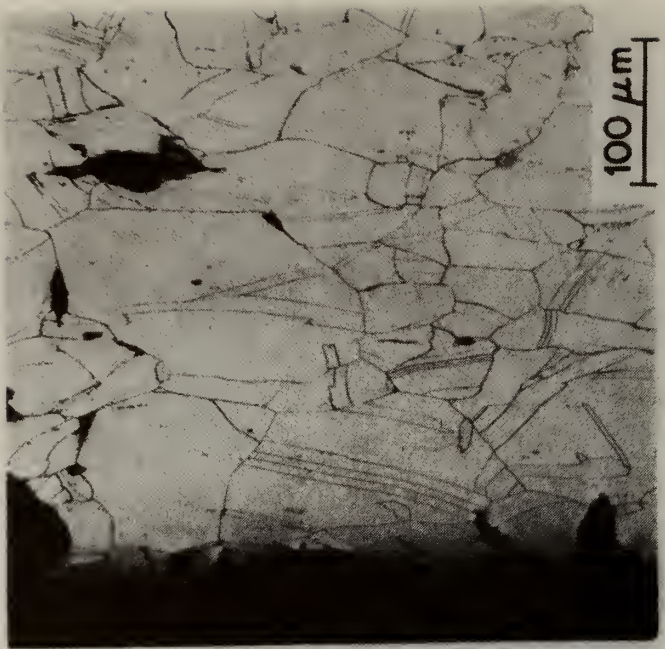
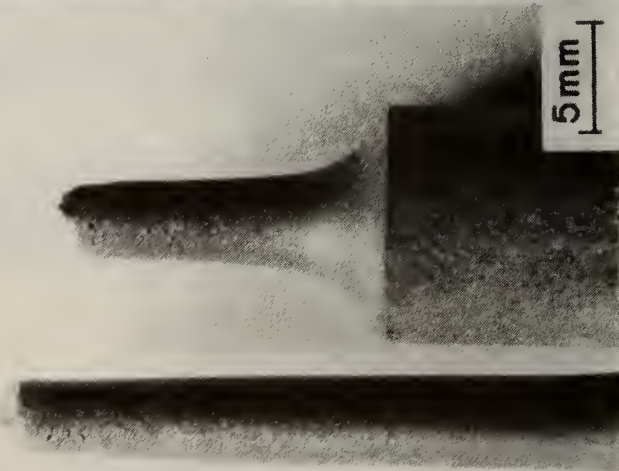
Fig. 25. Type 310S stainless steel tested in dry He at 600 °C at a strain rate of 1×10^{-6} /s.
 (a) Photomicrograph of the fractured specimen.
 (b) Scanning electron micrograph at the region of fracture.
 (c) Photomicrograph of the sectioned specimen near the fracture.

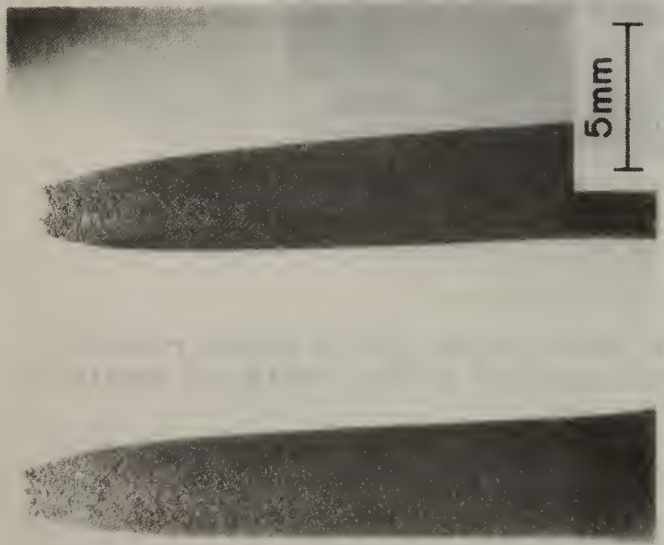
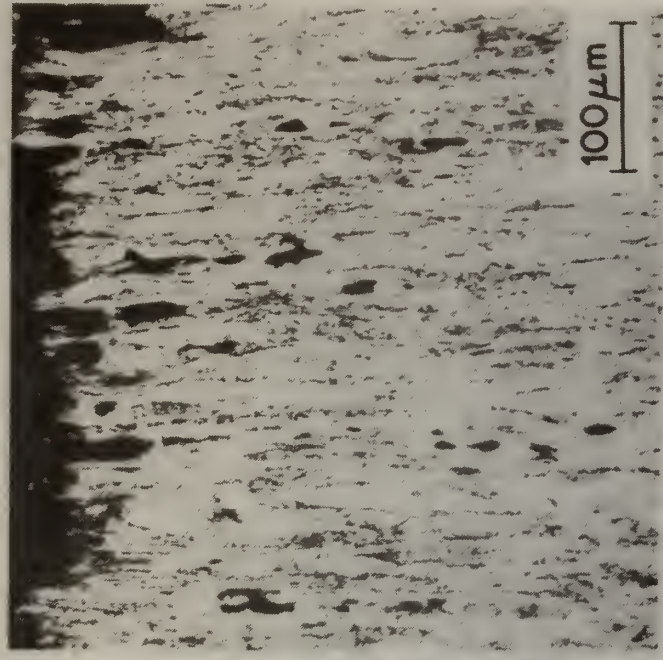
Fig. 44. Type 446 stainless steel tested in the oxidizing/sulfidizing environment at 600 °C at a strain rate of 1×10^{-6} /s. (a) Photomicrograph of the fractured specimen. (b) Scanning electron micrograph at the region of fracture. (c) Photomicrograph of the sectioned specimen near the fracture.

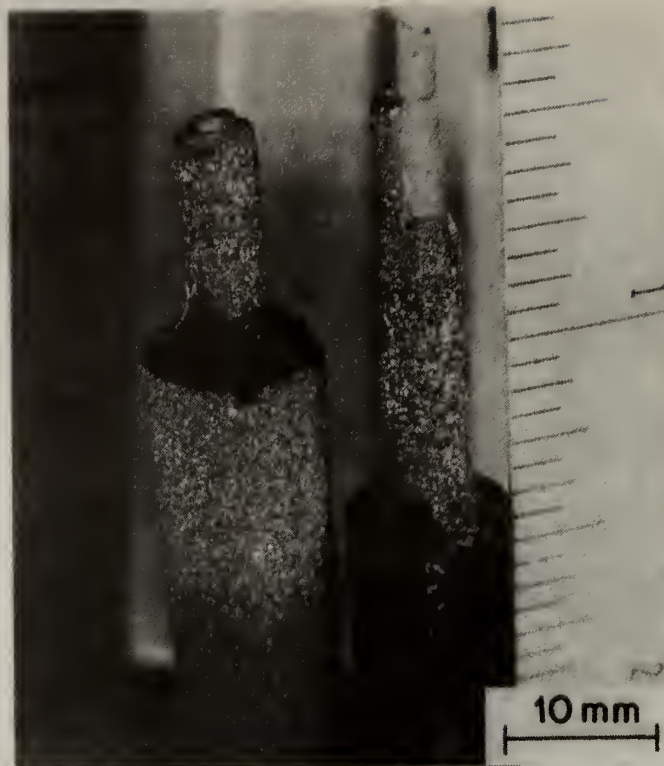
Fig. 46. In 800 specimen tested at 540 °C in wet H₂S at strain rate of 1.7×10^{-7} /s showing large amount of surface scale and remaining metal.

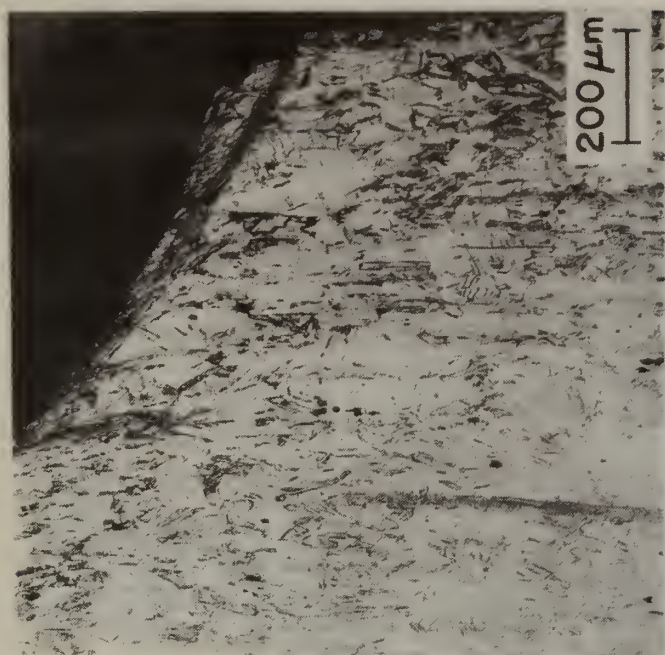
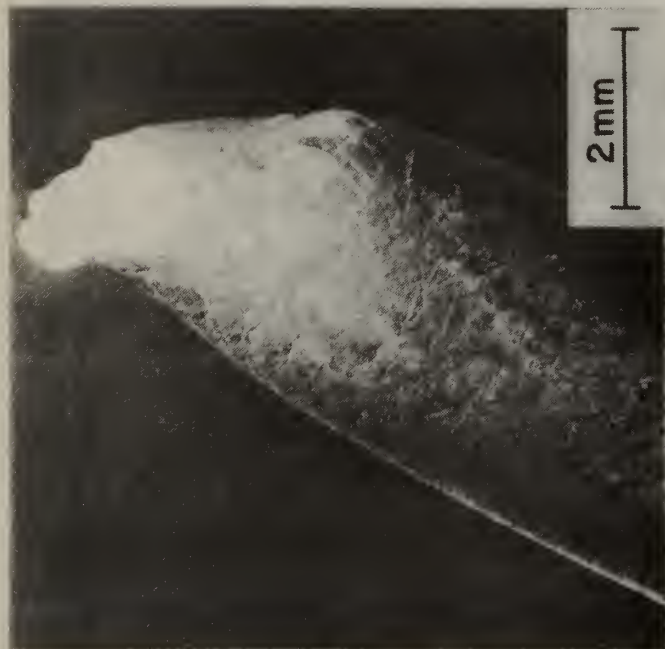
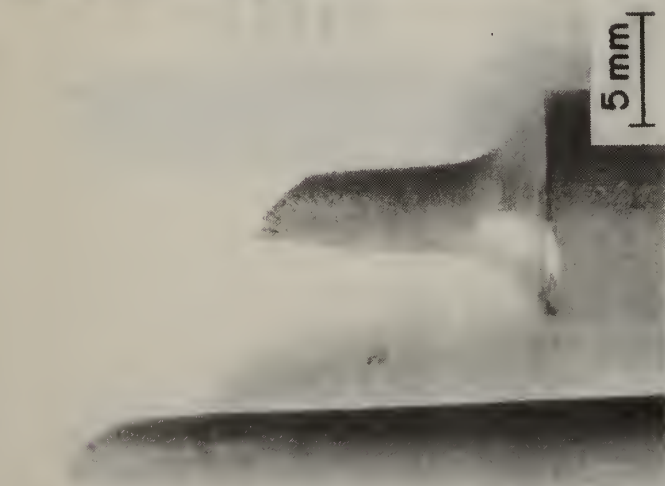
UTS — 544 MPa (78,900 psi)
 Elongation — 32.6%
 RA — 65.8%

Fig. 49. Incoloy 800 tested in the oxidizing/sulfidizing environment at 450 °C at a strain rate of 1 X 10⁻⁶/s. (a) Photomicrograph of the fractured specimen. (b) Scanning electron micrograph at the region of fracture. (c) Photomicrograph of the sectioned specimen near the fracture.

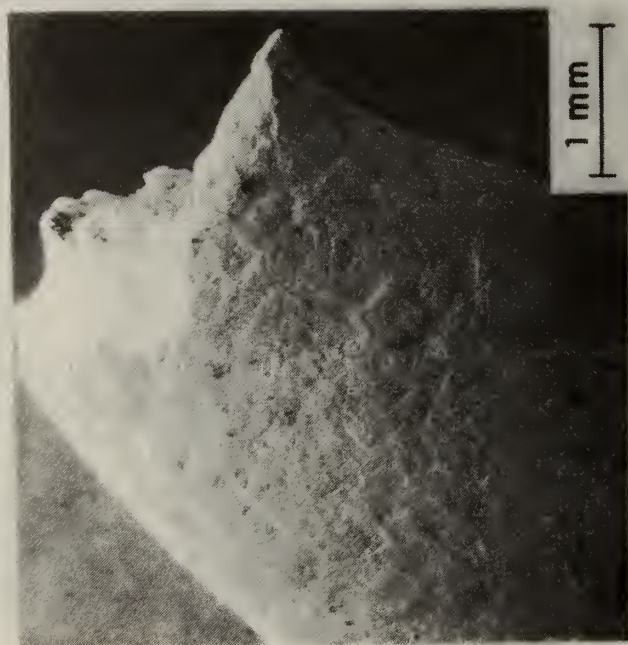
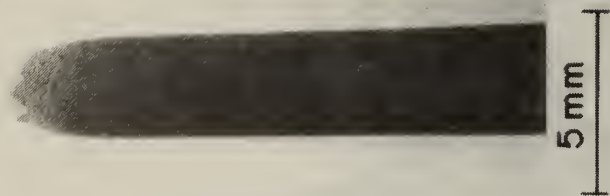
UTS — 551 MPa (79,800 psi)
 Elongation — 34.3%
 RA — 70.5%

Fig. 50. Incoloy 800 tested in the oxidizing/sulfidizing/carburizing environment at 450 °C at a strain rate of 1 X 10⁻⁶/s. (a) Photograph of the fractured specimen. (b) Scanning electron micrograph at the region of fracture. (c) Photomicrograph of the sectioned specimen near the fracture.
