NBSIR 77-1288 (NASC-Navy)

# Stress Corrosion Behavior of K01-T7 Aluminum Alloy Castings

September 1977

Prepared for  
**Naval Air Systems Command**  
Department of the Navy  
Washington, D. C. 20360

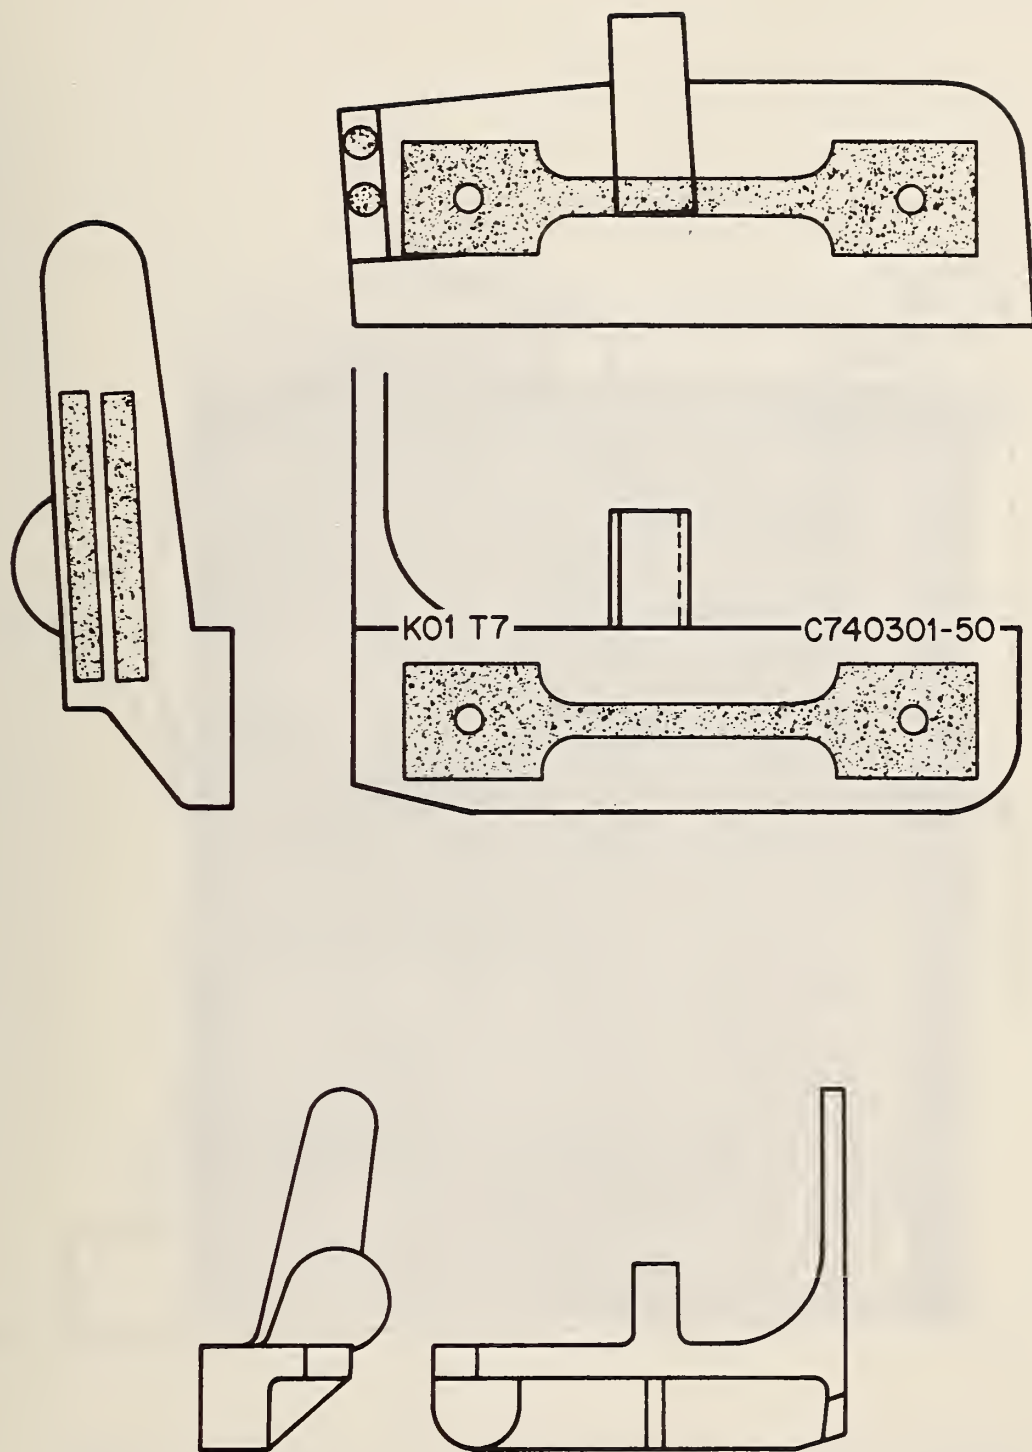
Figure 1. Drawing of bracket casting (C740301-50) showing origin of test specimens.

Four test specimens were prepared from each of the two bracket castings (part C740301-50). Two flat stress corrosion specimens were machined from the base of each bracket and two round tensile specimens were machined from the side of each bracket as shown in Figure 1. Fourteen round tensile specimens were machined from the one aluminum alloy flange casting marked C5T27377. Figure 2 illustrates the position of each specimen obtained from the parent material. All specimens were taken from solid sections of the castings and there were no visual indications of voids or flaws.

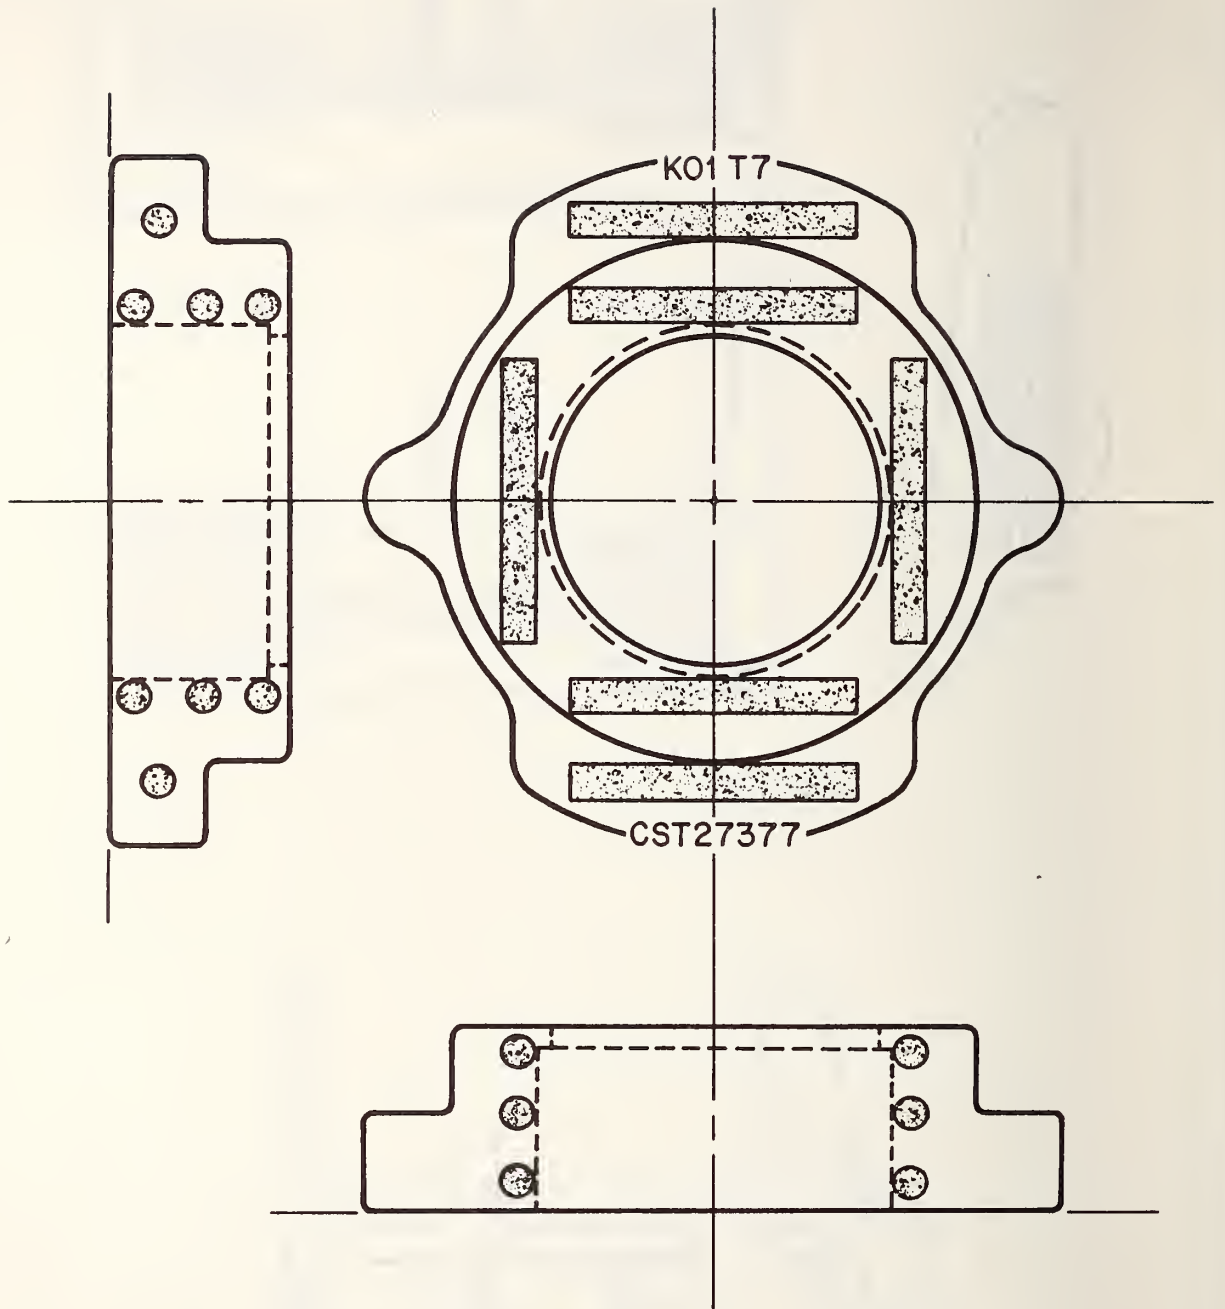
Figure 2. Drawing of flange casting (C5T27377) showing origin of test specimens.

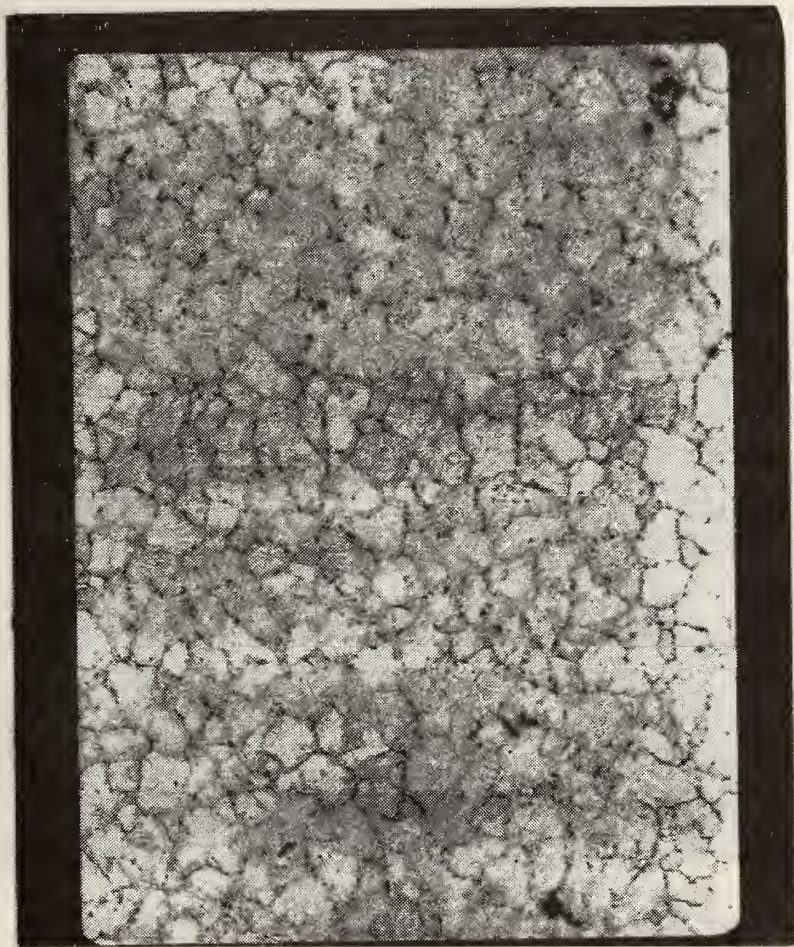
Figure 3. Microstructure of K01-T7 aluminum alloy. Etched, Keller's, etch. X50.

Sections were obtained from areas at and adjacent to the fracture surfaces of the failed specimens for metallographic examination. In general, the microstructure for both specimens revealed a uniform grain size and the presence of intermetallic precipitates at the grain boundaries (Figure 3). Metallographic examination of areas at the fracture showed that the fracture surface was both intergranular and transgranular (Figure 4) with no evidence of secondary cracking.

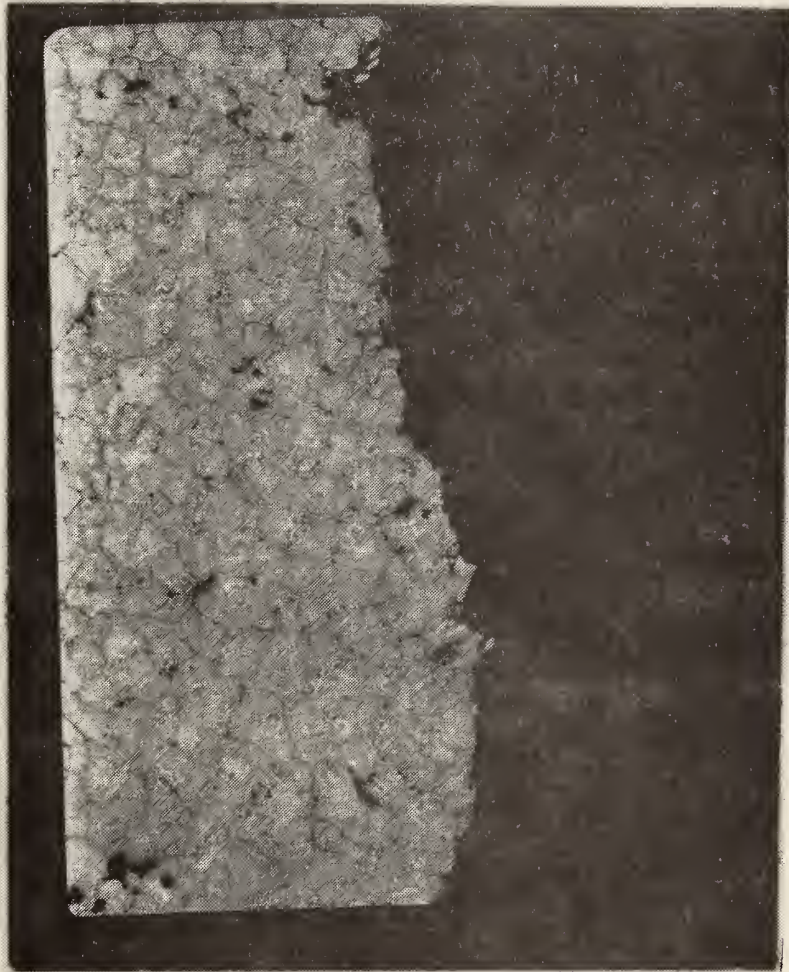
Figure 4. Fracture surface of failed K01-T7 aluminum alloy specimen after exposure for 37 days. Fracture is both intergranular and transgranular. Etched, Keller's etch. X50.

The results obtained from stress corrosion tests on K01-T7 aluminum alloy indicate that the alloy may be subject to stress corrosion. Examination of failed (37 and 249 days) specimens, which had been stressed by the constant load method, showed that the fractures were both transgranular and intergranular in nature. Other specimens stressed by the constant strain method had not failed after 1160 days of exposure. Both of the failures which occurred during exposure in the marine atmosphere were from specimens removed from the brackets. However, these were the only specimens exposed utilizing a constant load system. The alloy also exhibited a considerable amount of shallow surface pitting which was accompanied by heavy adherent gray corrosion products. Since the number of specimens tested was limited by the amount of material available, due consideration should be given to further testing of this alloy under constant load conditions at the same and lesser applied stresses.
