**NIST****National Institute of Standards and Technology**
Technology Administration, U.S. Department of Commerce***NIST Technical Note 1541*****Propagation and Detection of Radio
Signals Before, During, and After the
Implosion of a Large Sports Stadium
(Veterans' Stadium in Philadelphia)**

Christopher L. Holloway
Galen Koepke
Dennis Camell
Kate A. Remley
Dylan F. Williams
Susan A. Schima
Seturnino Canales

October 2005

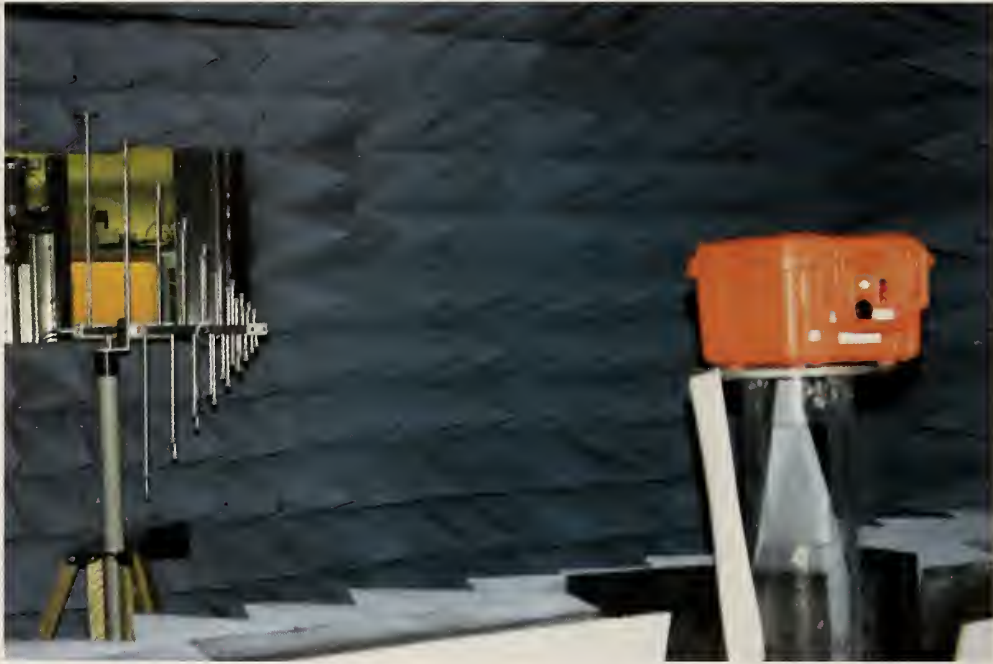
Figure 7. Transmitter in the NIST Boulder anechoic chamber.

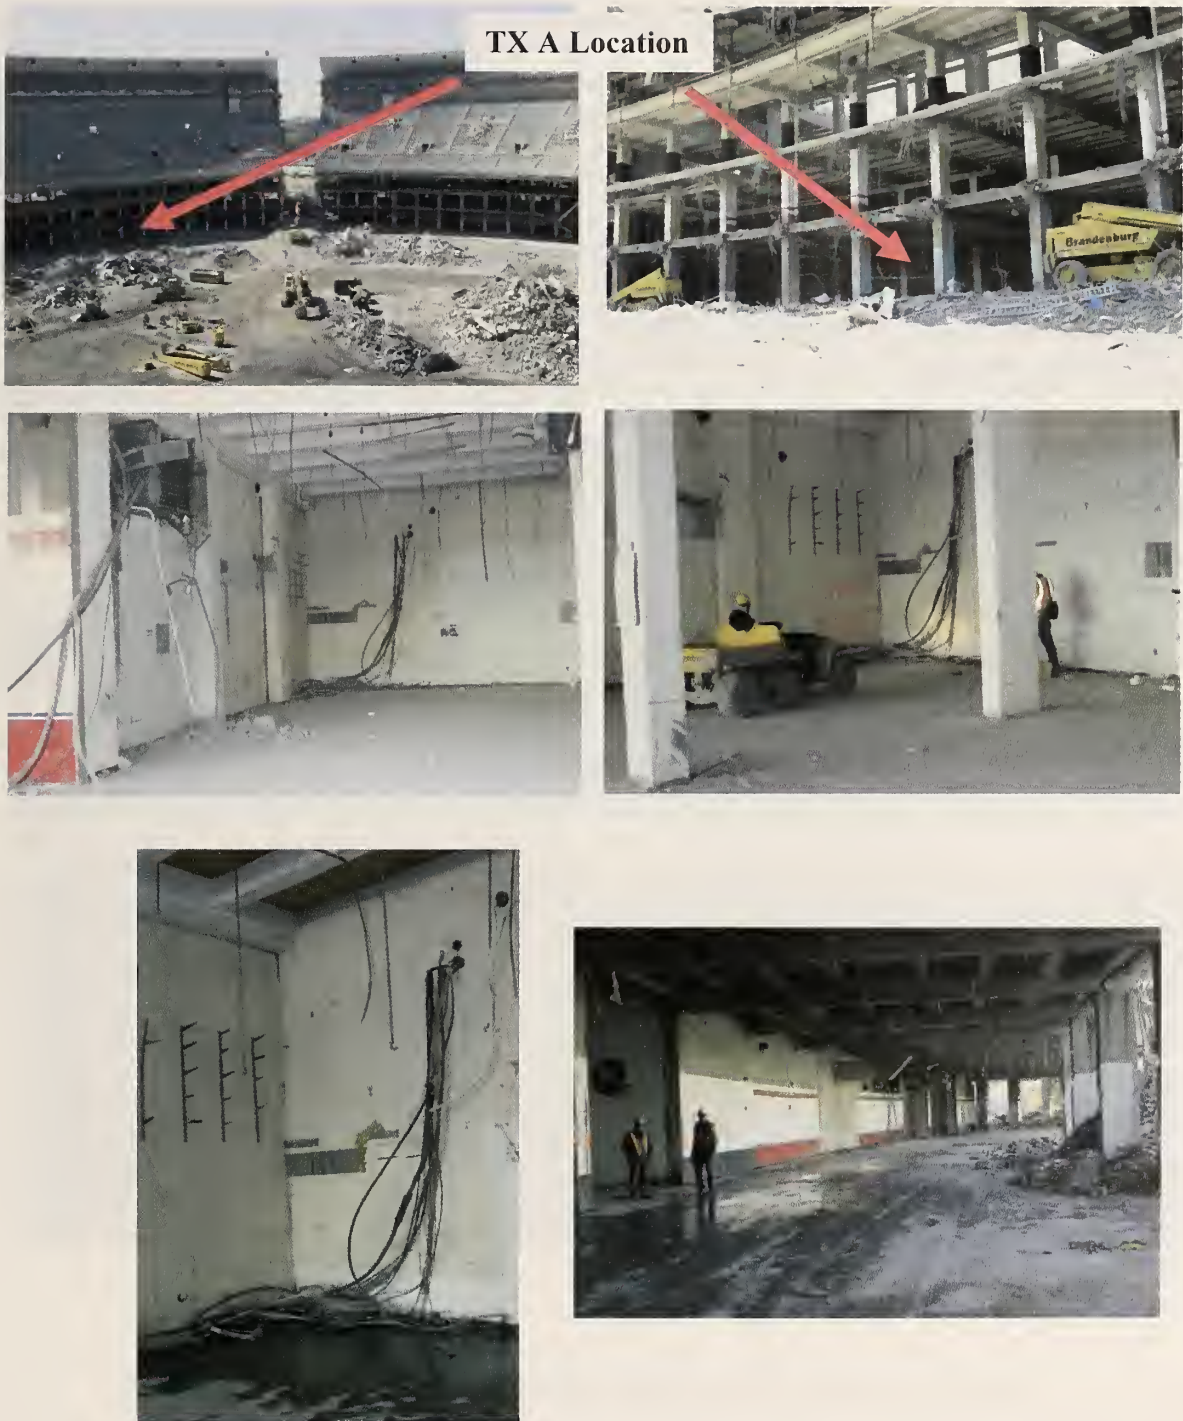
Figure 15. Fixed transmitter location TX A on south-side of sub-level.

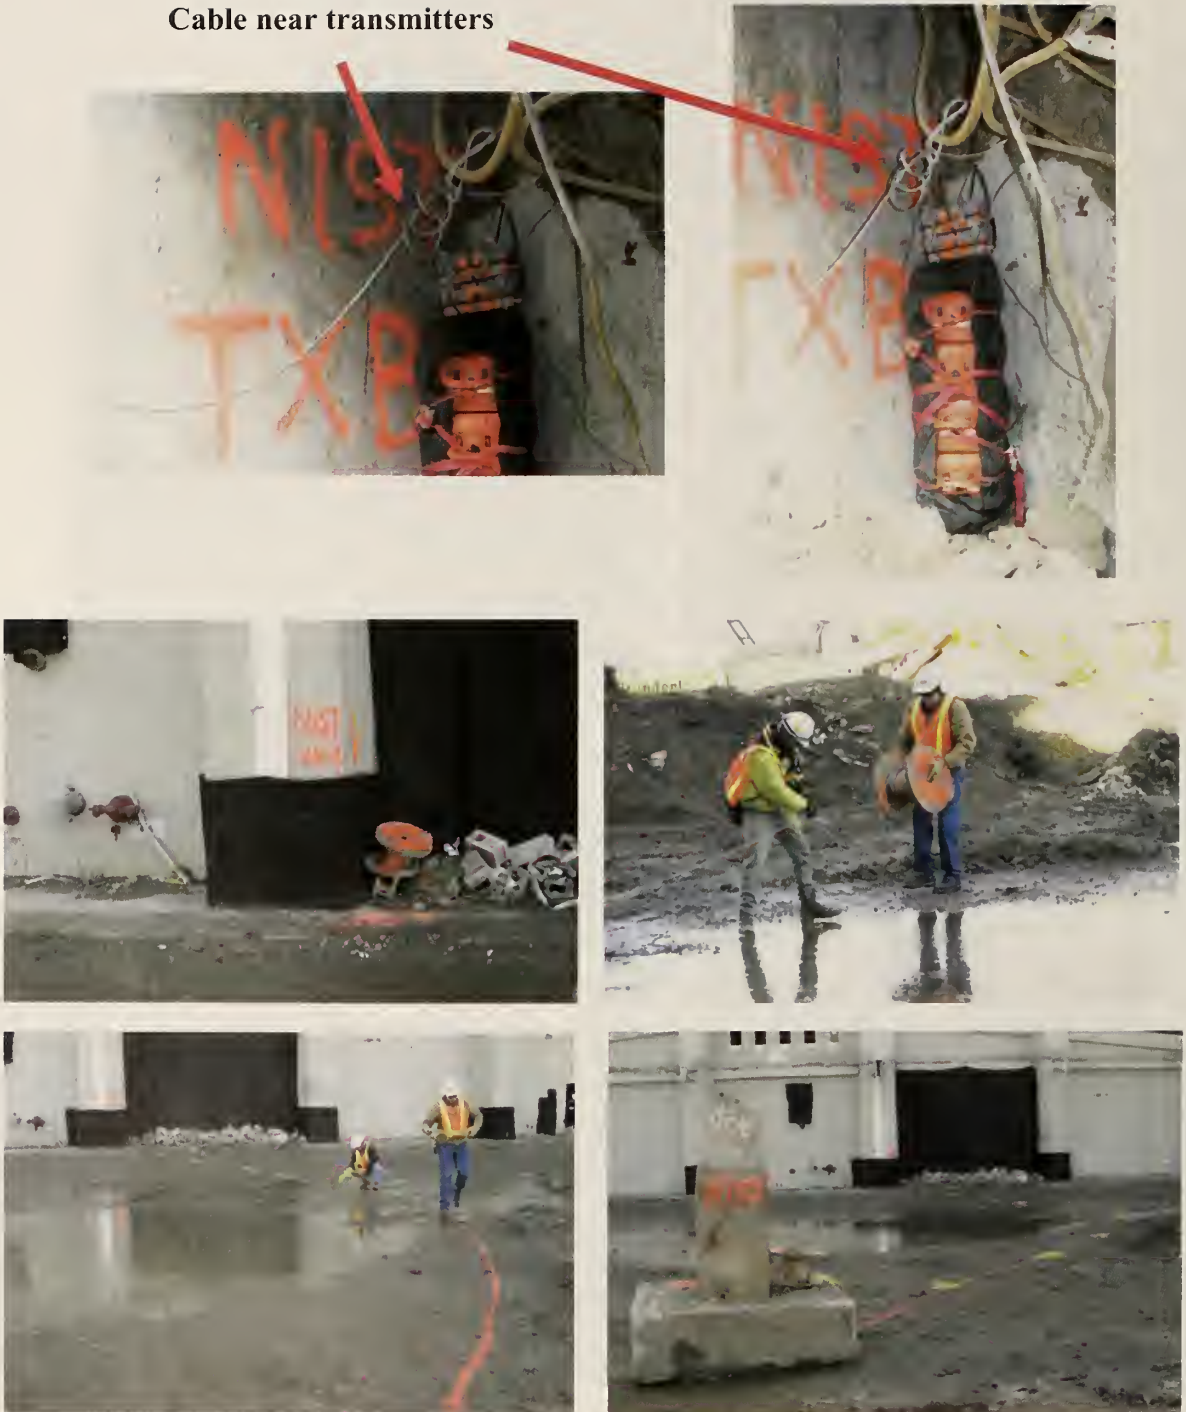
Figure 22. Cable on north side of stadium. This cable was run from the transmitter site on the playing field (TX B).

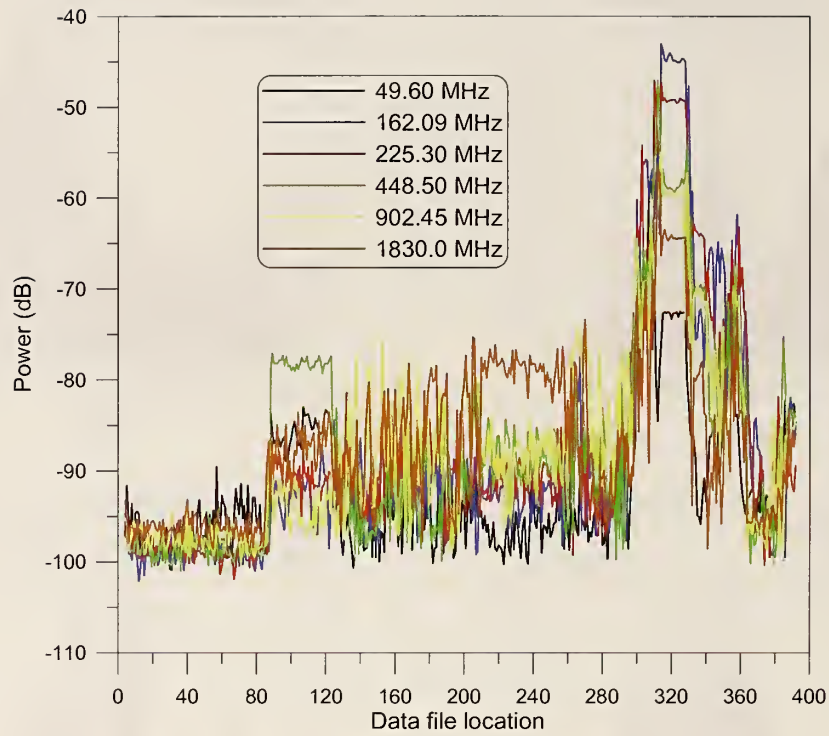
Figure 34. Signal strength measurements around the perimeter of the stadium for the transmitters located at fixed Site A and vertically polarized receiving antennas.

Figures 34 and 35 show the variability in the signal strength around the perimeter of the stadium for all six frequencies for transmitters located at fixed Site A. These two figures are for vertically and horizontally polarized receiving antennas, respectively. It should be noted that as the cart was pulled around the building, the antennas on the cart were always pointed toward the center of the stadium. Figures 36 and 37 show the data in Figure 34 and 35 normalized with respect to the overall (either horizontal or vertical polarization) maximum received signal. That is, each frequency is normalized to its maximum level for all data recorded during both perimeter travels of the receiving cart. We should note that this normalization reference includes a certain unknown amount of attenuation, caused by the structure between the transmit site and the location of best coupling on the exterior perimeter, which we cannot remove. These two plots show the relative variability in the signal strength as the cart is moved around the stadium. From these plots, we see that the presence of the stadium causes the signal to vary by as much as 55 dB around the stadium perimeter.

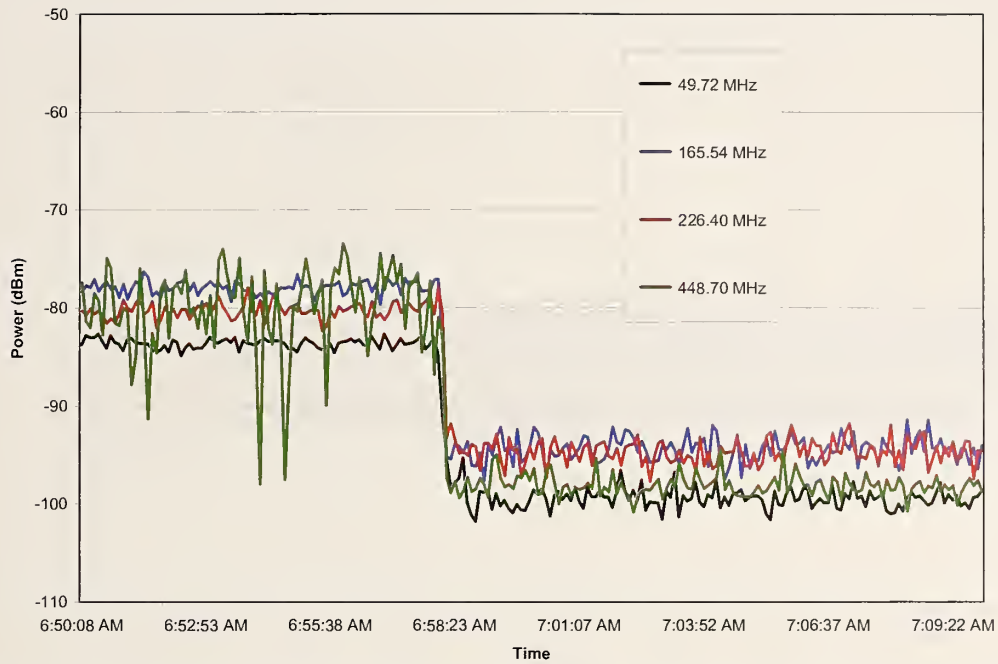
Figure 60. Pre- and post-implosion data collected from Receiver Site 1 for the transmitters located at Site C.

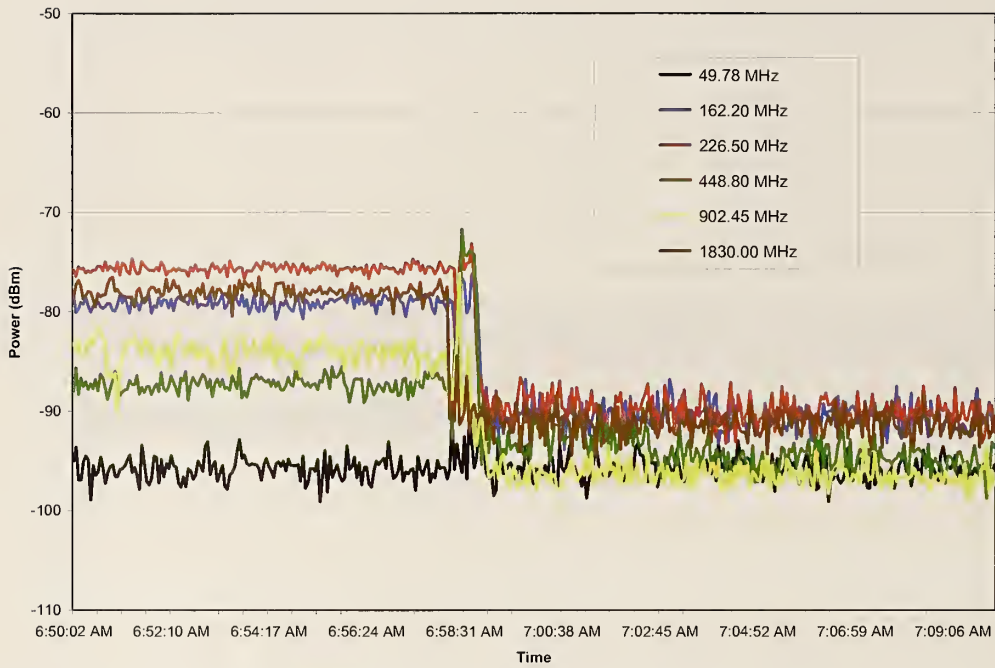
Figure 66. Pre- and post-implosion data collected from Receiver Site 3 for the transmitters located at Site A.

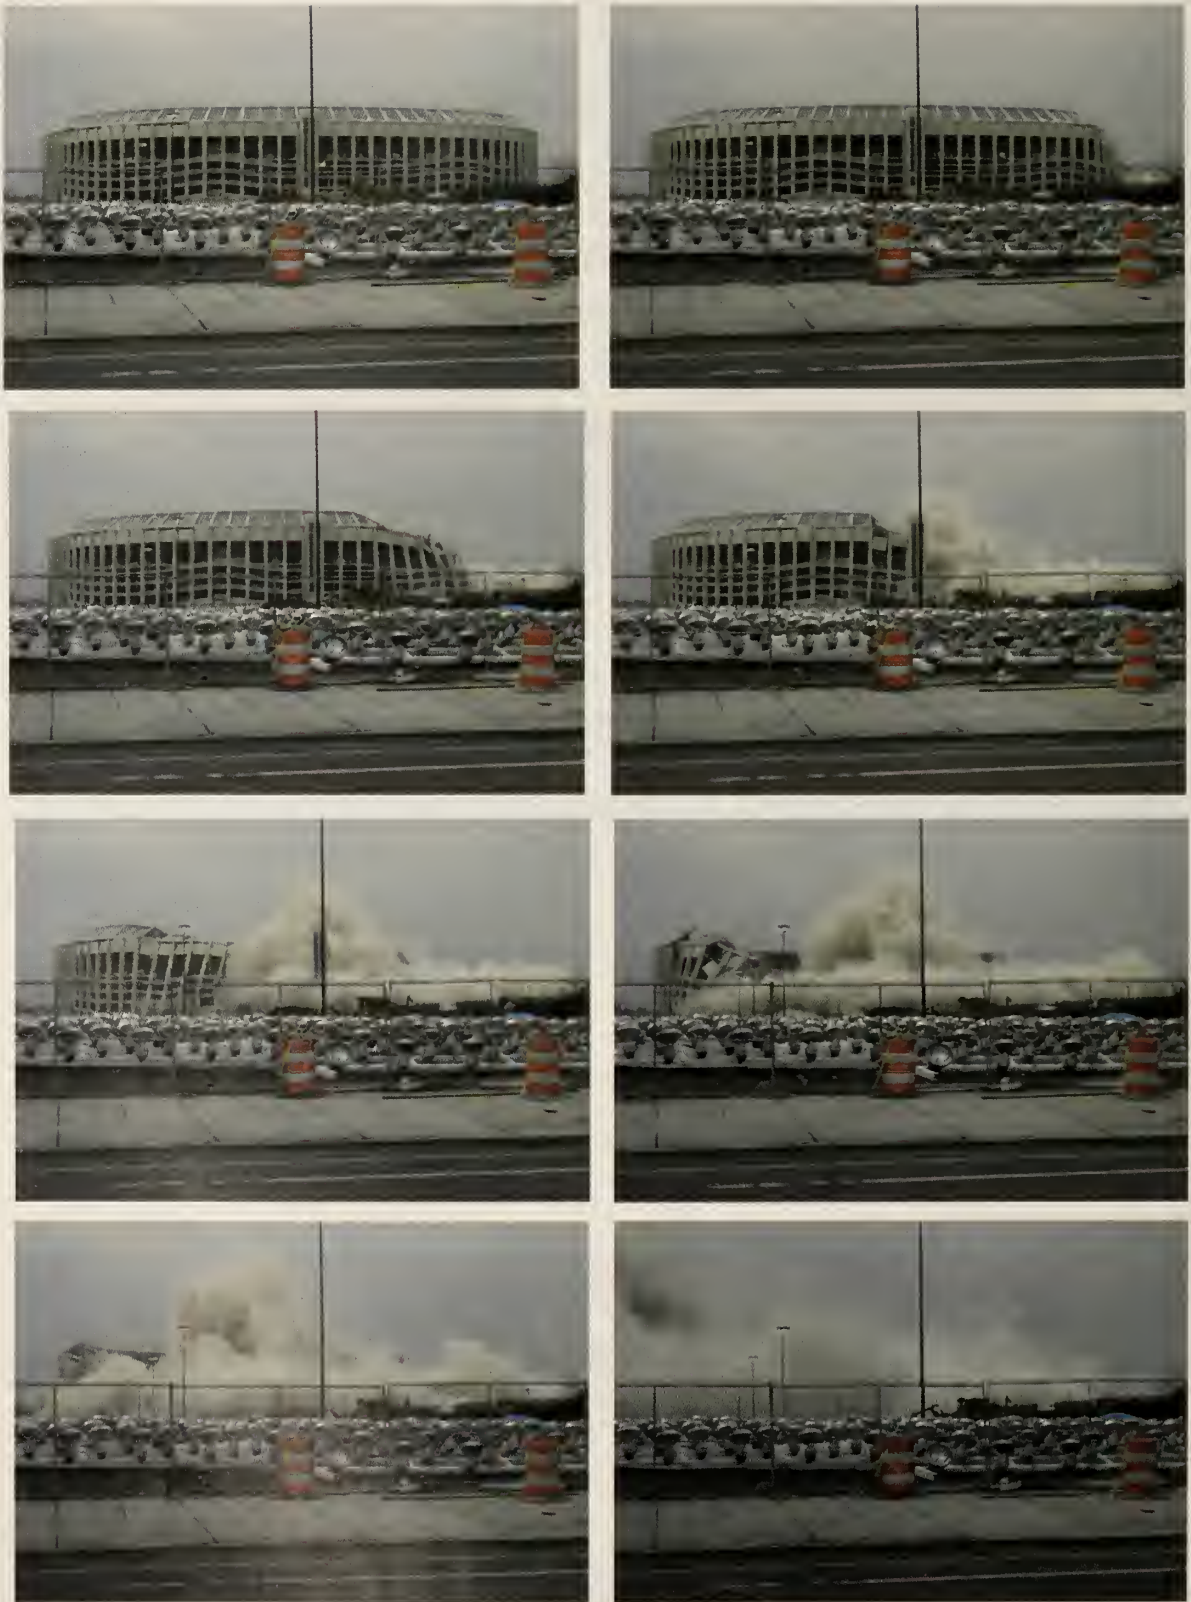
Figure 70. The stadium collapses during the implosion sequence.

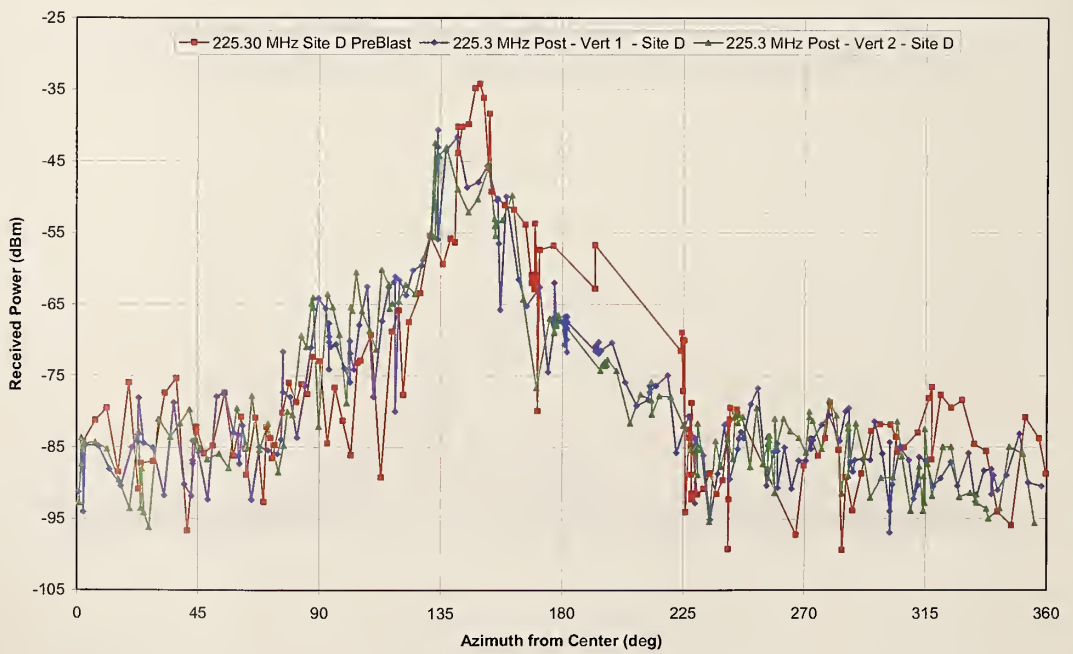
Figure 118. Comparison of pre- and post-implosion mobile cart perimeter measurements for the transmitters at transmitter Site D for horizontally polarized receiving antennas: 225 MHz band.
