Uncovering the Historic Roots of Brumidi's Decorations

AN INTERVIEW WITH CONSERVATOR CHRISTIANA CUNNINGHAM-ADAMS

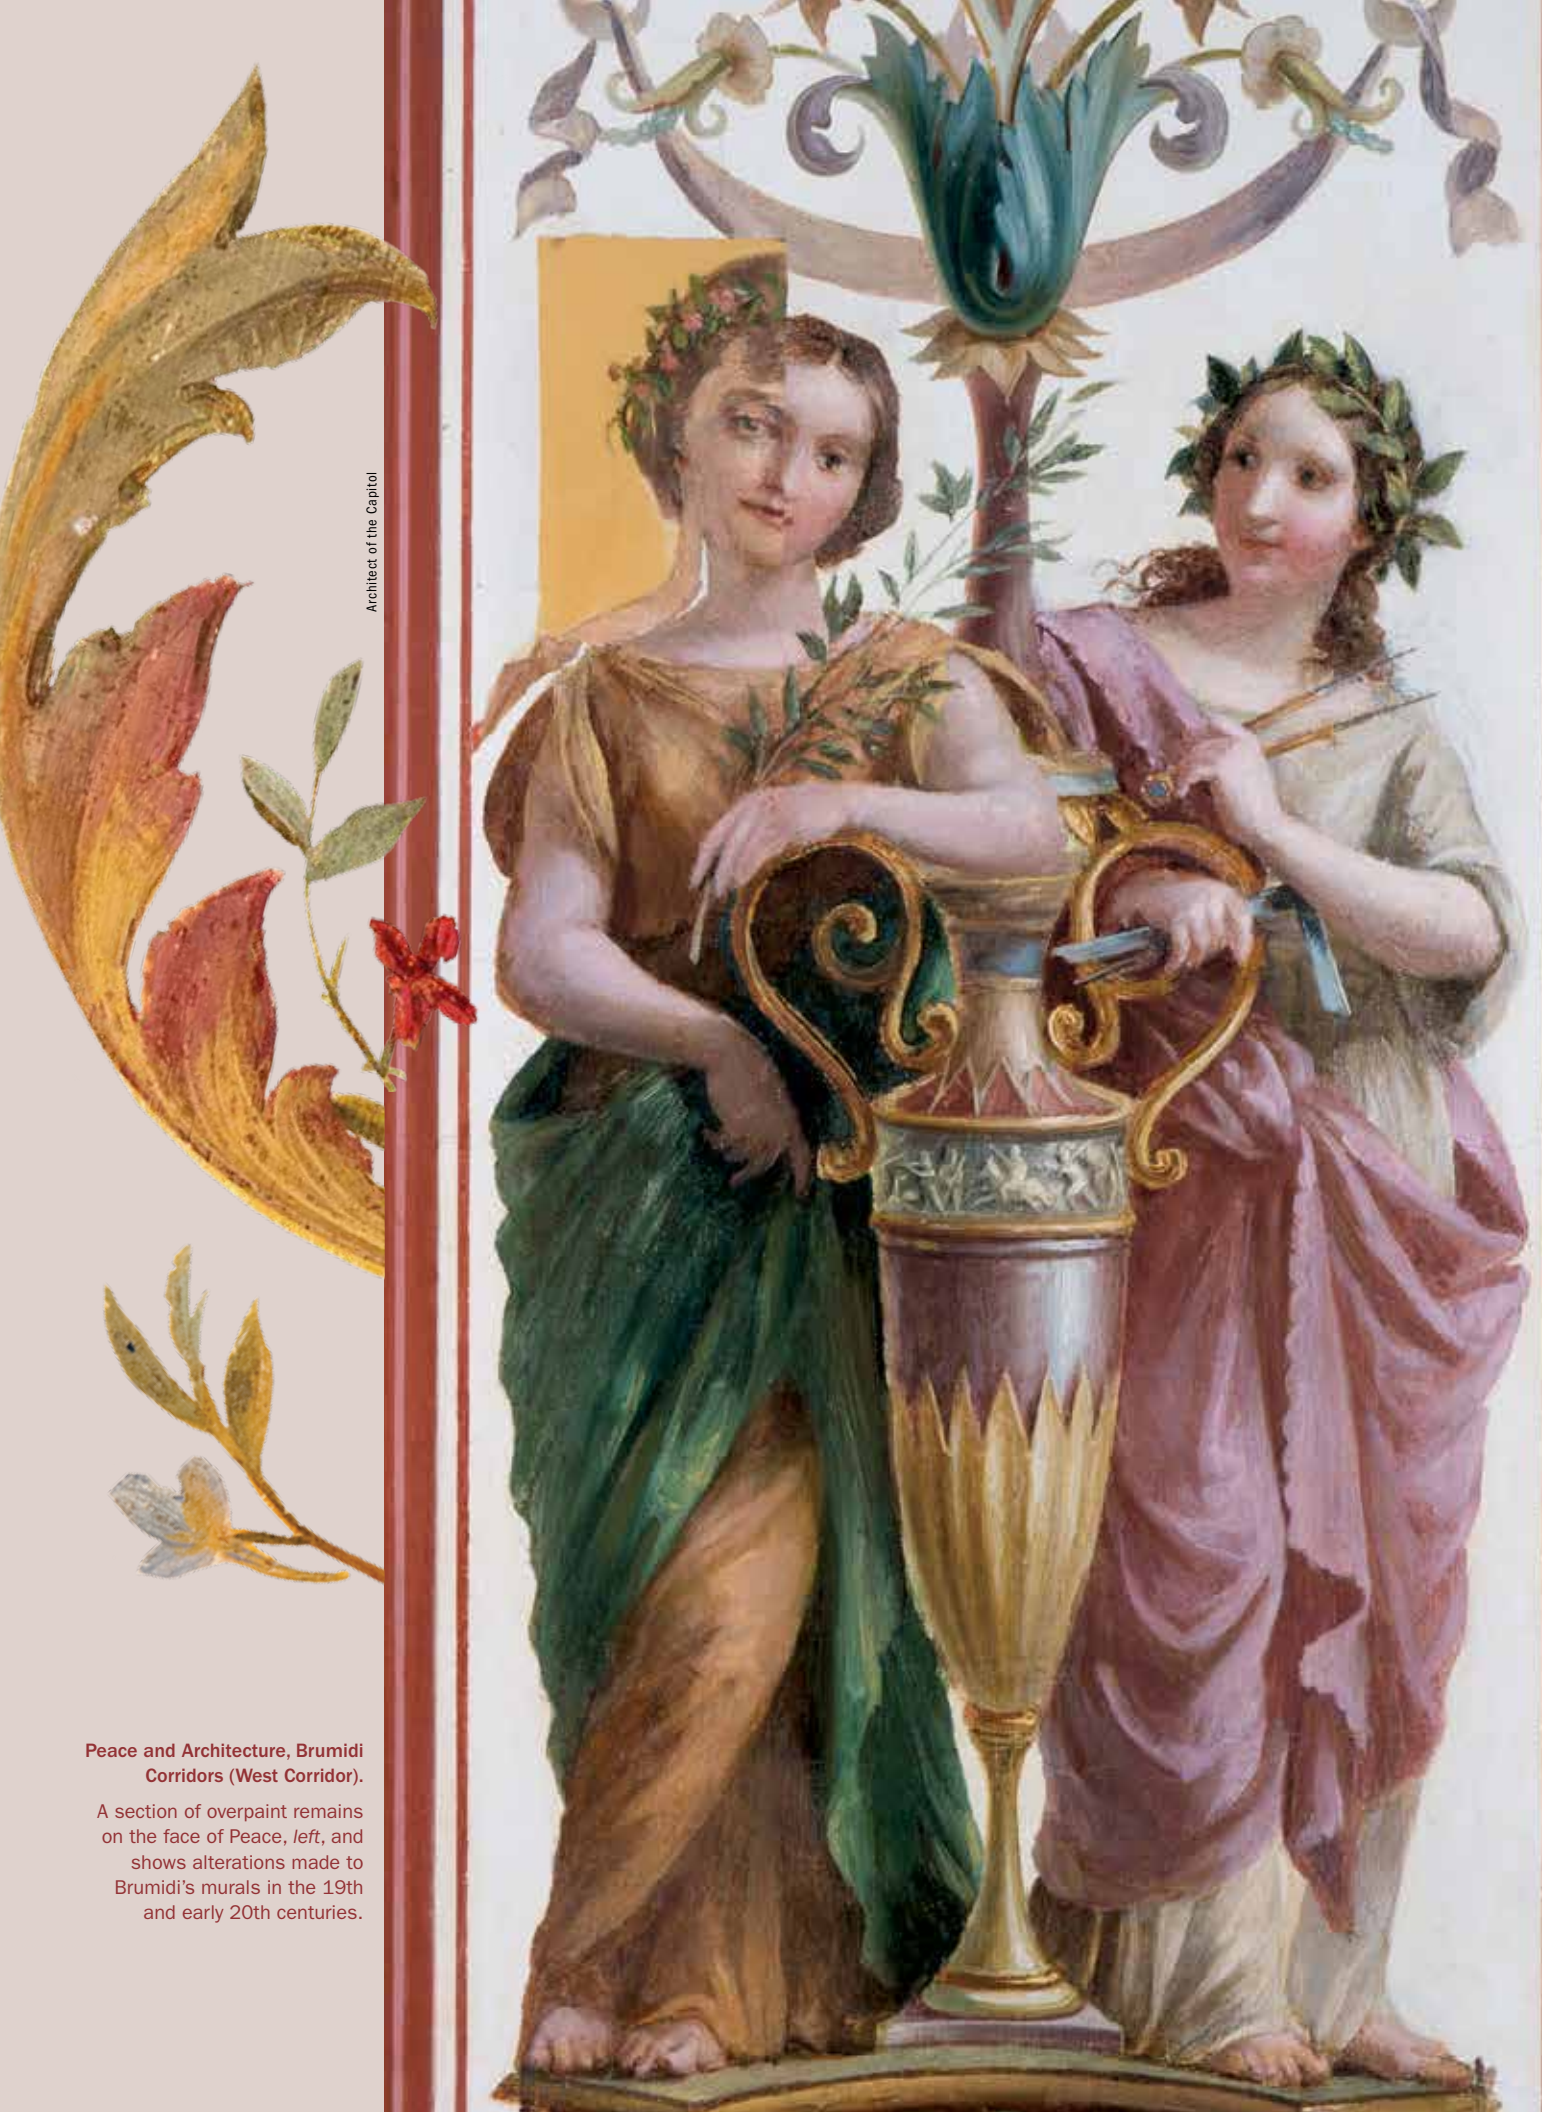
Peace and Architecture, Brumidi Corridors (West Corridor).

A section of overpaint remains on the face of Peace, left, and shows alterations made to Brumidi's murals in the 19th and early 20th centuries.

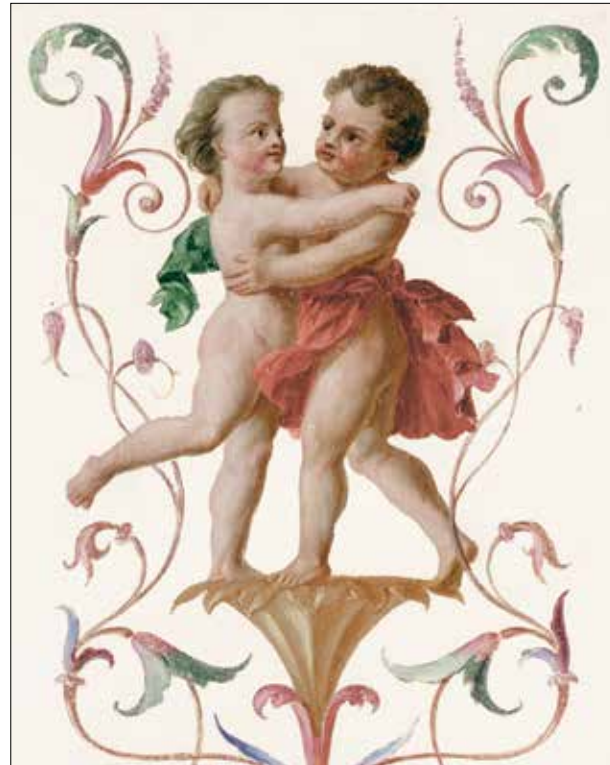
Putti, Brumidi Corridors (North Corridor).

Brumidi's style is evident in even the minutest details of his murals, such as the diminutive putti with their graceful stance and the scrolling vines that delicately frame the figures.

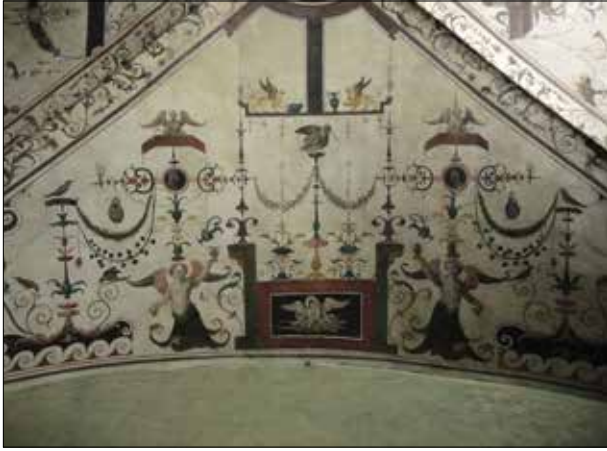
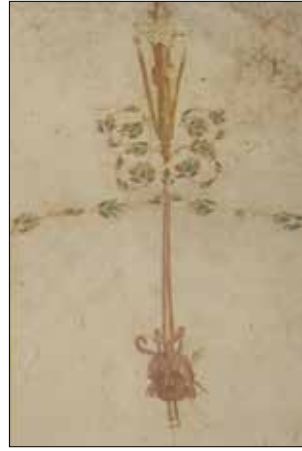
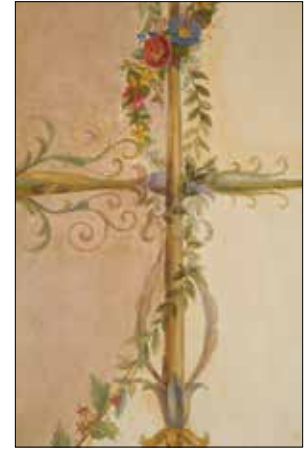
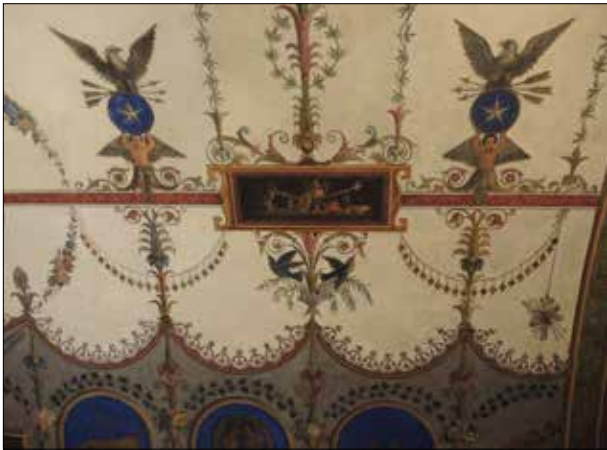
Left: Ceiling mural, Brumidi Corridors (Zodiac Corridor).

Above left: Ceiling mural, Palazzo Vecchio, Florence, Italy, 16th century.

Above center: Wall mural, Villa Poppaea, Oplontis, Italy, 1st century B.C.

Above right: Wall mural, Brumidi Corridors (West Corridor).

Brumidi's wall and ceiling murals in the U.S. Capitol reference the motifs and designs typical of ancient Roman and Renaissance decorative work.

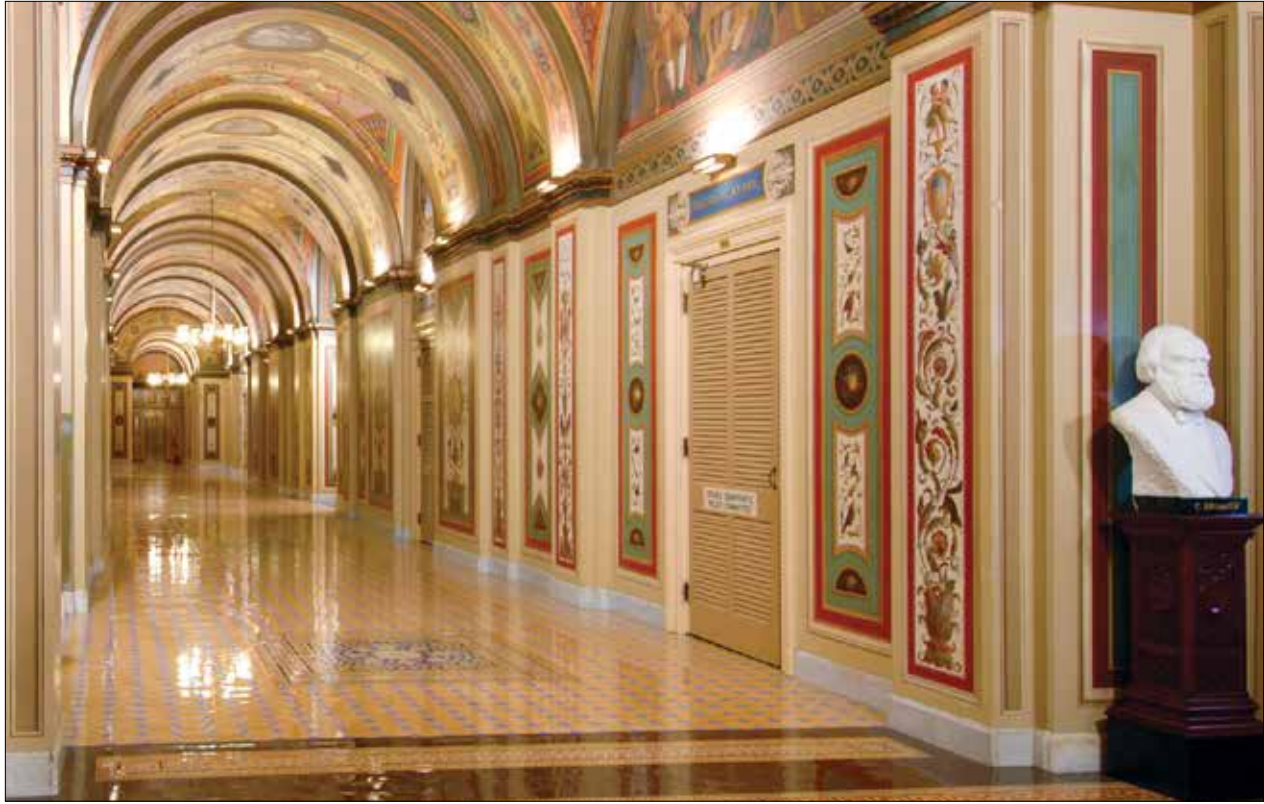
Restored wall murals in 2004, Brumidi Corridors (North Corridor).

The extensive wall mural conservation project involved plaster consolidation, overpaint removal, stabilization and infilling of losses in the original paint layer, and finally, varnishing of the corridors' 153 panels.

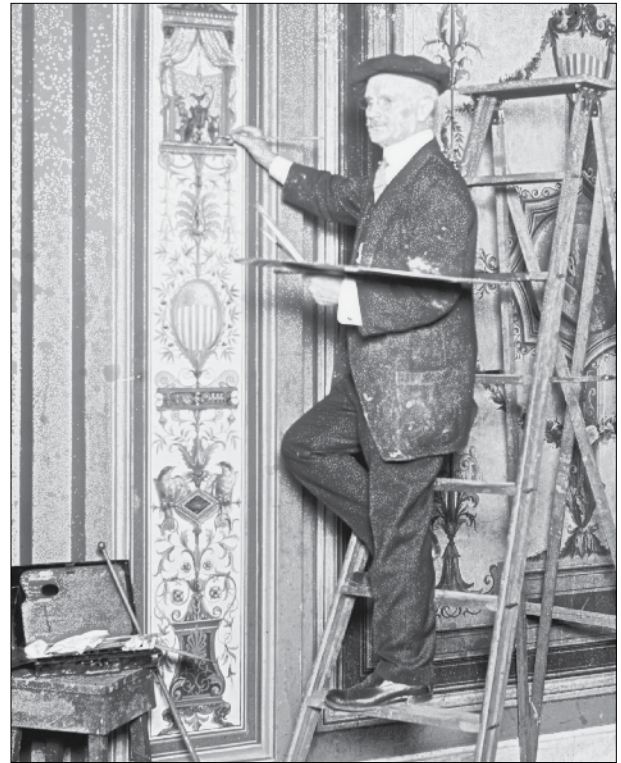
Right: Charles Whipple repainting the Brumidi Corridors, ca. 1920.

Below: Conservation test exposure showing overpaint layers and original mural designs, Brumidi Corridors (North Entry).

Overpaint altered the appearance of the murals in the Brumidi Corridors. Numbered arrows indicate the six layers of overpaint applied successively over a century to the original surface.

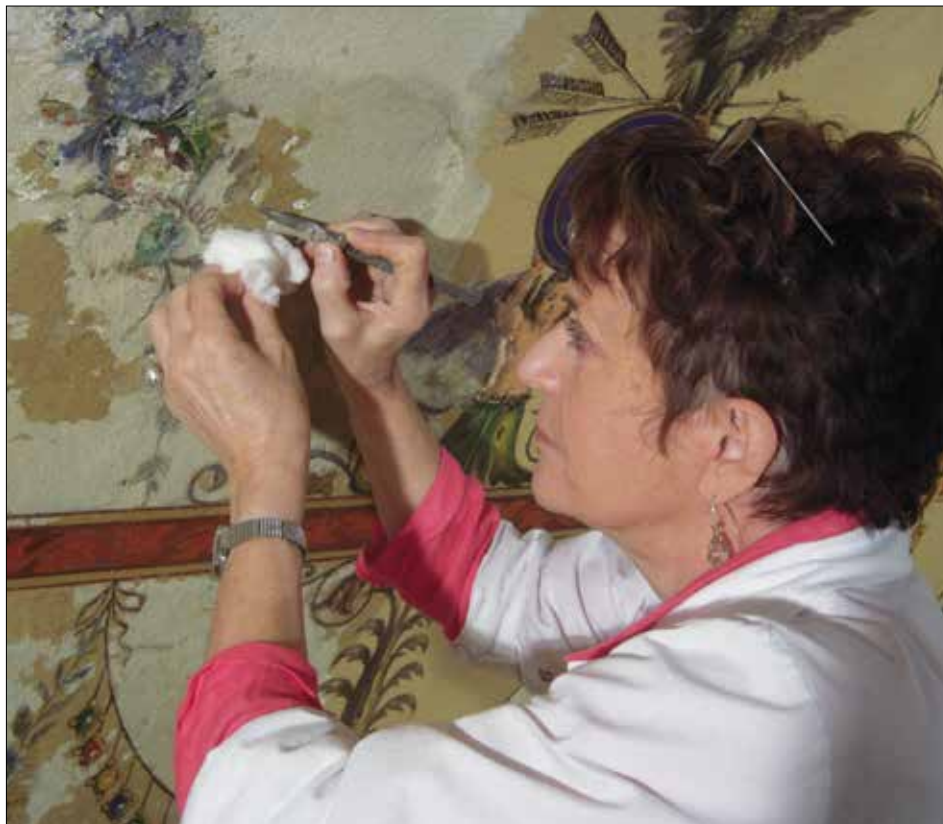
Above left: Plaster instabilities identified in *The Signing of the First Treaty of Peace with Great Britain*, fresco, 1874, Brumidi Corridors (North Corridor).

The condition of the underlying plaster is determined so that any deficiencies can be stabilized. Indicated in red are areas where the plaster detached from the architectural substructure, requiring consolidation. Indicated in blue are areas to monitor.

Before addressing the paint layers in the murals, however, we first examine and treat instabilities that we detect in the underlying plaster. We evaluate and document the different types of plaster failures, including the breakdown of the plaster itself or its failure to adhere to the architectural substrate. We then fortify any deficient areas to restore the integrity of the walls or ceilings supporting the paintings.

Our conservation team's engineer, George W. Adams, developed a consolidation technique tailored to the particular plaster deficiencies found in the Brumidi Corridors. The system—essentially a reservoir of consolidant connected to the substrate by a tube—allows infusion of the consolidant into the plaster at a controlled and slow rate of pressure. This delivery system enables the plaster to more thoroughly accept the consolidant. As the mural's support, the plaster and its condition are essential in securing the continued preservation of the painting.

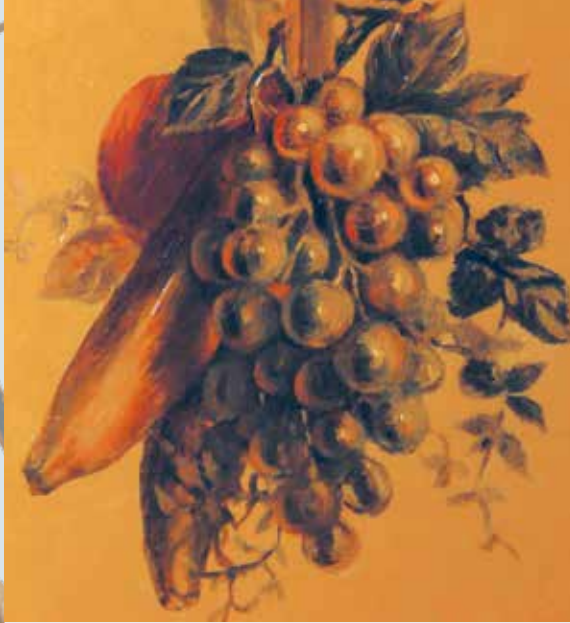
Fruit cluster before conservation, overpainted with a pair of bananas and additional grapes, Brumidi Corridors (West Corridor).

Late 19th- and early 20th-century attempts to repair and restore the Brumidi Corridors resulted in overpainted surfaces that altered the character of the historic, mid-19th-century murals and changed many of Brumidi's original details. A conservator's trained eye often detects these stylistic or technical differences between overpaint and original work, even before testing the paint surfaces. In 2008, conservator Christy Cunningham-Adams observed that a pair of ripe bananas in the West Corridor looked out of proportion in a panel depicting bountiful clusters of fruit. She removed the layers of overpaint and discovered that the bananas had been a later addition to the mural. Brumidi's original painting, hidden under the bananas, depicted peppers, whose smaller size better suited the composition.

Cunningham-Adams speculates that a crack in the wall plaster near Brumidi's peppers may have resulted in a subsequent artist's painting over the repaired fissure, as well as the original peppers, with the longer and more "modern" bananas.

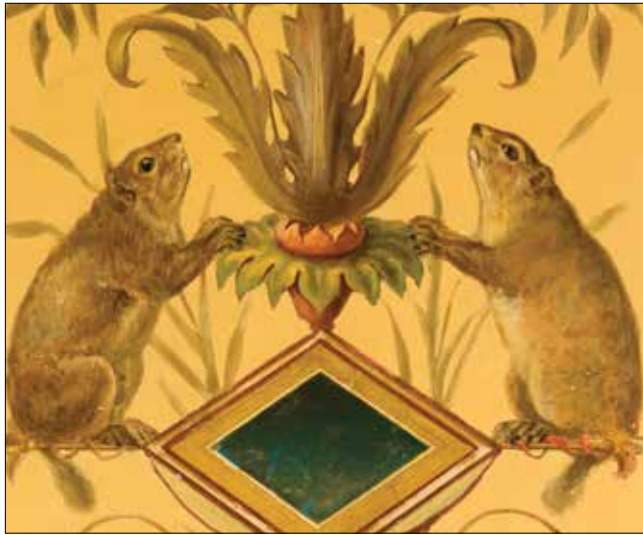
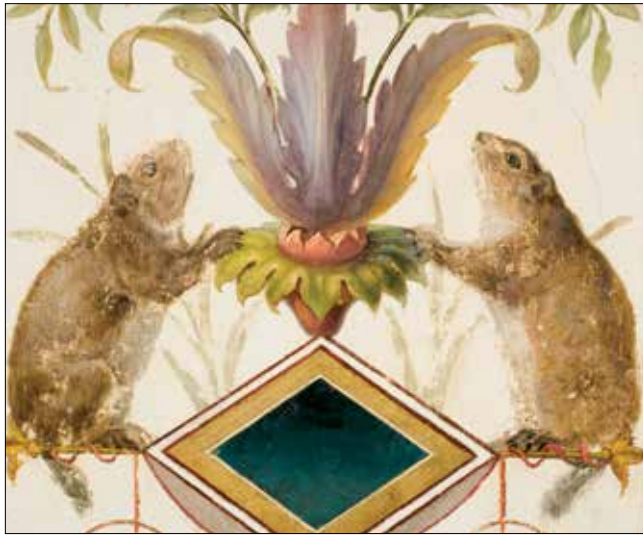
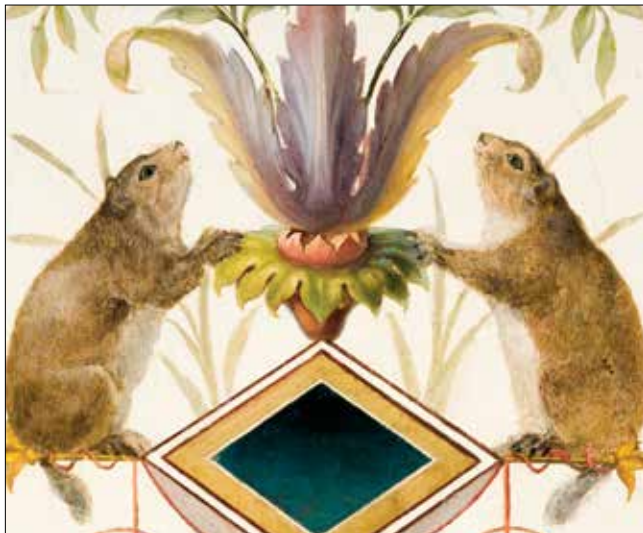
Left, top to bottom: Groundhogs before, during, and after conservation, Brumidi Corridors (West Corridor).

Conservators documented the restoration of this mural depicting a pair of groundhogs. Before treatment, *left top*, overpaint introduced teeth and heavily rimmed eyes. After removal of overpaint, *left center*, paint losses in the original mural are evident. The same detail is shown after careful inpainting of the paint losses, *left bottom*.

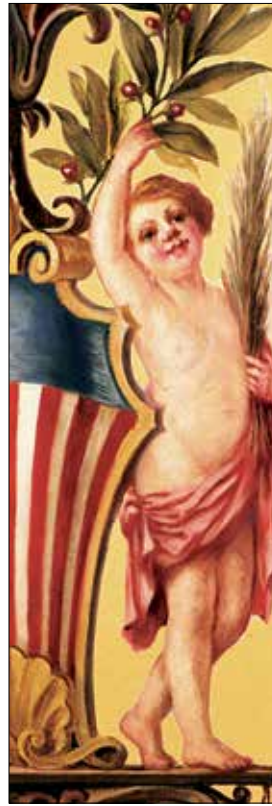
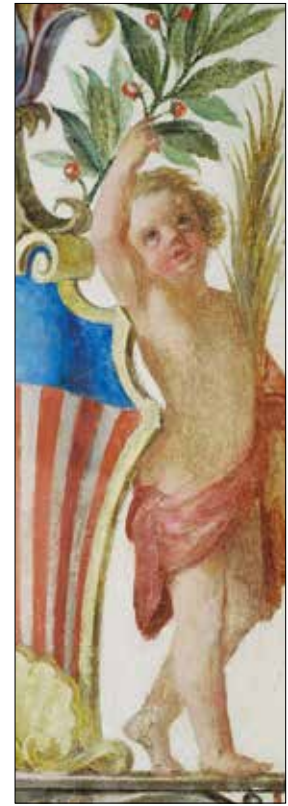
A putto before and after conservation, Brumidi Corridors (North Corridor).

Before conservation, overpaint gave the putto a cartoon-like appearance, *left*. The greater refinement of the original putto's face and modeled forms can be seen after conservation, *right*.

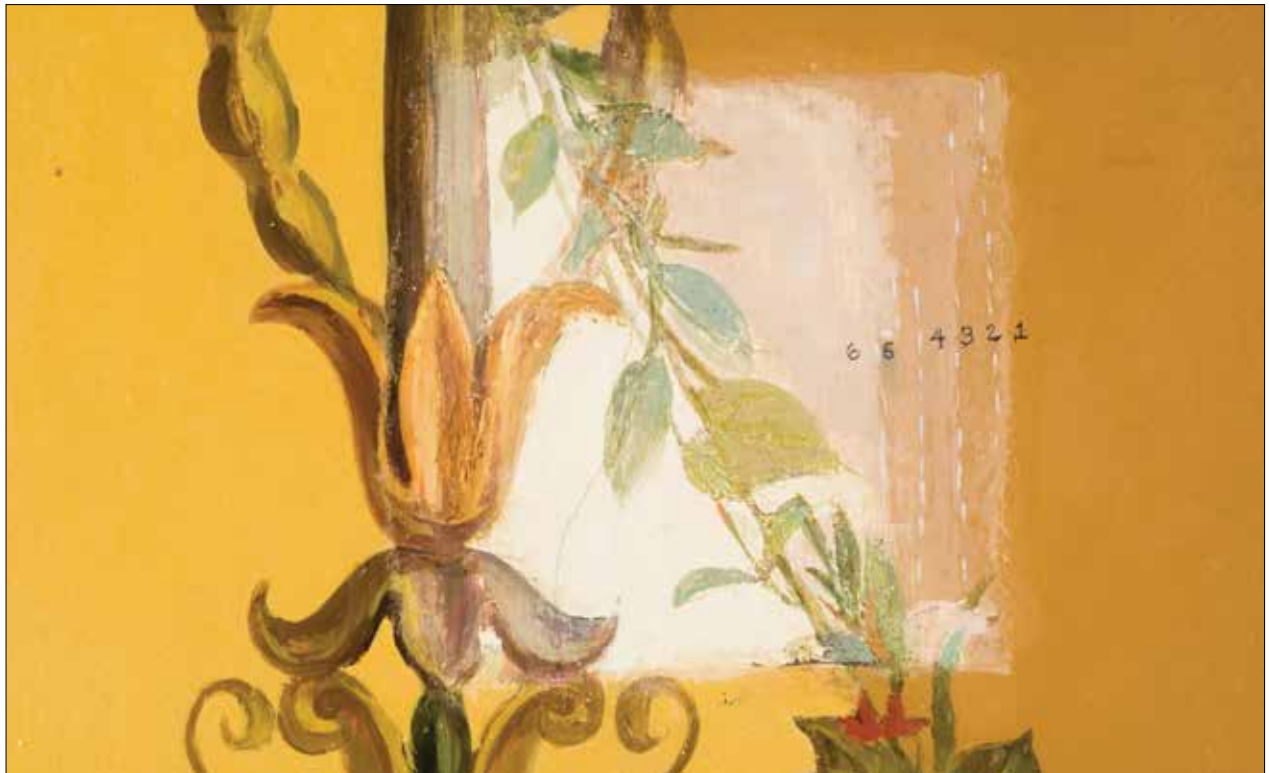
Below: Original surface versus color shift with five layers of overpaint, Brumidi Corridors (West Corridor).

With each repainting of the murals, color shift gradually occurred. Here, overpaint eventually transformed the white and light pink background to a dull yellow and made the details darker, heavier, and uncharacteristic of Brumidi’s original painting.

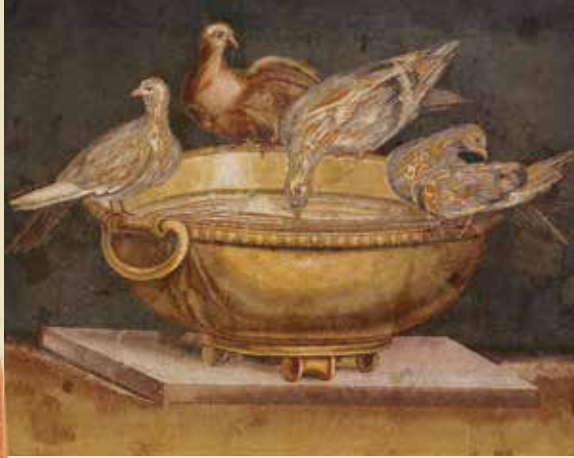
Mosaic of the Doves, Roman copy of the Greek mosaic attributed to Sosos (active 2nd century B.C.).

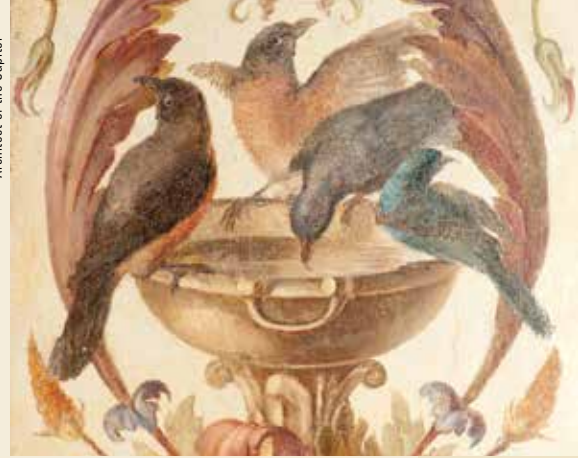
Brumidi's adaptation of the birds at a vessel, Brumidi Corridors (North Corridor).

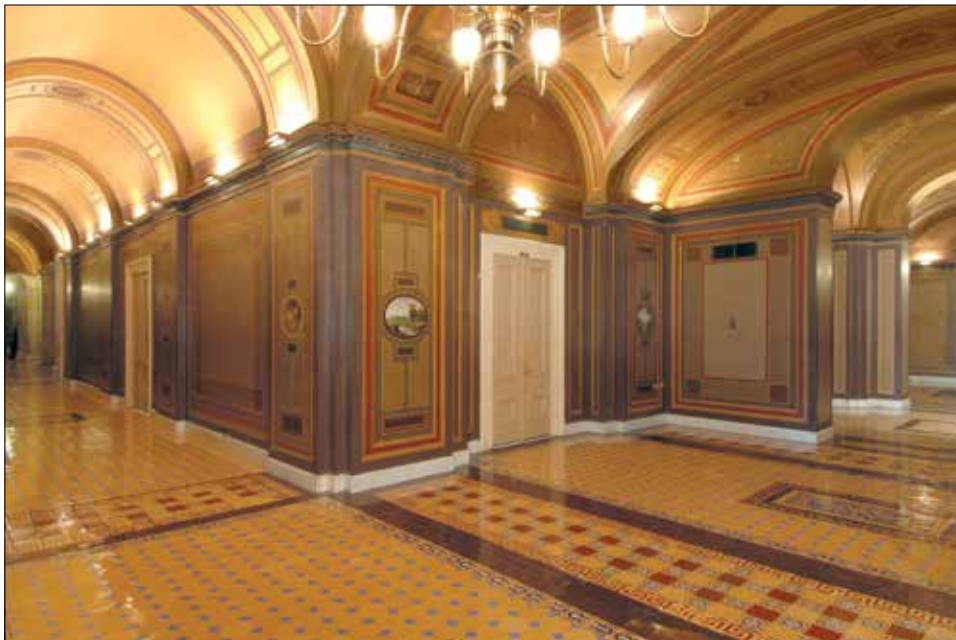
Left: Senate reception area before restoration, Brumidi Corridors.

Darkened incrementally by numerous repaintings, the reception area developed a predominantly brown, grim appearance.

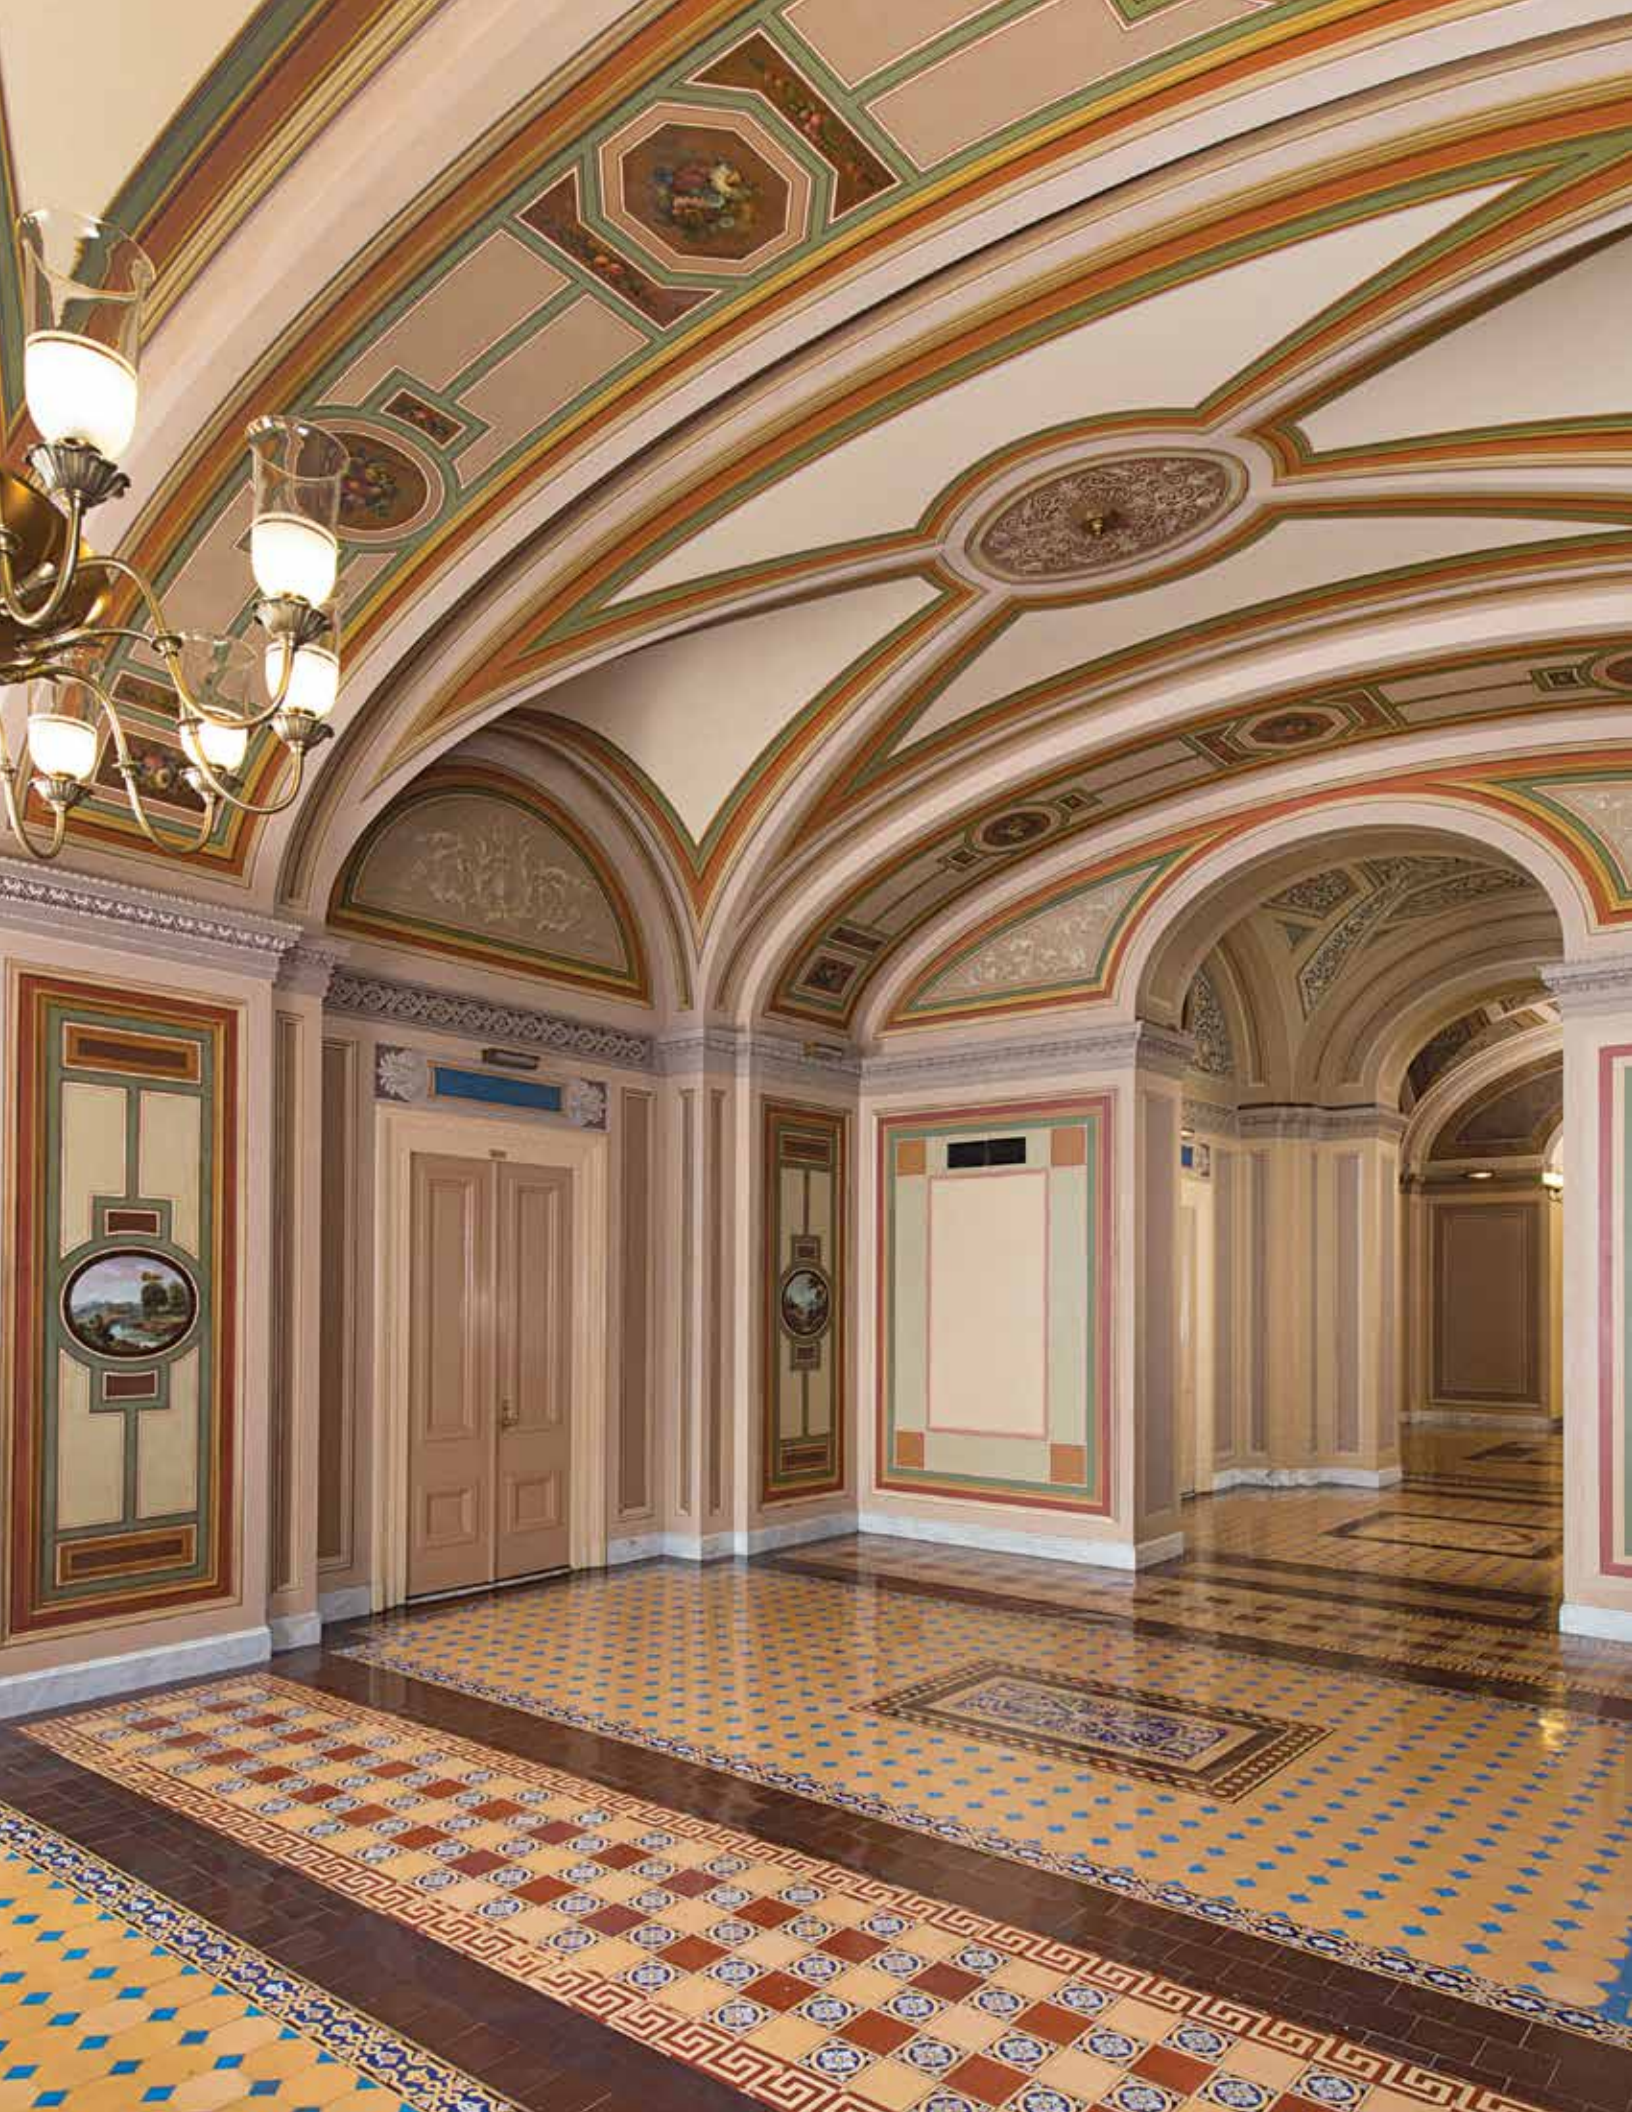
Opposite: Restored Senate reception area, Brumidi Corridors.

A combination of conservation and replication of the wall and ceiling murals reinstated the original bright colors and the dimensionality of the trompe l’oeil panels. The restoration effort has helped reconnect Brumidi’s designs with ancient Roman prototypes.

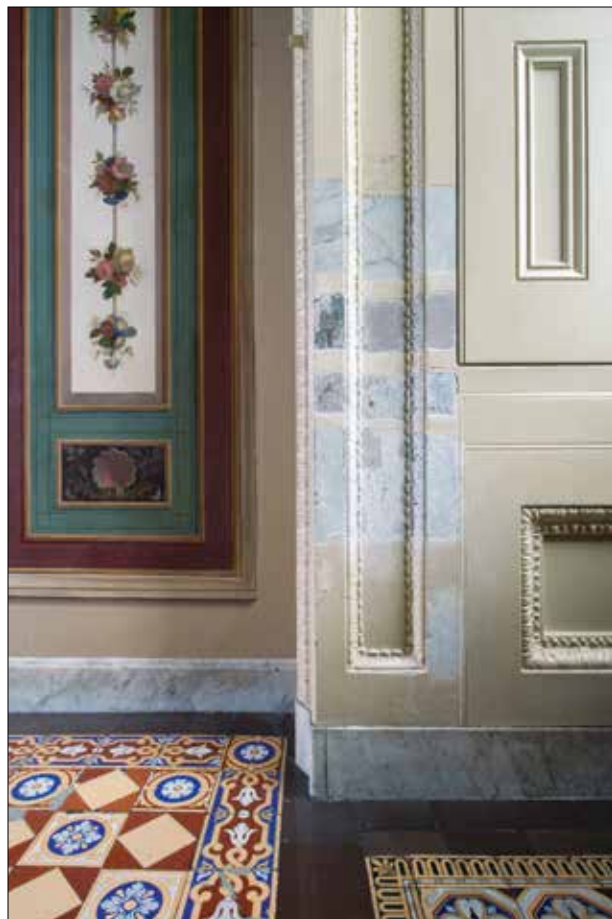
Conservation test exposures of cast-iron window enframement, Brumidi Corridors (Patent Corridor).

The earliest layers of paint appear to have created a marble effect, seen in the top exposure. Nearly 25 layers of overpaint on the enframement covered the marble effect.

finishes on the cast-iron window enframements. The enframements’ existing cream-colored paint was incongruous with the types of historic effects that would traditionally accompany a decoration like the one Brumidi created for the corridors. We wondered if paring away the overpaint would reveal something more relevant.

With extreme care, under a microscope at 10x, we revealed some sophisticated faux marble in a one-square-foot test area. Our exposure found a grey-colored coating applied directly to the cast-iron enframement. A previous study indicated that this was a primer applied at the factory. The next layer that we uncovered was a pinkish-mauve color that I believe functioned as a chromatic base and preparation for the marbleizing. When we revealed an off-white layer with grey patches and bluish-grey veining, the effect of simulated marble immediately became apparent. The faux marble matches genuine marble used throughout the Capitol, particularly in the columns in the Senate’s adjoining East Entry. More testing and analysis will be necessary to complete these promising initial findings.

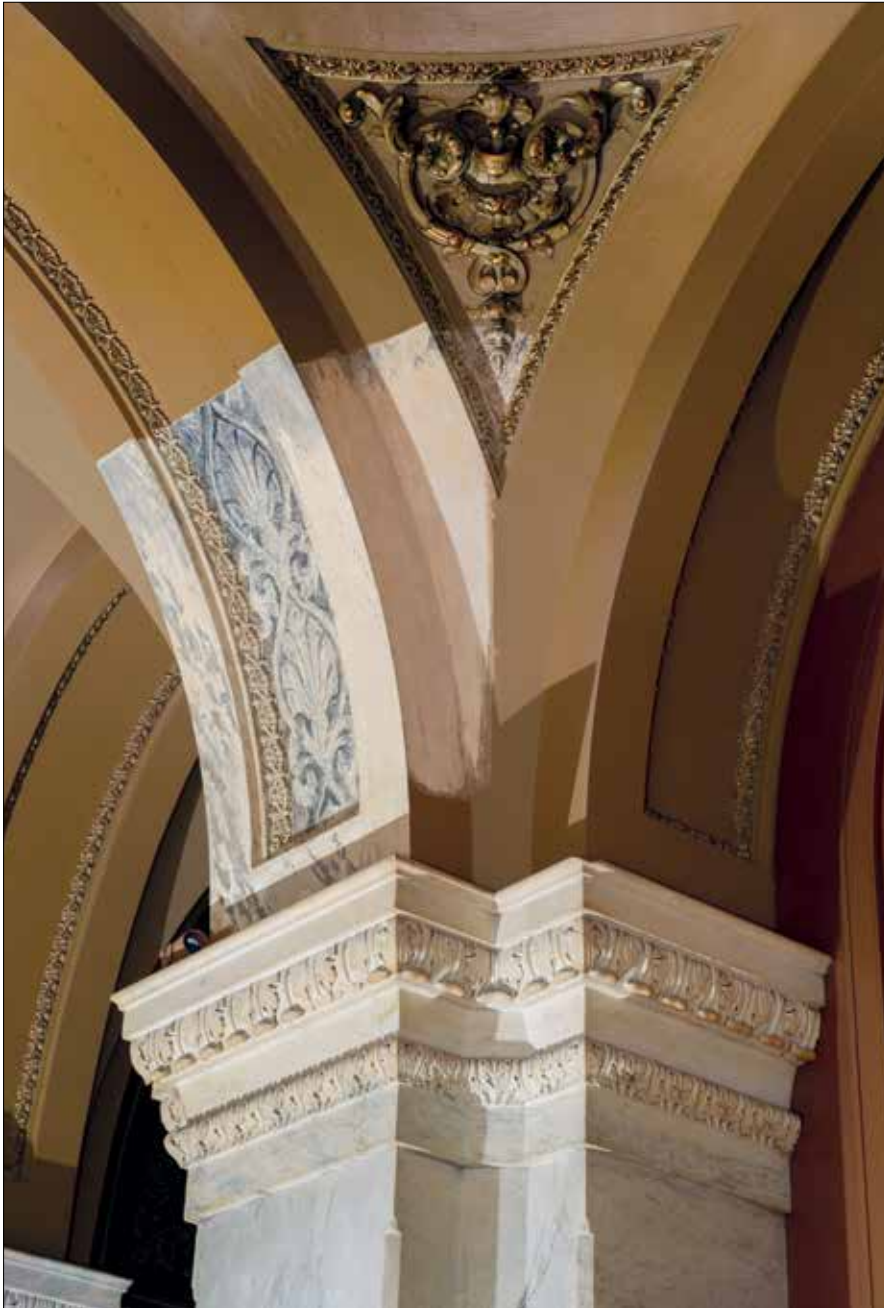
Discovery of trompe l'oeil ceiling, conservation test exposure, Brumidi Corridors (East Entry).

Overpaint concealed the nuanced faux marble and trompe l'oeil anthemion pattern and drastically altered the once-elegant appearance of the East Entry.

Finally, in 2010, we performed overpaint removal tests. Our patience was amply rewarded. We discovered that underneath the dull, mustard-colored ceiling was a striking faux marble that made the ceiling resemble the real marble columns in the entry. Not only did the ceiling appear to be constructed of marble, the arches in the dome-vaulted ceiling also looked as if they had been carved with ornate bands of anthemion, a classical border motif with palmette, or fan-shaped, leaves. The trompe l'oeil ceiling was a remarkable find and offered a dazzling testimony to the range of skills of Brumidi and his assistant artists. Among Brumidi's many talents was his ability to connect his designs to the architecture of the Capitol. With this thrilling discovery of the trompe l'oeil ceiling, we are now able to envision the original resplendent and impressive entranceway in the Senate wing.

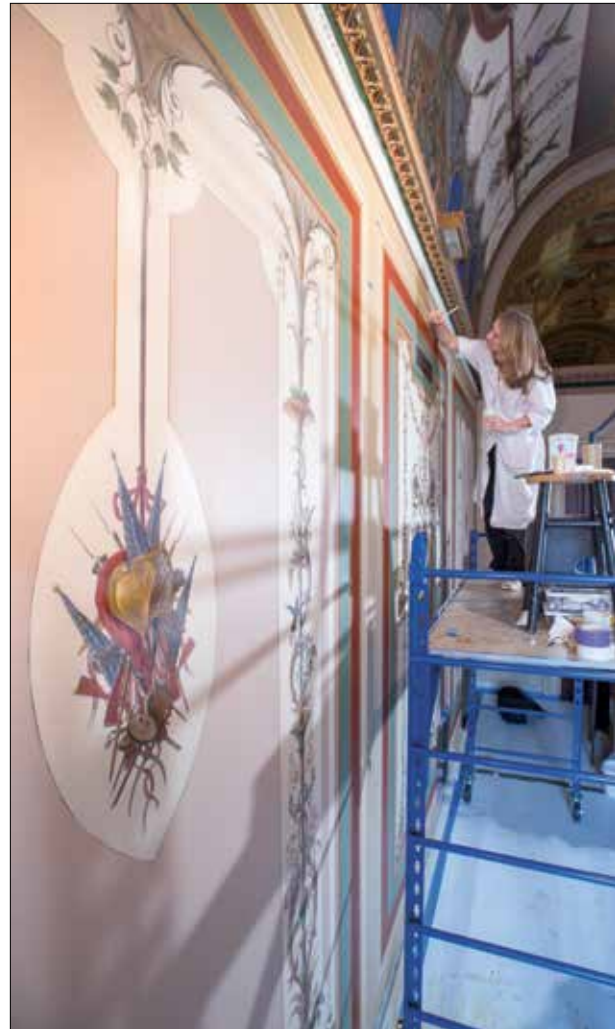
Part of the Brumidi Corridors conservation team for the past 15 years, Laurie Timm is shown retouching the trompe l'oeil borders in the Zodiac Corridor. After the challenge of removing overpaint, this phase of recovering the original aesthetic character is the conservator's reward.
