Research
Paper
FPL-RP-674

Durability of Hardboard Lap Siding

Performance in Laboratory Testing and in Long-Term Exterior Exposure

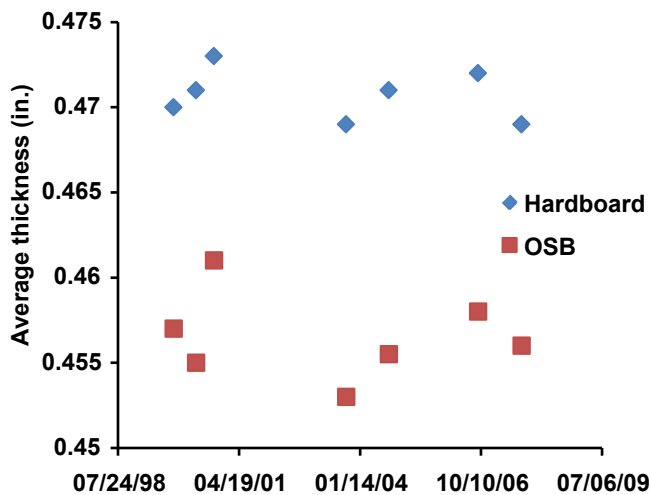
Figure 6. Siding thickness, measured in-place at the drip edge, on seven dates between October 1999 and September 2007. Neither the hardboard sidings nor the OSB siding underwent progressive thickness swelling, despite nearness of open end joints to the points at which thickness was measured.

decade of exposure. Localized edge swelling often became visually apparent at the specimen ends. The swelling at specimen ends, being localized, did not affect measurements made at the drip edge roughly 2 in. (51 mm) from the specimen ends. As mentioned previously, after paint touch-ups in July 1998, cracking of paint at nail heads did not occur during the exposure period. At specimen removal in August 2010, there was no observable paint cracking or thickness swelling at nail heads. Cumulative wetting of the boards over the exposure period was not sufficient to cause measurable swelling near the nail heads (where thickness was measured). Figure 2 shows that swelling at the drip edge sometimes occurred. It did not, however, occur at the points where thickness was measured. On the spray fences, the same spatial pattern of drip edge swelling had occurred (least near the thickness measurement points) but measurable and progressive swelling had nonetheless been recorded (figure 10 of Carll and TenWolde 2004). The lack of measurable thickness swelling of specimens on the building (as opposed to measurable thickness swelling on the fences) is most likely attributable to less water exposure on the building than on the fences.

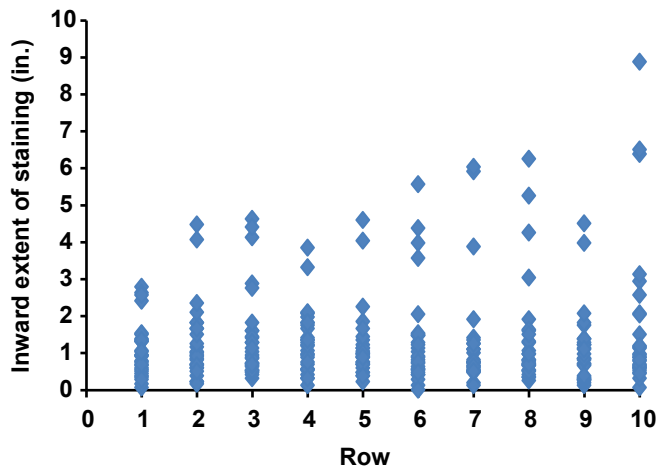
Figure 8. Measurements of inward extents of water stains from board ends, in areas above the lap, by siding course (26 hardboard specimens per course).

Of the 18 boards with perceptible back-surface staining at mid-specimen length, 10 were in bottom-course locations. In all the other siding courses, either no, one, or two specimens had staining at mid-specimen length. The inward extent of back-surface staining from specimen ends also varied with the siding course, with more staining being present in lower siding courses. Some course-dependency of inward extent of staining at board ends (above the lap area) can be seen in Figure 8. In summary, staining on the back surfaces tended to be less extensive on boards in upper courses than on boards in lower courses, and most extensive on boards in the lowest course. The specimen placement scheme, which as mentioned previously assigned two specimens of each of the board classes to each siding course, accommodated for course-dependency of water exposure.

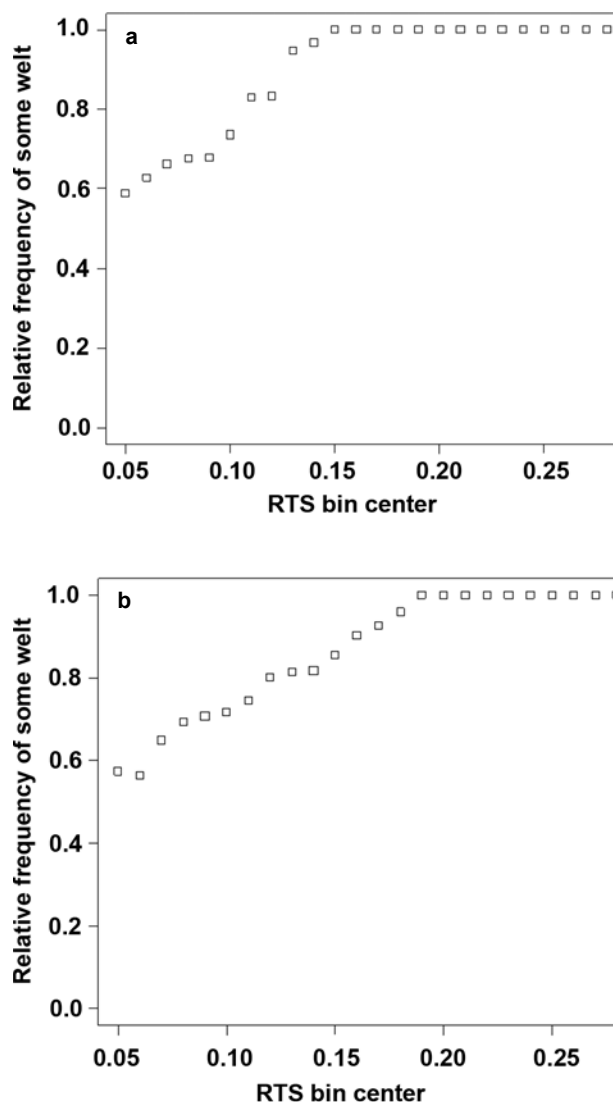
We found residual thickness swelling to be a reasonably good predictor of the likelihood of a board developing edge wetting in service, both for the noncommercial siding (Fig. 9a) and commercial boards (Fig. 9b). We also found it

Figure 9b. Relative frequency in 155-month exposure of edge-welt development as a function of residual thickness swell (RTS) of matched specimens in laboratory testing; (a) noncommercial hardboard sidings, (b) commercial hardboard sidings.

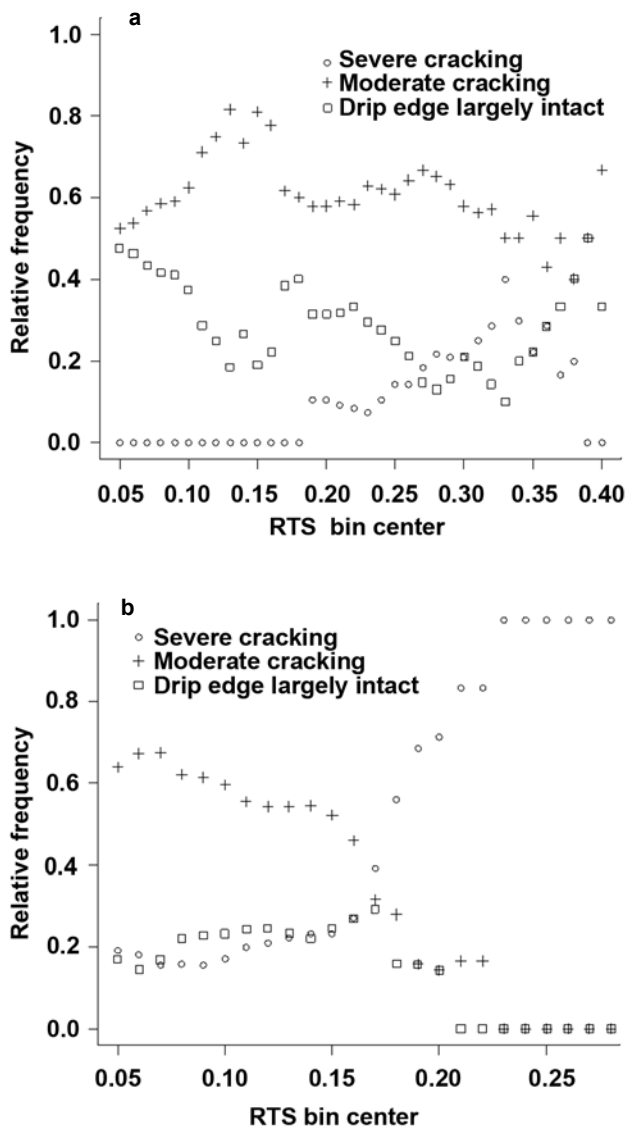
indicates that the relative frequency of significant or severe drip-edge paint cracking was not lowered as bin center value fell below 9% RTS. Figure 10b also indicates that the relative frequency of intact or nearly intact drip edges did not increase as bin center value fell below 9% RTS.

Figure 10. Relative frequencies in 155-month exposure of three different levels of drip-edge paint cracking as a function of residual thickness swell (RTS) of matched specimens in laboratory testing; (a) noncommercial hardboard sidings, (b) commercial hardboard sidings. Legends have abbreviated text: squares indicate drip edges in intact or largely intact condition, crosses indicate drip-edge paint cracking ranging from minor to moderate, and circles indicate paint cracking ranging from significant to severe. A specimen with drip-edge paint cracking restricted to board ends would have been classified as intact.

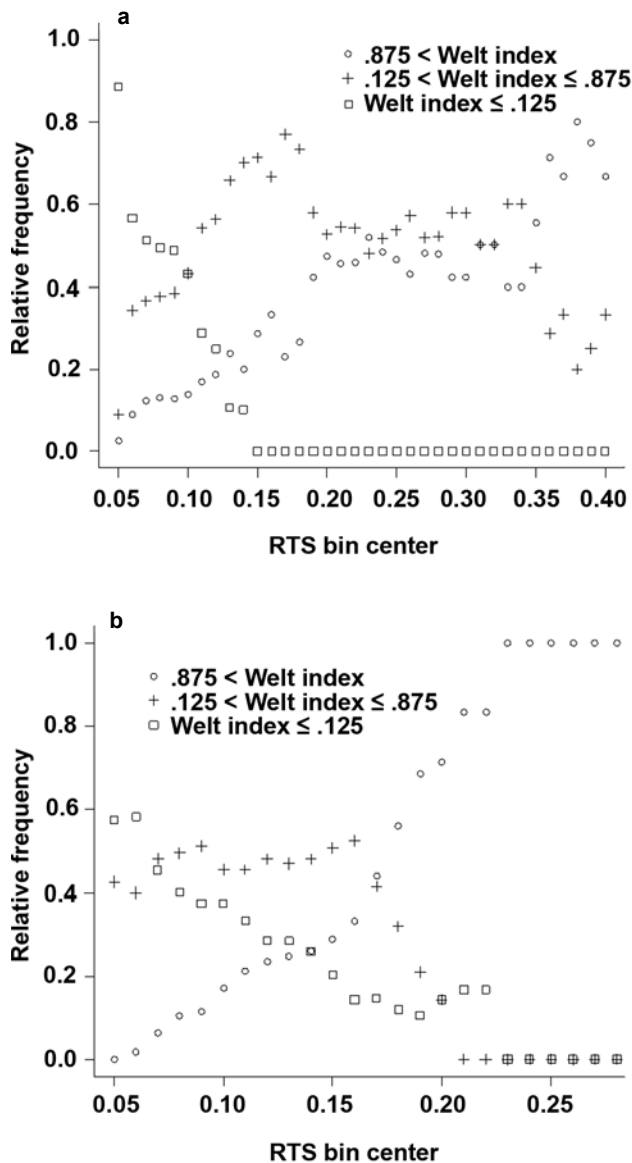
(lack of “plateau” value) was observed with regard to welt performance, and was sometimes observed with regard to drip-edge paint cracking. In the case where there was an apparent “plateau” value for RTS, below which further reduction in RTS did not result in improved performance with regard to drip-edge paint cracking, the plateau value was at 9% RTS, (well below the 17% criterion in the 2006 revision of the Standard). Carll and TenWolde (2004) made three

Figure 11b. Relative frequencies in 155-month exposure of three different levels of edge-welt index in as a function of residual thickness swell (RTS) of matched specimens in laboratory testing ; (a) noncommercial hardboard sidings, (b) commercial hardboard sidings.
