# NATIONAL BUREAU OF STANDARDS REPORT

## FAILURES IN WIRE BASKETS OF URETERAL STONE DISLODGERS

**NBS REPORT**

10 009

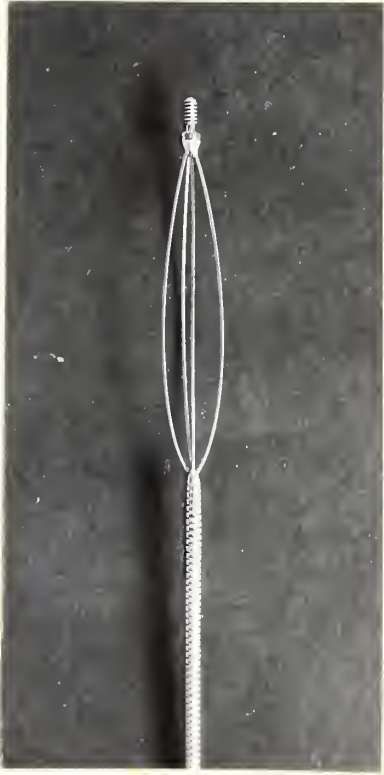
(a) IX  
Unused stone dislodger, showing a portion of the flexible cable, the connector between flexible cable and basket wires, the basket wires, and the connector between basket wires and filiform tip. (Filiform tip is not shown.) Unit produced by Greenwald Surgical Co. for C. R. Bard, Inc.

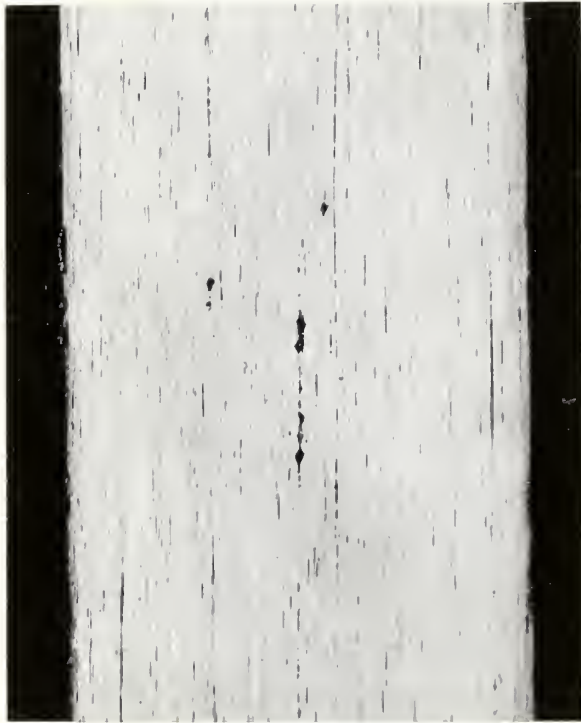
250X

Both Figures 3c and 4c show a typical structure for "spring temper" material, i.e., a fibrous appearance with the fiber direction parallel to the longitudinal axis of the wire. For comparison with Figures 3c and 4c, the fibrous appearance of a basket wire from an unused stone dislodger appears in Figure 5. Shape distortion is also apparent in Figures 3c and 4c. These further observations support the viewpoint that the cause of wire-basket failure is fracture of the basket wires themselves, and not rupture of the soldered joints.

Figure 5. Fibrous appearance of basket wire in spring temper condition. Sample taken from unused stone dislodger appearing in Figure 1a. Etched in 20% HCl, 5% HNO<sub>3</sub>.
