Analysis of the Pneumatic Burst of a Large Seamless Steel Pressure Vessel in Natural Gas Service

NBSIR 78-1589

Failure Analysis Report

Prepared for
Office of Hazardous Materials Regulations
Materials Transportation Bureau
Department of Transportation
Washington, D.C. 20590
Contract No. DOT AS-40034

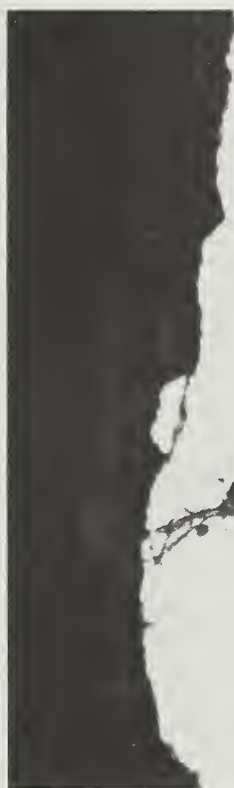
Incipient type L cracks which appear to have originated at radial jogs in a type C crack. This cracking was found in specimen TR-5. (a) As polished section showing cracks, (b) Same section as in 16a after etching with ammonium molybdate.
