Engineering Aspects of Cyclone Tracy Darwin, Australia, 1974

NBS Report on Structural Damage
111

Richard D. Marshall

Issued June 1976

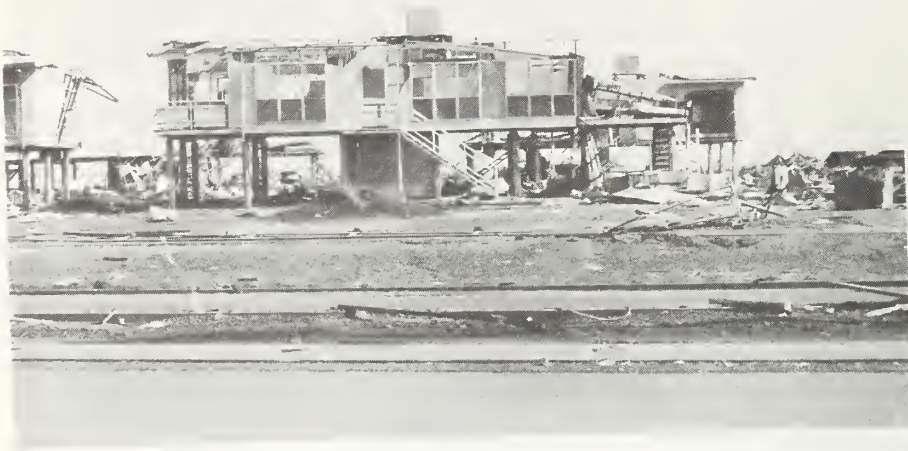
By far the most popular style of house in Darwin is the so-called "high-set" house constructed for the Department of Housing and Construction. Although there are several variations the basic unit consists of an elevated platform and light timber frame with a gable roof (see Figure 3). The plan dimensions are approximately 7 x 16 meters with the platform some 2.5 meters above ground. Prior to 1968 galvanized steel pipe columns with cross-bracing were used to support the platforms (see Figure 4). These were superseded by concrete columns on simple spread footings and the cross-bracing was replaced by concrete block shear walls installed between 4 adjacent columns, the resulting enclosure serving as a laundry room or storage space.

The high-set houses performed reasonably well in the older subdivisions such as Fannie Bay and Larrakeyah where there was some protection provided by other buildings and trees and where the wood frames contained diagonal bracing. Many of these older houses were roofed with corrugated asbestos cement sheets. In the northern suburbs, however, the new high-set houses suffered extensive damage. The failure of upwind buildings created a source of missiles which undoubtedly played a major role in the widespread damage observed in the northern suburbs. This tended to be a self-sustaining effect as other structures failed downwind. The sequence of failure is believed to have been loss of roof cladding and purlins, followed by collapse of roof trusses and large unsupported walls, particularly in the living rooms. The racking strength of the walls was reduced by missiles fracturing the asbestos cement cladding and these sheets completely failed once racking deformations occurred. In many cases the entire wood frame was removed from the elevated platform (see Figure 5). The piers and platforms generally remained intact, but there were cases where the entire structure collapsed or where the piers were racked following failure of the concrete masonry shear walls due to overturning (see Figure 6). No failures of the older steel pipe columns were observed (see Figure 4). A typical connection between the concrete pier and floor beam is shown in Figure 7. Note that the floor joists are toenailed to the nailing strips which are attached to the steel beams by "Ramset" studs. Some high-set houses used metal cladding on the endwalls as seen in Figure 6 and this generally performed very well, being much more resistant to missile impact than the asbestos cement cladding. The cyclone bolts which were installed in all houses built after mid-1972 (see Figure 8) do not appear to have made any significant difference in performance since the main problem was a lack of racking strength once the asbestos cement cladding had failed. Many instances of endwall failure were observed (see Figure 9), suggesting inadequate corner connections and roof-wall connections at the gable ends. The performance of roof cladding is dealt with in a separate section of this report.

Fig. 3. Typical high-set house

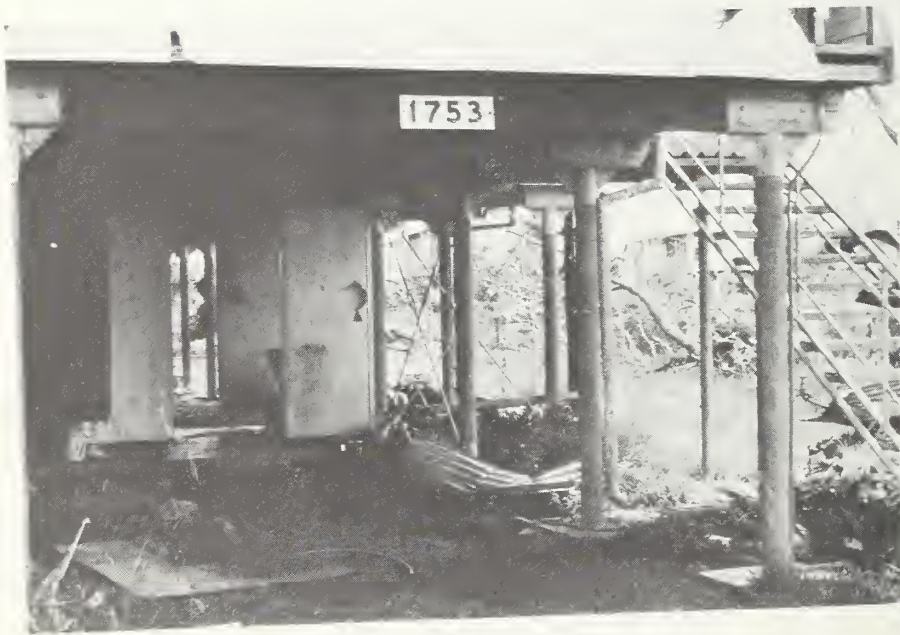
Fig. 4. Pipe columns used in older construction

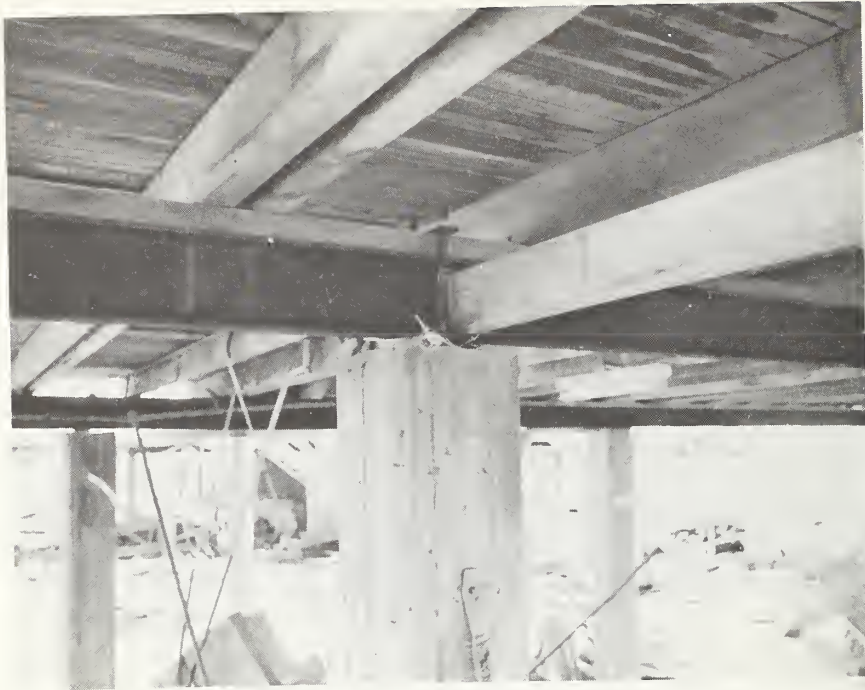
Fig. 7. Typical floor systems and pier anchorage

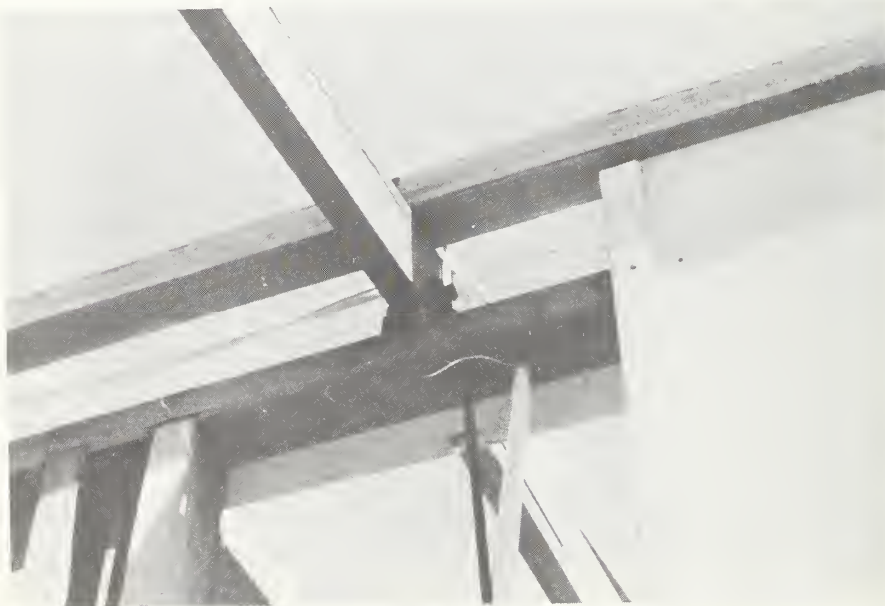
Fig. 8. Cyclone bolt and rafter connection

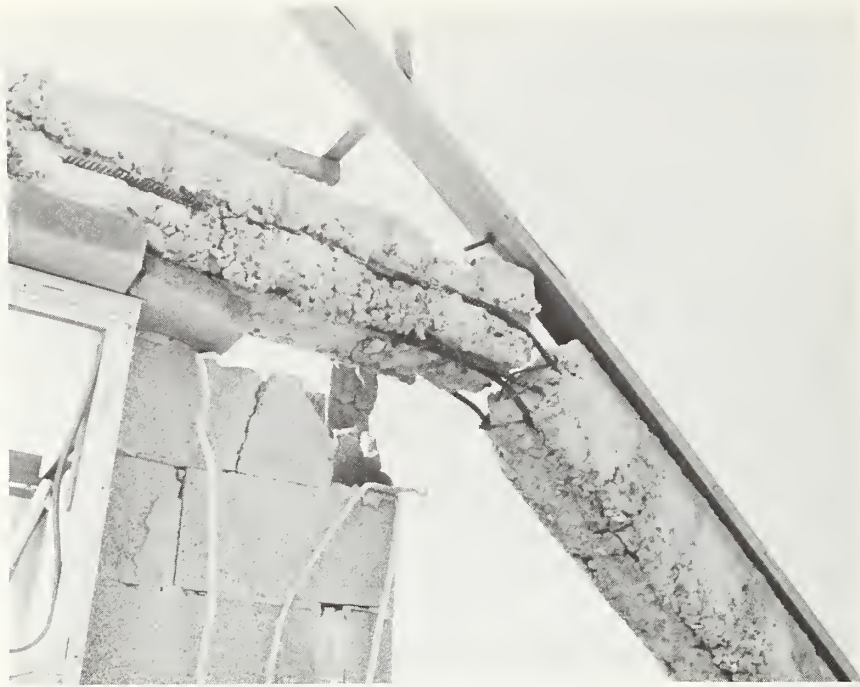
Fig. 11. Concrete bond beam and timber plate
(single-story construction)

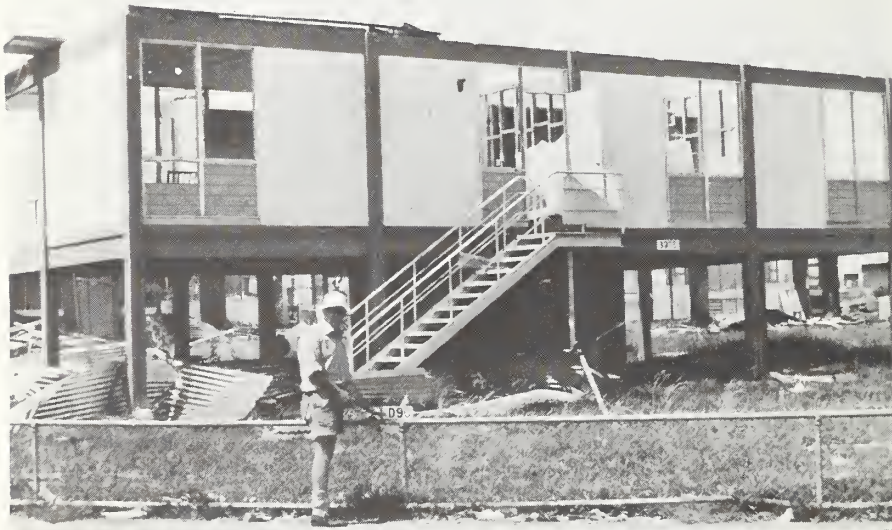
Of the several prefabricated housing systems used in Darwin, only two were investigated in some detail and are described herein. The first is a high-set house with the same general floor plan and overall dimensions as the timber high-sets constructed for the Department of Housing and Construction (see Figure 12). All components are of precast concrete with welded and grouted beam-column connections. Columns are 200 x 200 mm in cross-section and the beams are 300 mm deep and 75 mm wide. The floor and roof panels are approximately 50 mm thick except for the edges which are 100 mm thick. A screed course is placed over the floor panels and the roof panels are bolted into sockets provided in the top edge of the beams. Wall panels lock into slots provided in the beams and columns. Conventional aluminum window frames, jalousie windows and metal louvers are also used in these houses. A conventional truss-purlin-CGI roof is placed over the ceiling panels, the timber plate being bolted down with the precast ceiling panels. This system would have performed very well had it not been for the fact that anchor bolts were installed only along the perimeter of the roof, even though the interior ceiling beams contained bolt sockets (see Figure 13). The result was that many of the panels were lifted from the interior beams, causing the perimeter anchors to fail.

Fig. 12. High-set house with precast concrete frame and interlocking precast concrete panels.

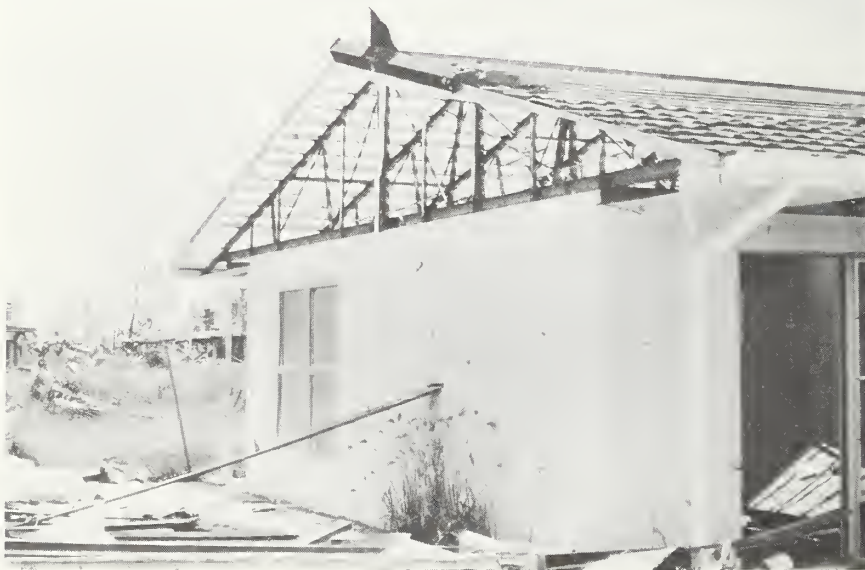
The second prefabricated system inspected is a single-story dwelling with a gable roof as shown in Figure 16. The walls are sandwich panels of 6 mm asbestos cement with a polyurethane core. The panels are framed with steel "H" sections (two channels back to back) and the roof system consists of welded, light-gage steel members. Roofing varied from structure to structure, the type shown here being "Decramastic," a steel sheeting stamped into the shape of tiles and coated with an asphaltic compound. Sandwich panels are also used for the ceiling, the channel framing also serving as the bottom chords of the trusses. This detail allowed the ceiling to act very effectively as a diaphragm. Although there were some window failures and substantial loss of roofing, this system performed exceptionally well. The walls and roof trusses exhibited no permanent deformations and the resistance of the sandwich panels to missiles was far superior to the ordinary asbestos cement cladding used on the high-set houses.

Fig. 16. Prefabricated house with asbestos cement-polyurethane sandwich panels and steel wall and roof frames

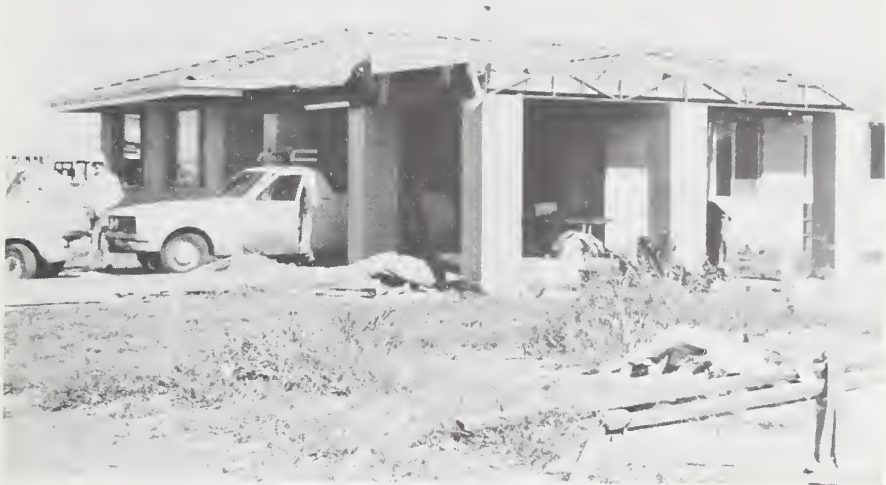
Several privately constructed houses performed well with damage being limited to loss of CGI roof cladding or tiles and some broken windows. The house shown in Figure 17 is located in Nakara and has a welded steel frame with brick veneer. Note that the roof tiles have been replaced since the storm. Commercially produced timber connectors were used in many of these houses to attach purlins and trusses.

Fig. 17. Privately constructed residence with welded steel frame and brick veneer
