NISTIR 8077

Investigation of PMU Response to Leap Second: 2015

August 2015

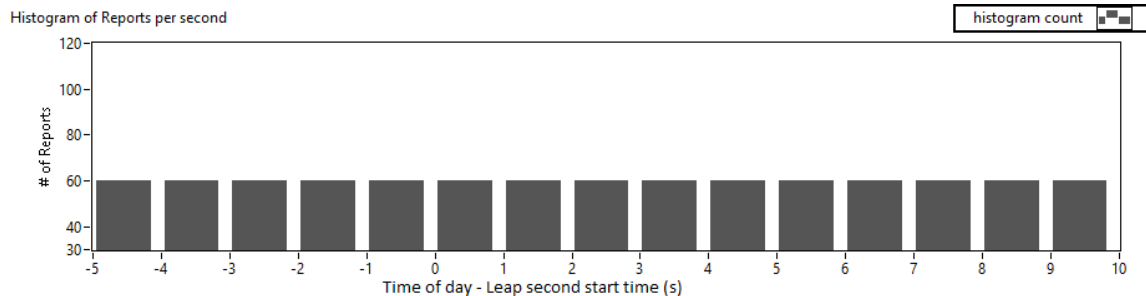
Figure 2 below shows a histogram of the number of reports per TOD second versus TOD relative to the TOD of the leap second. TOD 23:59:60 is shown on the histogram as 0 seconds. For an ideal PMU configured for a reporting rate of 60 frames per second, there will be 60 reports each Time of Day second (including the leap second, TOD 23:59:60). As shown in Section 3, the commercial PMUs' response to the leap second is different than for the ideal case.

Figure 2: Ideal Histogram of Reports per SOC
