NBS MONOGRAPH 158

Corrosion and Protection of Steel Piles in a Natural Seawater Environment

This report describes the first eight years of a long term program in which twenty-three coating systems and five cathodic protection systems are evaluated on their ability to protect steel piles in offshore conditions. These systems are made up of nonmetallic coatings, metallic pigmented coatings, nonmetallic coatings on metal filled coatings, nonmetallic coatings on metallic coatings, metallic coatings, and cathodic protection on bare and coated piles.

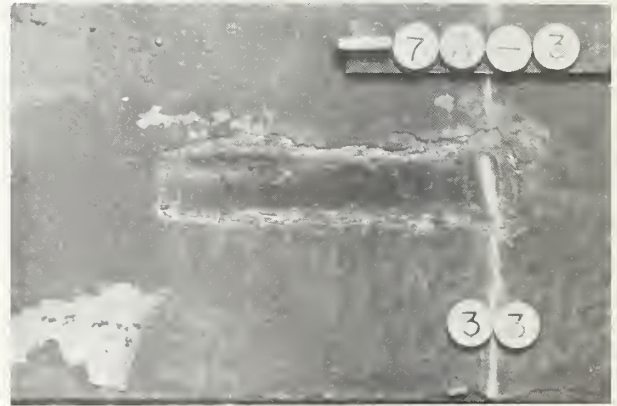
FIGURE 20

trochemical measurements. The physical measurements of these three piles are illustrated in figures 15, 16, and 17. The poor resistance of the coal tar epoxy coatings in the atmospheric and splash zones is well indicated in these drawings. Below the waterline, however, they have performed well. Pile 7A shown in figure 16 indicated that the armor coat did reduce the rate of coating deterioration in the erosion zone. Figure 18 is a photograph of the window in the atmospheric zone of pile 7A. Note the severe undercutting extending half the width of the pile. The window in the tidal zone, that zone between mean high water and mean low water, reveals only a slight amount of undercutting that extends 0.25 in (0.7 cm) as shown in figure 19. Pitting due to coating failure is evident. Below the mud line undercutting resistance is even better as shown in figure 20. Generally the coal tar epoxy looks good in this region.

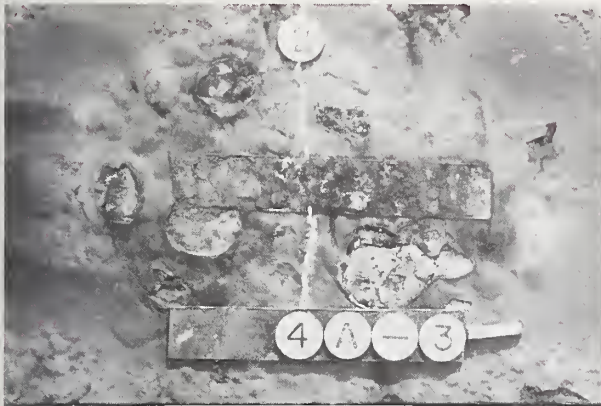
FIGURE 21

Pile 4A shown in figure 21 lacks the armor protection and has developed greater deterioration of the coating in the erosion zone as compared to pile 7A. The appearance of the window

in the atmospheric zone of pile 4A is similar to that of 7A after six years of exposure as figure 21 shows. In the tidal zone, however, the window on 4A has undergone considerable damage not readily seen in figure 22. Undercutting in this area extends almost 1 in (2.5 cm) beneath the coating. General damage to the coating in the surrounding area is also apparent. Below the mud line the coating is in excellent condition with practically no undercutting as shown in figure 23.

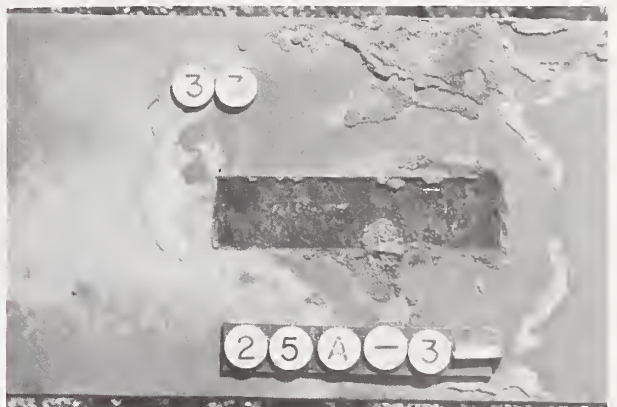
FIGURE 26

In the erosion zone, the coal tar epoxy on mariner steel, System 25, has not fared as well as the same coating on carbon steel (System 4A). Figure 17 indicates loss of metal at the flange in this area. Its pitting resistance below the mud line, however, is far better than any of the other similarly coated piles. Undercutting of the coating in the atmospheric zone is severe as illustrated in figure 24. Coating damage in the tidal zone is also very extensive (fig. 25). Below the mud line, however, figure 26 illustrates that the coal tar epoxy on mariner steel has not been undercut.

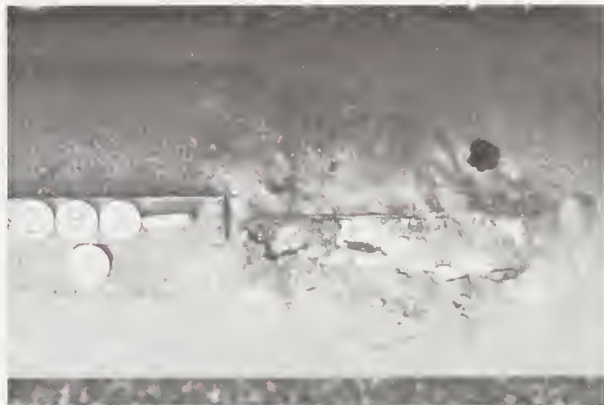
FIGURE 32

mud line, undercutting of the coating has progressed almost 1 in (2.5 cm) from the edge of the window. Coating delamination is also visible in this photograph. The windows in the coating on pile 28A are almost identical in appearance to those on 27A. In the atmospheric zone deterioration is extensive (fig. 32). In the tidal zone undercutting of the coating is moderate (fig. 33) with some mechanical damage visible. Below the mud line undercutting has progressed at least 1 in (2.5 cm) from the edge of the window (fig. 34).

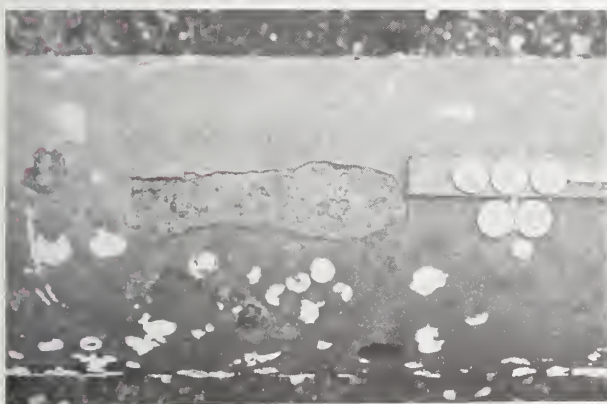
FIGURE 30

The physical measurements on the pipe piles consists only of pit depth measurements (figs. 27 and 28) as meaningful wall thickness measurements were not practical. These observations indicate that though there were fewer coating failures on the pipe piles, (% area pitted) as compared to the H-piles, the resulting pits were deeper on the pipe piles. The deepest pit in the erosion zone of 27A was almost 0.2 in (0.5 cm) deep. Undercutting of the coating on pile 27A extends about 2 in (5 cm) beyond the edge of the window as shown in figure 29, and is considered severe. In the tidal zone undercutting resistance is improved. Undercutting extends 0.5 in (1 cm) at the most (fig. 30). Figure 31 illustrates that below the

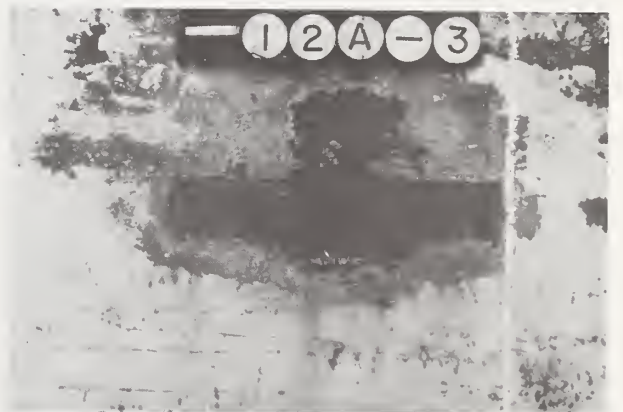
FIGURE 47

coating has been undercut almost two inches (5 cm) beyond the original edge of the window as shown in figure 47.

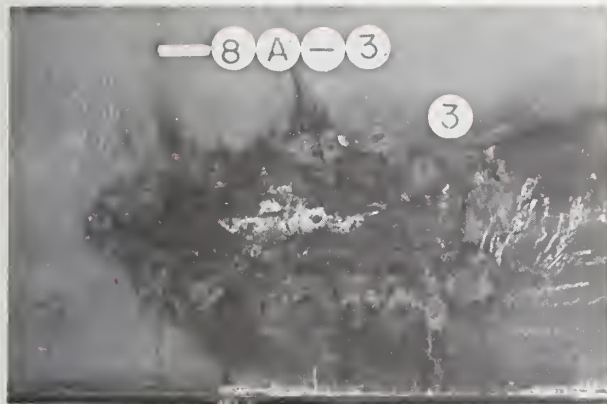
FIGURE 50

minor over most of the pile. In the atmospheric zone, undercutting of the coating extends less than 1.2 in (3 cm) beyond the original edge of the window as shown in figure 50. The same figure shows the otherwise excellent condition of the coating in the surrounding area. Most of the apparent damage is rust staining. In the tidal zone the coating at the edge of the window is in fairly good condition with only 0.1 in (0.2 cm) of undercutting as seen in figure 51. Some coating damage is visible in the surrounding area. Figure 52 is a similar window below the mud line which displays essentially no undercutting and no coating deterioration in the visible area.

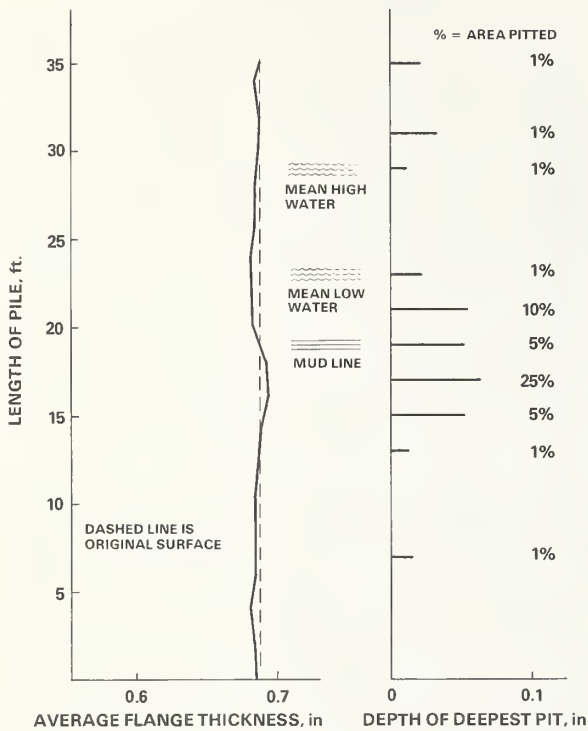
FIGURE 53

The second system of aluminum pigmented coal tar epoxy, System 9, has a film thickness that is 30 percent thinner than System 8. Specimen 9A has undergone more damage as the physical measurements illustrate in figure 53. Incomplete sandblasting of the surface during the cleaning process has caused the flange of specimen 9A in figure 53 to appear thicker in the erosion zone than it really is. The coating 1 in (2.5 cm) from the edge where the flange thickness measurements are made is in

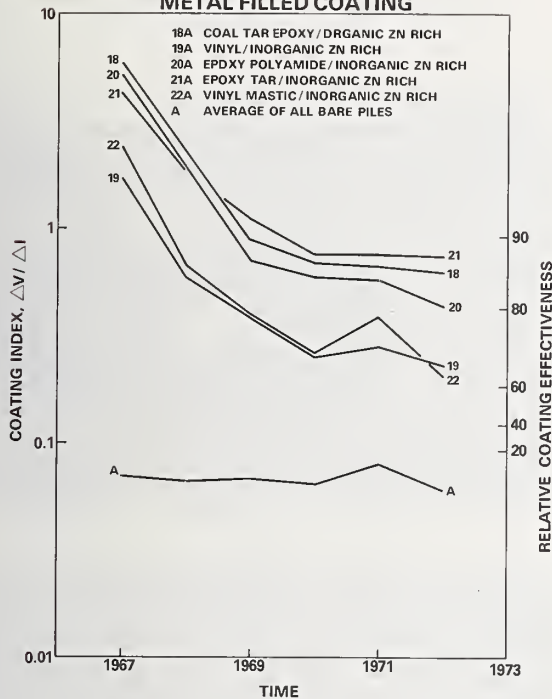
FIGURE 57

Nonmetallic Coatings on Metal Filled Coatings—Metallic Zinc powder has been used in the metal filled undercoats of the five 2-coat systems discussed here. Whereas all of the topcoats are electrically insulating, three of the five metal filled undercoatings are electrically conducting. These three, Systems 18, 20, and 21 will be considered separately from the rest. Figure 57 is a plot of the electrochemical data

Attention is again directed to figure 57 which illustrates the electrochemical data for the nonmetallic coatings on metal filled coatings. Systems 18, 20, and 21 have been described. The remaining systems in this category are piles 19A (vinyl over zinc rich inorganic primer), and 22A (vinyl mastic over zinc rich inorganic primer).

The electrochemical data indicate that Systems 19 and 22 are very similar in their deterioration and degree of protection as figure 57 illustrates. The relative coating effectiveness

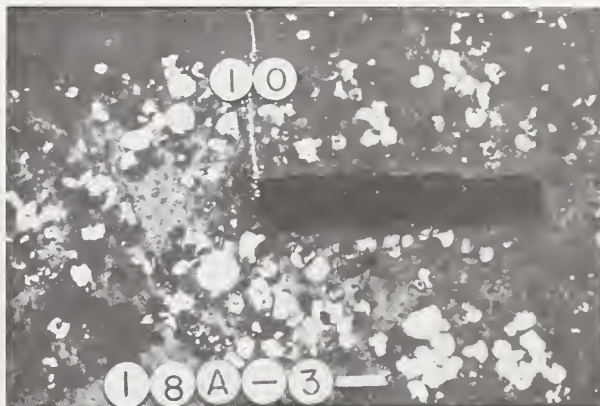
FIGURE 60

minor as shown in figure 60. Below the mud line the effect is negligible as seen in figure 61. Some of the coating damage visible in this photograph is mechanical abrasion due to removal and shipping.

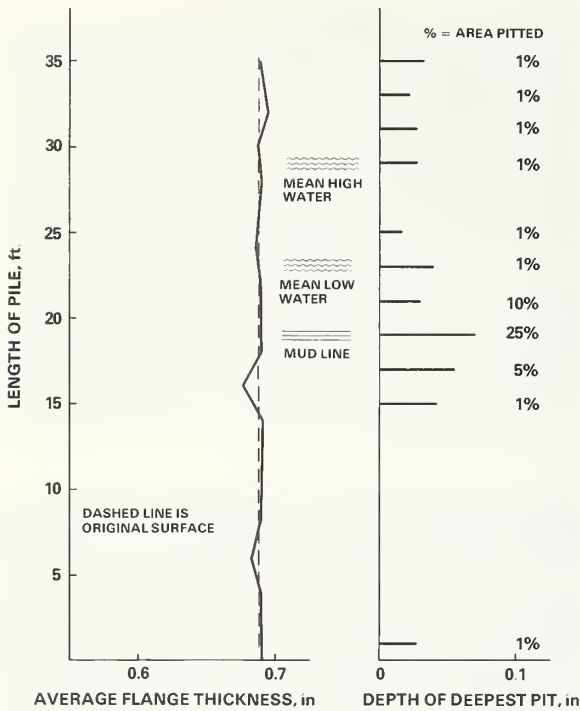
FIGURE 62

System 20A has also shown good resistance to the ocean exposure as illustrated by the physical measurements of figure 62. In this case some deterioration has occurred at the erosion zone, but with insignificant attack below the mud line. The coating was not completely removed in some areas which accounts for the flange appearing thicker than it was originally. This certainly indicates that the coat was still protecting in these areas. The average corrosion rate for this pile was considerably less than 0.1 mil per year (0.5 mdd). Undercutting resistance has been very good in all zones. The window located in the atmospheric zone developed less than 0.5 inches (1.2 cm) of undercutting as shown in figure 63. General pitting can be seen in the surrounding coating. Figure 64 illustrates the excellent appearance of the coating in the tidal zone. Below the mud line undercutting resistance is also very good, however, some blistering is visible in the coating in the adjacent areas (fig. 65).

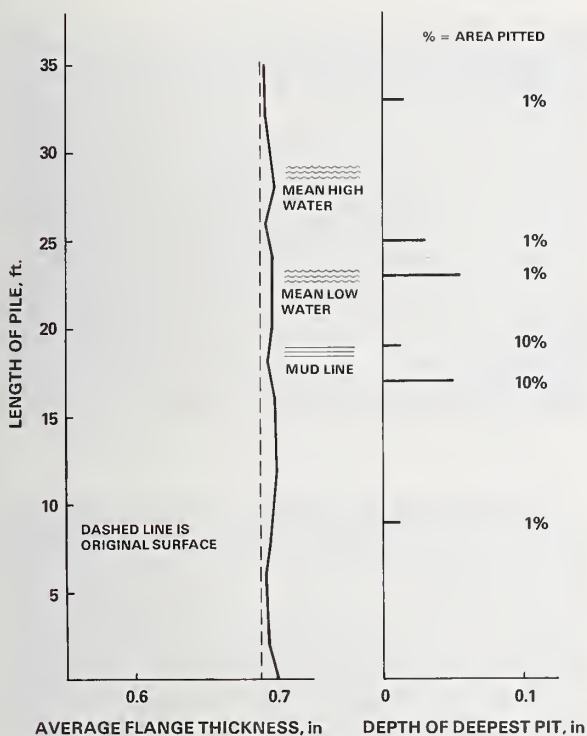
FIGURE 66

System 21 has displayed unusually good resistance to deterioration in the offshore exposure as shown in the physical measurements of figure 66. Incomplete sandblasting has led to the data showing the flange to be thicker than it was originally. As mentioned before, this clearly indicates that there was no metal loss in these areas. Thus, pile 21A is in excellent condition after six years of exposure. The amount of pitting is minor as the same figure shows. Undercutting of the coating in the atmospheric zone has been moderate with damage extending about 0.6 in (1.5 cm) beyond the window as seen in figure 67. The coating in the surrounding area is in excellent condition. In the tidal zone undercutting is of minor consequence and extends less than 0.1 in (0.2 cm) as illustrated in figure 68. Below the mud line there was no measurable undercutting of the coating as shown in figure 69. Mechanical damage to the edge has removed some of the coating.

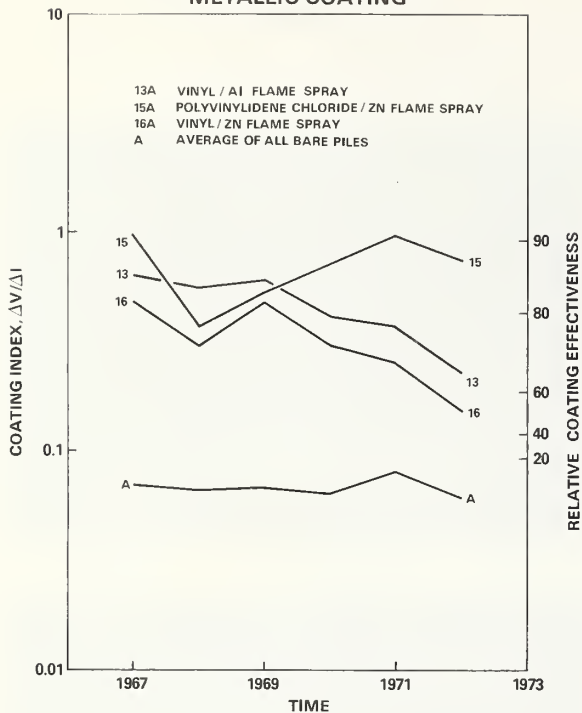
FIGURE 78

The vinyl over zinc flame spray system, pile 16A, has undergone the most deterioration of the topcoated metallic coating systems. The relative coating effectiveness of 16A is about 50 percent as figure 78 illustrates. After the top coat began to fail during the first year of exposure, the flame sprayed zinc protected the piling for a short period. Soon after, however, the system started to deteriorate steadily. It is of interest to note that the total coating thick-

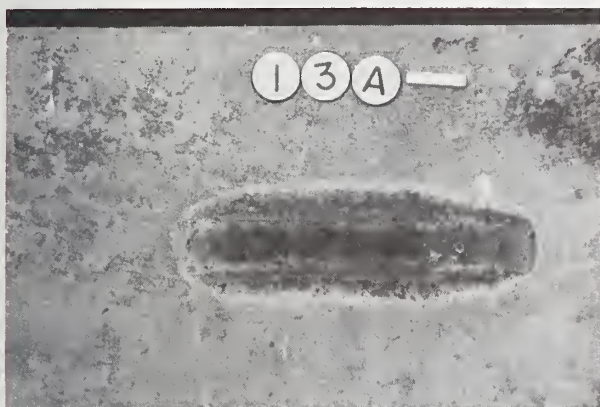
FIGURE 80

been less than 0.05 mils per year (0.3 mdd) for the six years of exposure. In the atmospheric zone, the coating is in excellent condition. Corrosion damage extends slightly less than 0.5 in (1.2 cm) from the edge of the window as shown in Figure 80. Undercutting of the coating at the window in the tidal zone is too slight to be measurable, however, general coating failure is visible as figure 81 shows. Though the coating has obviously deteriorated below the mud line (fig. 82), there has been little subsequent attack to the steel pile. Damage to the coating at the window extends about 0.1 in (0.2 cm).

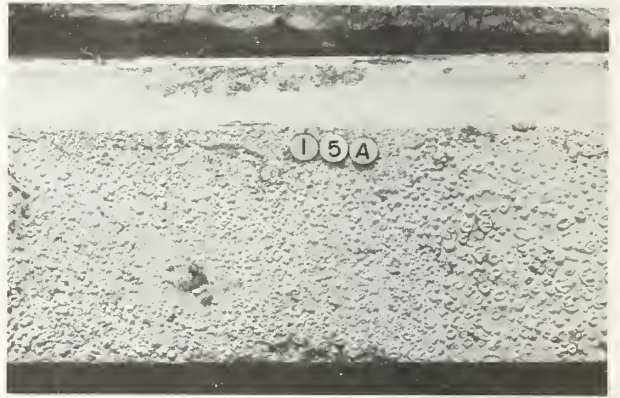
FIGURE 85

loss is small and uniform over the surface of the pile. Similarly, pitting is scattered and of minor consequence. The average corrosion rate for the entire pile is about 0.1 mil per year (0.5 mdd). There were no windows in the coating of this pile. The following photographs are included to display its appearance in areas similar to those seen for the other pilings. The coating in the atmosphere is in very good condition with only minor damage in a few areas. Unfortunately the photograph of this area is of such poor quality that it will not be shown. In the tidal zone the nonmetallic coating is badly blistered as figure 84 shows, but the piling is still being protected by the zinc. Top coat blistering extends into the area below the mud line as figure 85 illustrates, but corrosion damage to the pile is minor.

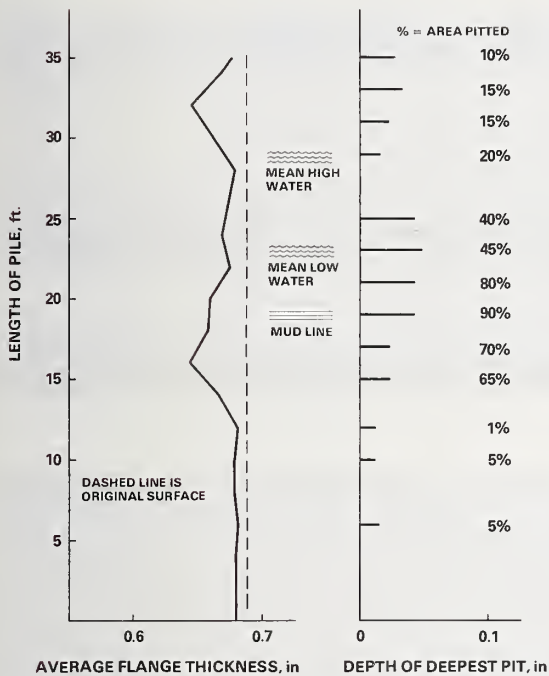
FIGURE 86

ness of this system is about 50 percent less than that of pile 15A. Corrosion damage to the steel pile in the form of general corrosion and pitting has been extensive as the plot of the physical measurements in Figure 86 illustrate. The average corrosion rate for the entire pile is about 1.5 mils per year (8 mdd). In the atmospheric zone coating failure was severe as figure 87 shows. The window in the coating is barely visible. In the tidal zone failure was also extensive as shown in figure 88. Figure 89 illustrates the condition of the piling below the mud line where it has fared somewhat better than in other zones. With such complete failure of the coating, evaluation of the undercutting is of no consequence and, therefore, is not attempted.

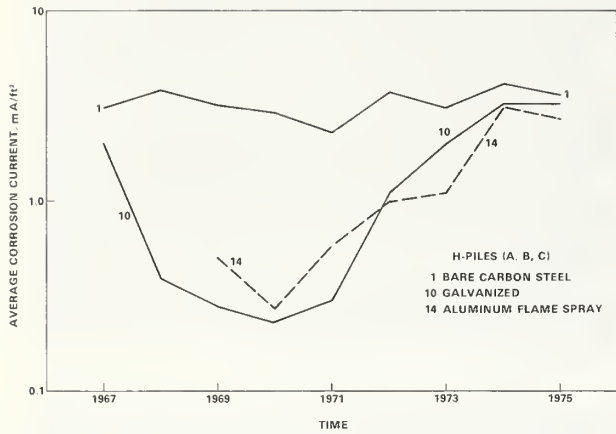
FIGURE 90

The flame sprayed aluminum system, pile 14A, is similar to pile 10A in its electrochemical behavior as indicated in figure 90. It too shows an increase in corrosion which is approaching that of bare steel as the aluminum deteriorates. The flange thickness measurements, figure 95, reveal some metal loss in the erosion zone, and practically no pitting anywhere. In the atmospheric zone the aluminum flame spray coating appears in excellent condition with the exception of the corrosion damage extending almost 1 in (2.5 cm) from the window shown in figure 96. In the tidal zone the coating is also in excellent condition (fig. 97) with minor damage extending from the window. From the mud line down, however, damage is more extensive. Figure 98 illustrates the window in this region with coating damage over most of the visible surface.

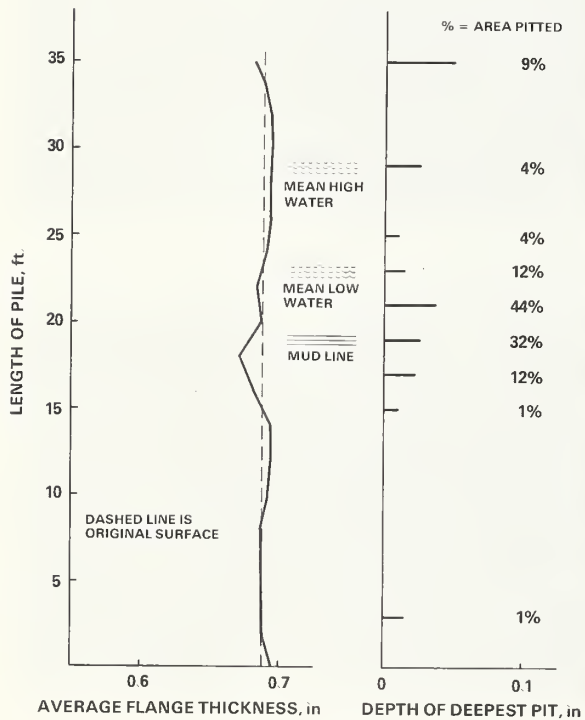
FIGURE 91

The results on the bare carbon steel piles are shown for reference as was done in all illustrations of electrochemical data. The corrosion current indicates that the bare steel corroded at a relatively uniform rate with time while the corrosion of the galvanized pile, 10A, has changed considerably in the same period. During the first three years, the corrosion current decreases by a factor of ten. Thereafter it increased steadily until now, eight years later, it is approaching the corrosion of the bare carbon steel pile. This data on the galvanized steel is made up of information from piles A, B, and C, two of which are still at the offshore site. Figure 91 illustrates the physical measurements on pile 10A. The pile shows some

corrosion in the atmospheric zone and considerable corrosion in the abrasion zone. The average corrosion rate for the pile is less than 0.15 mils per year (0.8 mdd). There are no windows in this system, but photographs are included for information. Above the high water line, coating failure is in the form of pits as figure 92 illustrates. In the tidal zone pitting continues along with some undercutting of the coating. A small section of coating was easily separated from the substrate as figure 93 shows. Below the mud line the coating was very thin or altogether missing in some areas as figure 94 illustrates.

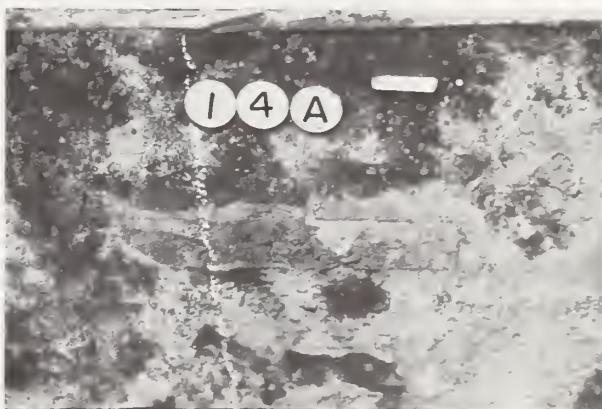
FIGURE 98

Sealed flamesprayed aluminum

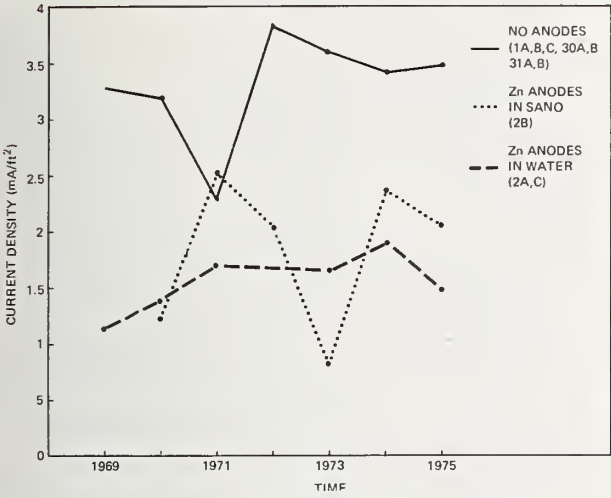
FIGURE 99

The average corrosion current densities of several bare steel piles and the average protective current densities of steel piles with zinc anodes are plotted in figure 99. The protective current density of the protected piles represent both the galvanic current as well as local action current on the anodes. The local action current was not directly determined but it has

As seen in figure 99, the protective current densities of the zinc anode protected systems are less than those of the unprotected piles. It appears that there is not very much difference in the protective current densities provided by the anodes in the water and buried in the sand over the 6 year period (1970 to 1975). More time will be required to determine any real differences.

BARE CARBON STEEL - WITH AND WITHOUT Zn ANODES

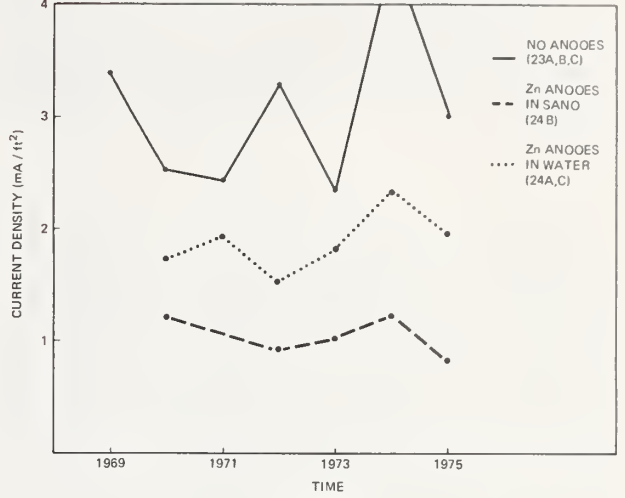
FIGURE 101

In the case of mariner steel, however, the protection current density of the zinc anodes buried in the sand, over the 6 year period, is definitely less than the current density of the zinc anodes exposed to the water (fig. 101).

BARE MARINER STEEL - WITH AND WITHOUT Zn ANODES

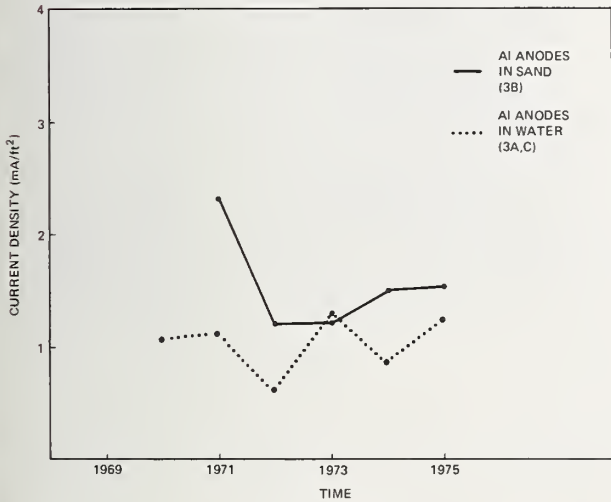
FIGURE 100

Aluminum anodes in the sand appear to be less effective than the anodes in water in protecting the steel (fig. 100).

BARE CARBON STEEL - PROTECTED WITH Al ANODES

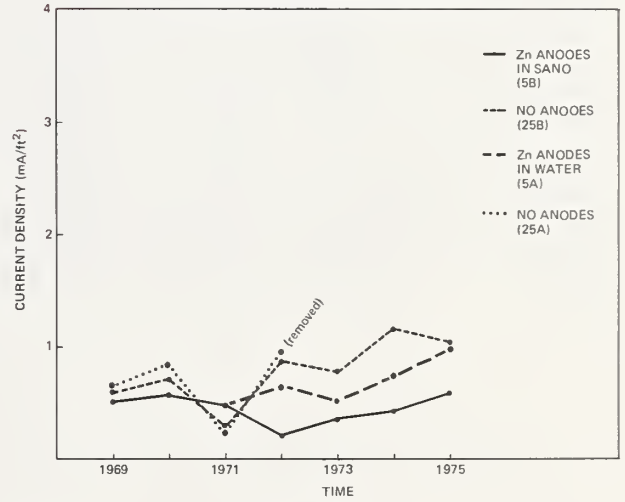
FIGURE 102

The coal tar epoxy coated piles, with zinc anodes in the sand appear to be more effective (from a galvanic current standpoint) than the coated piles without cathodic protection except for one year (1971). For the piles with windows (5A and 25A), there was little discernible differences for two years (1971, 1972) between the piles with anodes in the water and the piles without anodes (fig. 102).

CARBON STEEL - COAL TAR EPOXY COATING WITH AND WITHOUT Zn ANODES

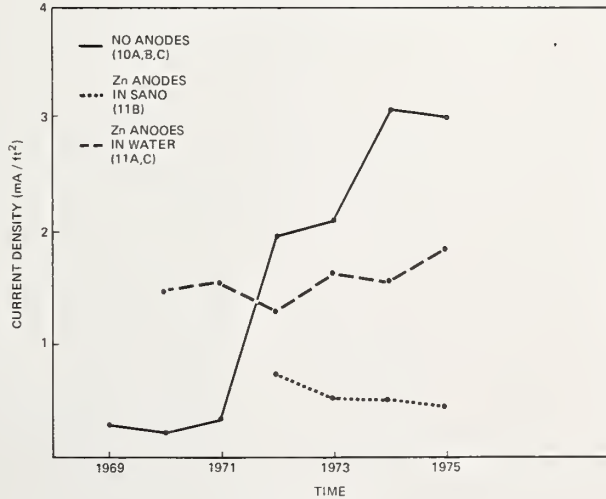
FIGURE 103

A comparison of the galvanized pile, with zinc anodes (System 11) and without zinc anodes (System 10), is shown in figure 103. Only a portion of the curve for the protective current density of the galvanized pile is shown. From 1973 to 1975 the curve represents the averages on piles B and C. Initially (1967) the average corrosion current density on piles A, B, and C was quite high and then decreased to very low values for 1967-1971 (fig. 90). The protective current density is very low for the zinc anodes buried in the sand and appears to be steadily decreasing with the passage of time. The protective current density for the zinc anodes in the water is about 3 times higher and appears to be increasing with time.

GALVANIZED STEEL - WITH AND WITHOUT Zn ANODES
