Case Study

U.S. Chemical Safety and Hazard Investigation Board

E.I. DuPont de Nemours & Co Inc.

Flammable Vapor Explosion

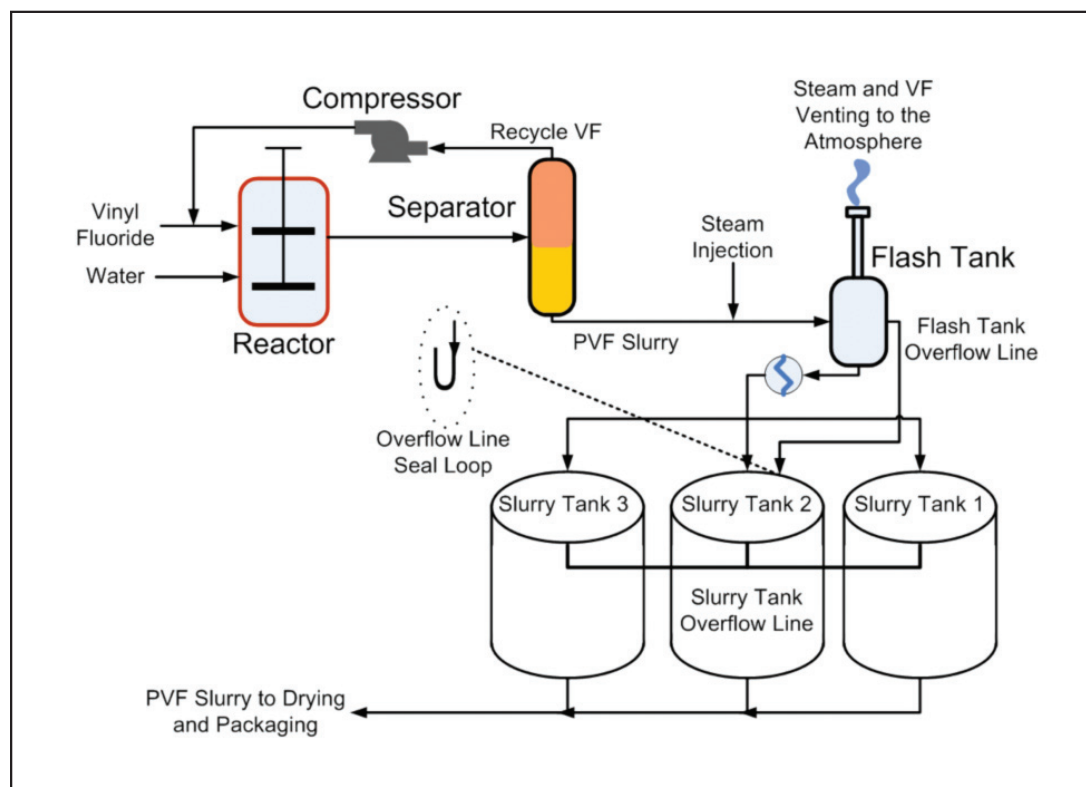
FIGURE 1

The non-combustible PVF slurry then passes to one of three insulated slurry holding tanks (numbered 1, 2, or 3) in the tank farm adjacent to the production building (Figure 1). Under normal operating conditions, slurry is pumped to slurry tank 3. Slurry tank 3 is newer than slurry tanks 2 and 1; it had been replaced in 2009 due to corrosion². Slurry tanks 2 and 1 were used as overflow storage space in the event slurry tank 3 was filled and slurry tank 1 was generally kept empty of slurry.

PVF process flow diagram

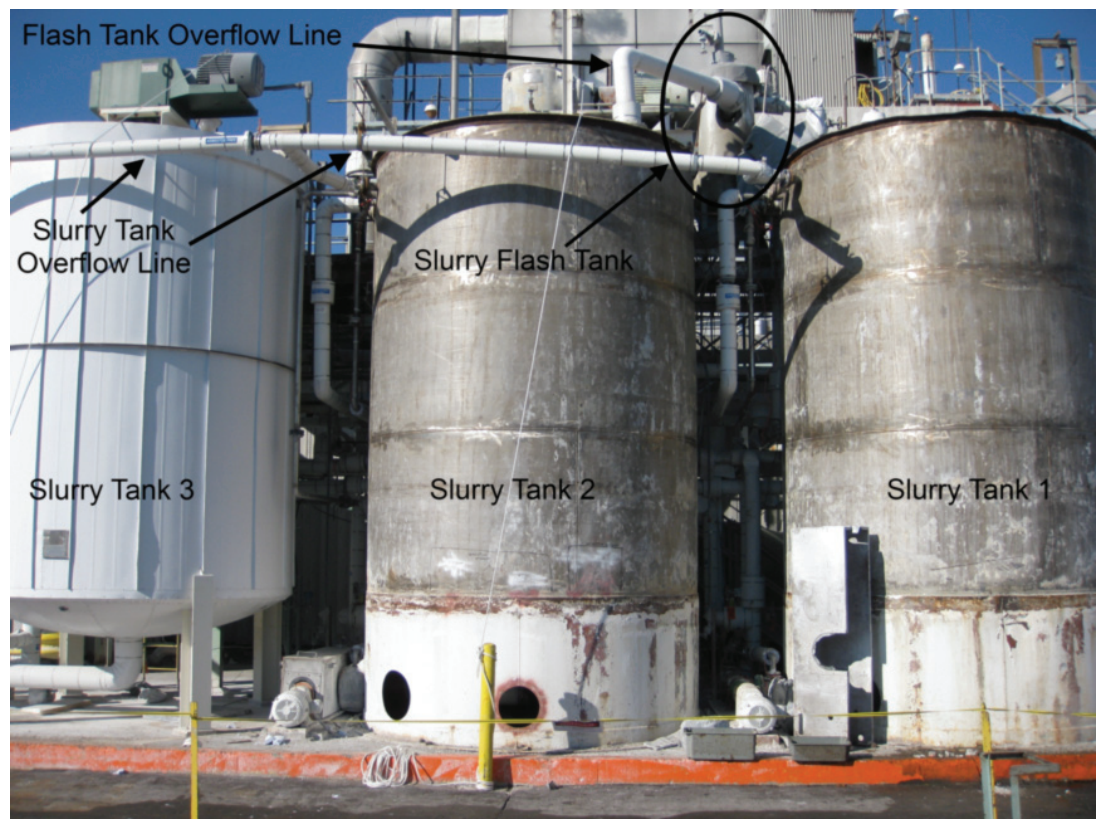
FIGURE 2

The flash tank and three slurry tanks are located in a tank farm adjacent to the Tedlar manufacturing building. The slurry tanks are 11 feet in diameter, 19 feet tall, and have a capacity of 10,800 gallons (Figure 2). The tank shell and top are one-quarter inch thick stainless steel. Each tank top has a hinged, unsealed steel cover on a 24-inch diameter manway and a large agitator motor drive and gearbox⁵. The agitator assembly is bolted to structural steel beams that are welded directly to the tank top.

PVF slurry holding tanks
