Research
Paper
FPL-RP-622

Durability of Hardboard Lap Siding

Determination of Performance Criteria

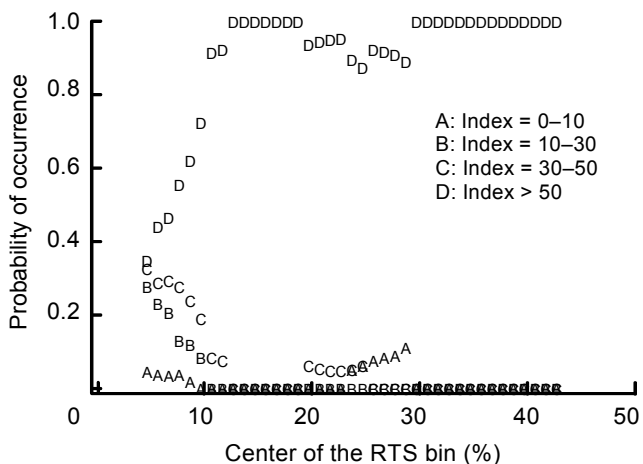
Figure 18—Edge welt index as a function of residual thickness swell (RTS), fence 1, non-commercial classes.

When consideration is confined to commercial board classes on fence 1 (Fig. 17), the data again show a steady increase in more severe wetting (categories C and D) between the 8% and 18% RTS bins (5% to 21% RTS) and a steep increase in the most severe index level (category D) in the 19% and 20% RTS bins (16% to 23% RTS). Above 17% RTS (20% RTS bin) there are no boards with a welt index below 30. A strong relationship between RTS and edge welt also exists for the non-commercial board classes on fence 1 (Fig. 18). With these boards, severe wetting ($I > 50$, category D) steeply increases at much lower RTS ratings, specifically between the 5% and 13% RTS bins (2% to 16% RTS). With a few exceptions, non-commercial boards on fence 1 with RTS ratings over 11% (14% RTS bin and higher) had severe wetting.

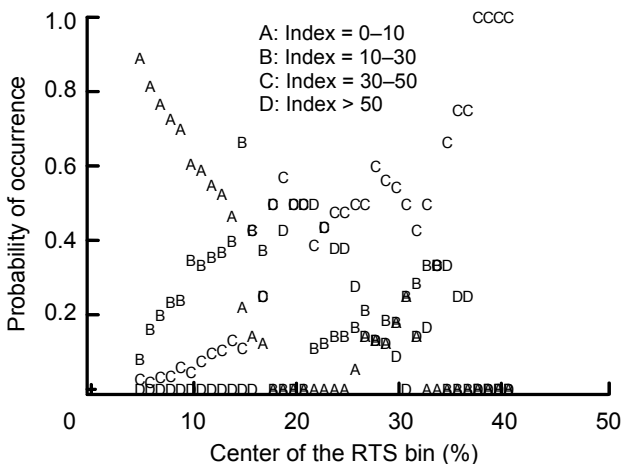
Figure 21—Edge welt index as a function of residual thickness swell (RTS), fence 2, non-commercial classes.

As on fence 1, the non-commercial boards on fence 2 show greater susceptibility to edge welt than do commercial boards at a given RTS level, even in the lower RTS bins (compare Figs. 20 and 21). The frequency of boards with little or no edge welt (category A) declines rapidly between the 14% and 18% RTS bins (11% to 21% RTS).

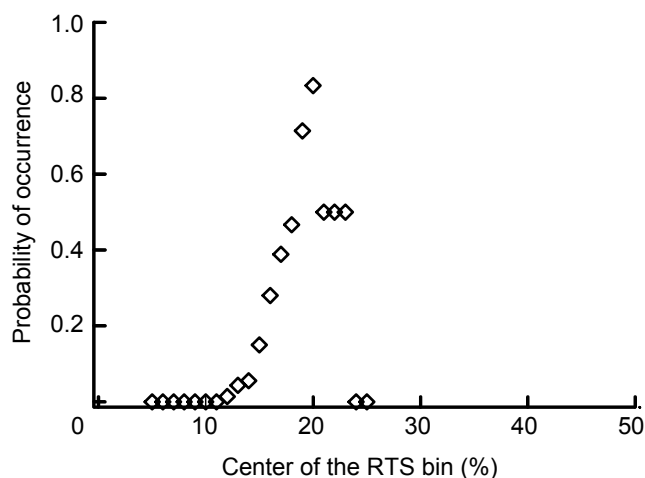
Figure 28—Probability of boards developing mildew as a function of RTS, fence 2, commercial classes only, except OSB (class 9).

The data for fence 2 (drip edges intact, Fig. 27) give somewhat different results. The likelihood that boards had mildew rapidly increases after the 13% RTS bin (10% to 16% RTS), but after the 20 RTS bin (17% to 23% RTS) there appears to be no clear correlation. When non-commercial classes are excluded from the data (Fig. 28), a somewhat clearer picture emerges. Occurrence of mildew increases sharply after the
