BUILDING MATERIALS

REPORT BMS82

Water Permeability of Walls Built of Masonry Units

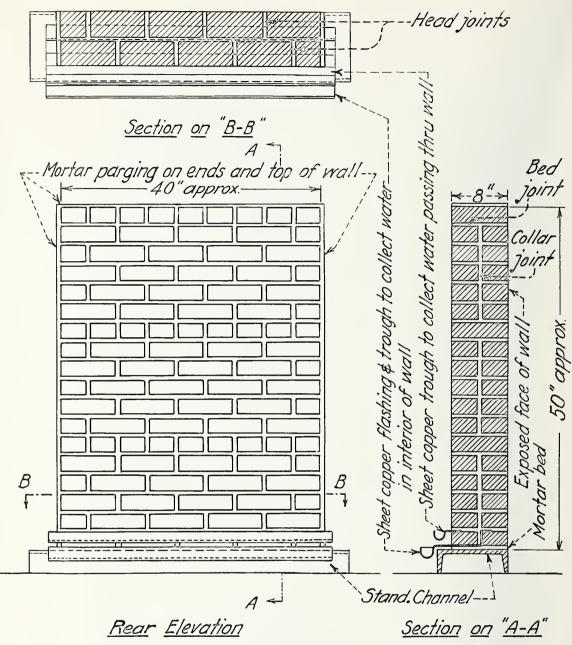
FIGURE 1.—Brick masonry wall specimen. 8-inch wall laid in common American bond.

the size of the units, the number of wythes, and the type of construction. The rear elevation and two cross sections of a typical brick masonry test wall are shown in figure 1. The walls, which were built at the Bureau by experienced masons, were supported on steel channels to facilitate handling, and contained one or more copper flashings so placed as to collect any leakage passing through them or dropping between the wythes. They were faced at the ends and top with a mortar parging $\frac{3}{5}$ to $\frac{1}{2}$ in. thick, sealing these areas, so that a pressure gradient from the face to the back of the walls was maintained within the masonry when an air pressure was applied to one face.

placed to divert possible leakage to the backs of the walls, as is shown in figure 1, and not to divert leakage to the exposed faces, as is usually recommended in specifications for cavity walls. Joints of the brick facings were tooled. A typical cavity-wall construction (similar to that described in BMS24) is shown in figure 12.

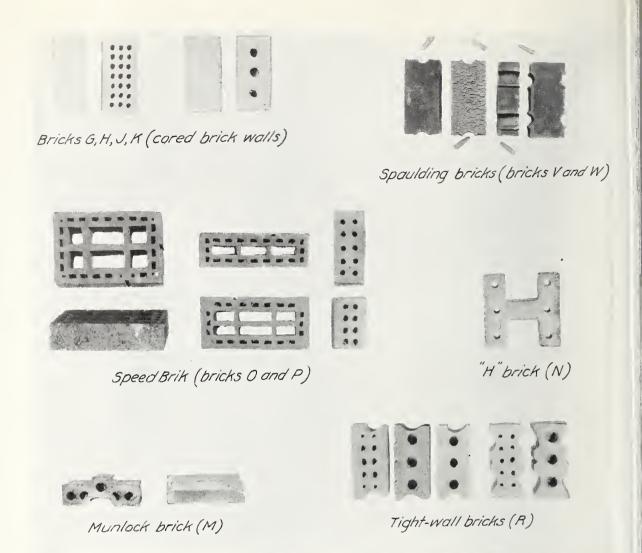
FIGURE 3.—Bricks of special shapes.

The 22 kinds of bricks included many units that were hollow or cored; some of the special shapes were designated as bricks by the sponsors even though their net areas were less than 70 percent of their gross cored section. Three kinds of solid bricks, designated as brick A, B, and C, were selected for their absorptive properties and were used in more than half of the wall specimens. The physical properties of all of the bricks are given in table 1. The dimensions of bricks of special shapes are shown in figure 2 and the photographs are shown in figure 3.

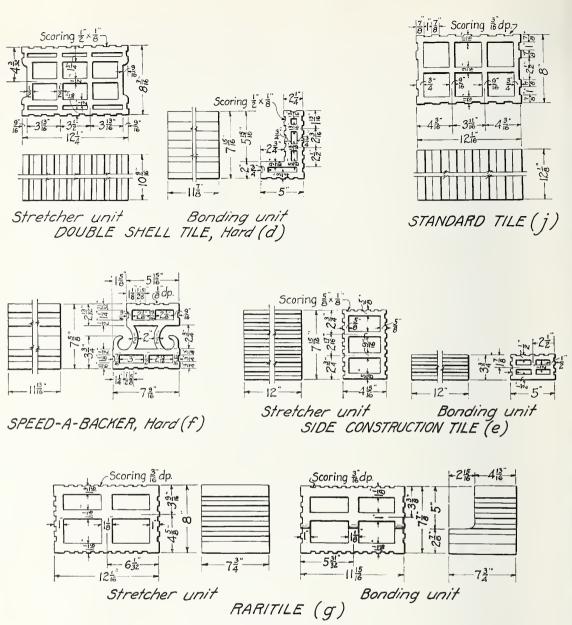
FIGURE 4.—Details of structural clay tiles.

Tile p.—End-bearing tile, similar to those used in the Harlem Housing project. Both stretcher and bonding units were 2-cell. Used as backing units in two walls.

The structural clay tiles were used principally as backing units. Their physical properties are given in table 2; detailed measurements and photographs are shown in figures 4, 5, and 6.

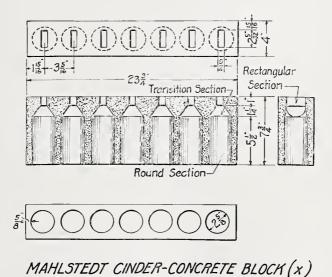
DUNSTONE UNITS (W)

FIGURE 7.—Details of concrete units.

Four 8-in. walls (B231-, 232-, 233-, and 234w8B2) were built with "Dunstone" units. They were similar in construction to those used for the structural tests described in BMS38. Two of these walls (B231 and 233) were built by placing 8- by 8-in. header units in a vertical position at each end of 8- by 12-in. stretcher units, also laid vertically. Each course was about 8 in. high. Bond of the vertical joints was broken by using 4- or 8-in. stretchers at alternate ends of successive courses.

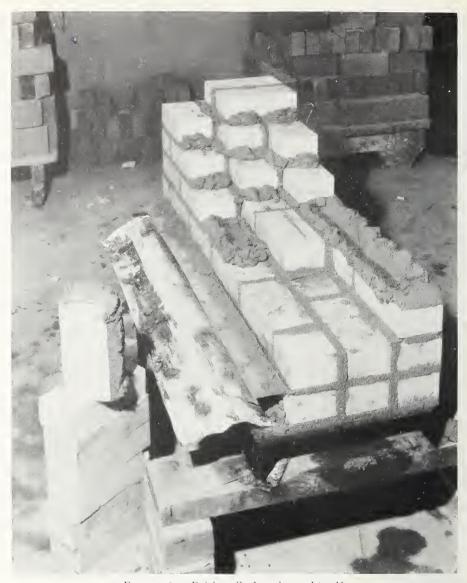
FIGURE 8.—Brick wall of workmanship A'. The bed joints are furrowed and vertical joints are completely filled. Note the mortar on the stretcher brick, which is ready to be placed in one of the backing wythes after the bed joint is placed.

Type A'.—Illustrated in figure 8 is workmanship A'. This was used in 10 walls and was the same as type A, except that the bed joints, under the brick, were furrowed, not leveled. The joints in the wall face were tooled.

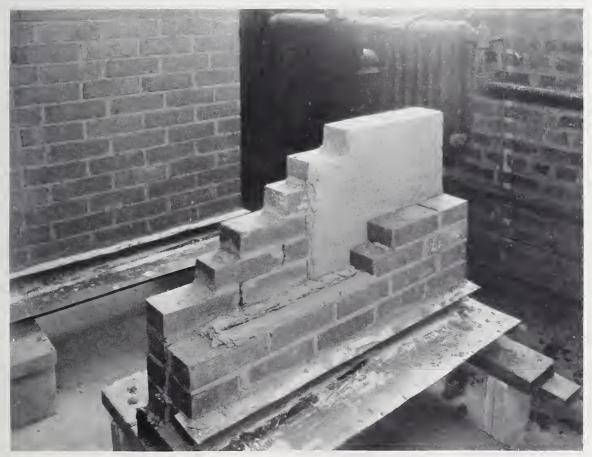
FIGURE 9.—Brick wall of workmanship F.

Except for the parging, this wall is typical of type B workmanship. Bed joints are furrowed and head joints are huttered at the wall faces. The parging is applied to the rear of the facing wythe before laying the backing wythe. This wall contains no header brick hut is honded by metal hrick ties (not shown).

Type F.—Workmanship F, illustrated in figure 9, was similar to that used in brick walls of workmanship B, except that the collar joints contained mortar pargings. The bed joints were furrowed, and the head joints were buttered at the wall faces. The stretcher courses in the facing were laid to the elevation of the header course or to that of the course containing brick ties. A mortar parging $\frac{3}{6}$ to $\frac{1}{2}$ in, thick was carefully applied to the back of the wythe and keyed into the open head joints. The units in the backing wythe were then brought to the elevation of the bonding course. If the wall contained three wythes, as in 12-in. all-brick walls, a mortar parging was similarly applied to

the back of the second wythe. The width of the collar joint was such as to leave a narrow space between the parging and the faces of the units in the backing. Since the head joints in header brick were buttered at the edges placed in the wall face, and not completely filled, the continuity of the parging was broken in the vertical joints at each header course. Walls with brick facings, and backings of hollow units, were constructed by first laying the brick to the height of a header course. The backs of the brick were then parged and the backing wythe was laid as in workmanship B to the elevation of the header or bonding units. The joints in the wall face were tooled. Twenty-four walls were built of workmanship F.

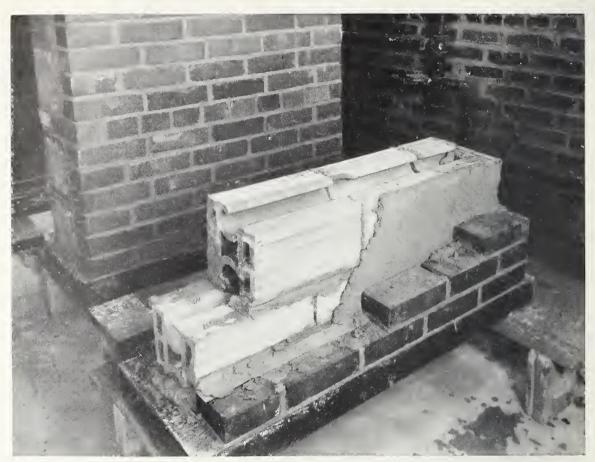
$\label{eq:Figure 10} Figure \ 10. \\ -Brick-faced \ wall \ of \ workmanship \ G \ and \ G'.$ Parging applied to face of the backing. Head joints in both the hollow units and the brick are buttered only at the wall faces.

Type G.—Workmanship G was used in three brick-faced walls backed with hollow units and is illustrated in figure 10. It was similar to that of type F, except that the parging in the collar joint was applied to the backing. The hollow units were laid to the elevation of the brick header courses, using workmanship B. Bed joints were placed under the outer shells of the hollow units, and the head joints were buttered only at the back of the wall. A mortar parging 3% to ½ in. thick was then applied to the backing, and the brick facing was laid as in workmanship B to the top of the header course. A narrow open space was left between the back of the bricks and the face of the parging. The head joints in header courses were buttered, not completely filled. The joints in the wall face were tooled.

Type G'.—The head joints between header brick in walls of workmanship G' were completely filled, not buttered; otherwise this workmanship was similar to that of type G. Six brick-faced walls with backings of hollow units were built with workmanship G'.

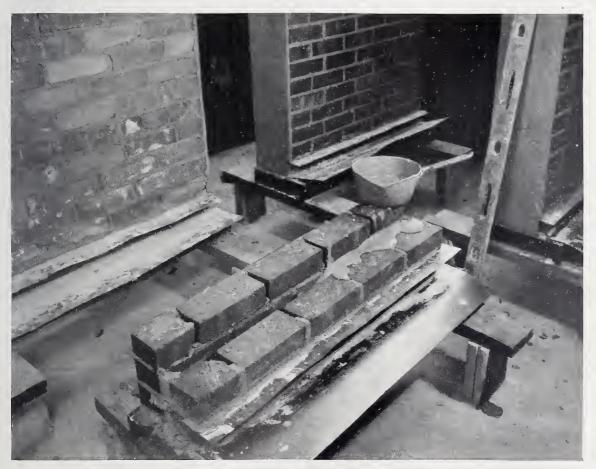
FIGURE 11.—Brick wall of workmanship H, grouted.

Wall B52-BB9H2 under construction. Note the mortar plugs at the ends of the collar joints and the buttered head joints. All the vertical joints were filled with grout as the backing was laid, one course at a time.

Type H.—The letter H designates a workmanship used in building eight grouted brick walls. The method usually followed, and illustrated in figure 11, was to lay the brick as in type B workmanship, plugging the ends of the collar joints with mortar, after which a grout was poured as the brick were laid, one course at a time. The brick in the facing were sometimes laid several courses above the backing or to the height of the bonding course. When furrows in the bed joints were made close to

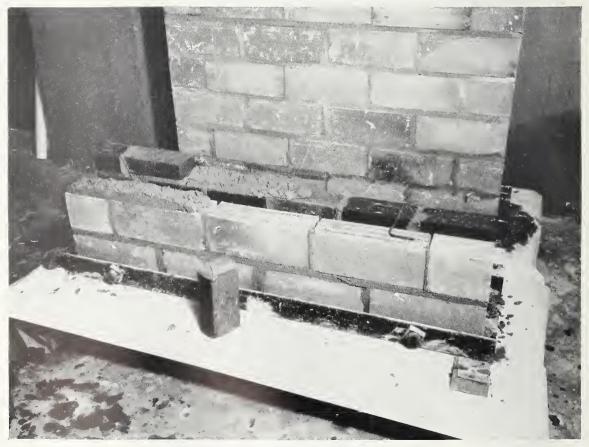
$\label{eq:Figure 12} Figure 12. \\ -Brick-faced\ cavity\ wall,\ workmanship\ M.$ Note the brick ties and the cut joints inside the cavity. The head joints in the tile are buttered on back face only. This wall was constructed for structural tests but is typical, except for lower flashing, of cavity walls built for water-permeability tests.

Type M.—Five walls of type M workmanship contained a 2-in. cavity between the wythes, which were connected by means of metal ties. Mortar for the bed joints was furrowed, and the head joints in the brick courses were filled or nearly filled by heavily buttering the ends of the brick. The head joints for the tile backings were buttered only on the outer edges. The cavity contained no projections except the metal ties, and the mortar joints inside the cavity were cut flush. During construction a timber was supported on the metal ties to catch the mortar droppings, thus preventing fouling of the bottom of the cavity. The flashings in these walls were

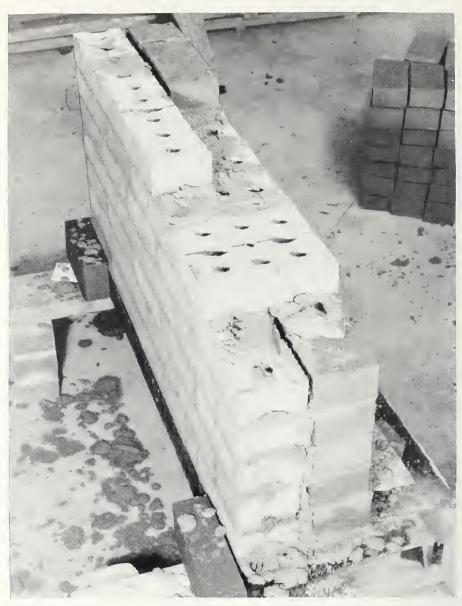
FIGURE 13.—Brick wall of workmanship N.

Sponsored construction wall B302 under construction. Note the recessed ends of the stretcher bricks and the sides of the header bricks, which are filled with mortar after the bricks are laid in the wall, without buttering the head joints; the collar joint was left open. The joints in the facing were subsequently tooled.

Workmanship N, illustrated in figure 13, was used in constructing three walls of "Tight-Wall" brick (bricks R_1 , R_2 , and R_3) laid in common American bond, with mortar 2. The bricks were recessed at the ends of stretcher units and at the sides of headers. The bed joints were furrowed, and the stretchers in the facing wythe were laid end to end on the bed joint without applying mortar to the ends of the units. Stretcher bricks R_1 and R_3 were about $\frac{3}{8}$ in longer at one face than at the other; and the long faces were laid in contact with each other at the back of the facing wythe, so that a 3/8-in. open joint was left at the head joints in the wall face. Stretcher brick R_2 were of equal lengths front and back and these brick were laid end to end, about 3% in. apart. The maximum width of aperture between stretcher units, measured parallel to the face of the walls, was about $1\frac{5}{8}$ in. for brick R_1 (wall B300) and about $1\frac{7}{8}$ in. for bricks R_2 and R_3 (walls B301 and B302, respectively). Mortar was slushed into the openings between the ends of the bricks, filling the space between the units. Header bricks were laid similarly, and both the front and rear cavities between the header bricks were filled with mortar.

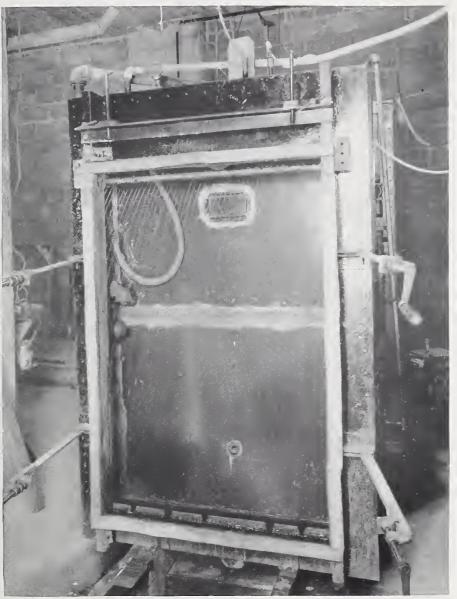
FIGURE 14.—Water-permeability test chamber, Face of chamber before placing wall in position. Note streams of water from perforated pipe at top of opening.

The apparatus is shown in figures 14 and 15. The walls were supported on metal skids during the permeability tests, and they were clamped into position against the sponge-rubber gaskets of the testing apparatus so that the exposed face formed one side of a pressure chamber. An air pressure was maintained within the chamber, and water from a perforated tube was applied to the upper portion of the exposed face (inside the chamber) at the rate of 40 gal (152) liters) per hour. Since the exposed length of the wall was 35 in., the amount of water applied per linear foot of wall per hour was 13.7 gal (52 liters), an amount sufficient to cover the wall face with a thin sheet of running water. The applied air pressure was equal to that produced by a head of 2 in. of water, about the maximum difference in pressure on two faces of a wall which may be caused by a wind having a velocity of 50 mph.

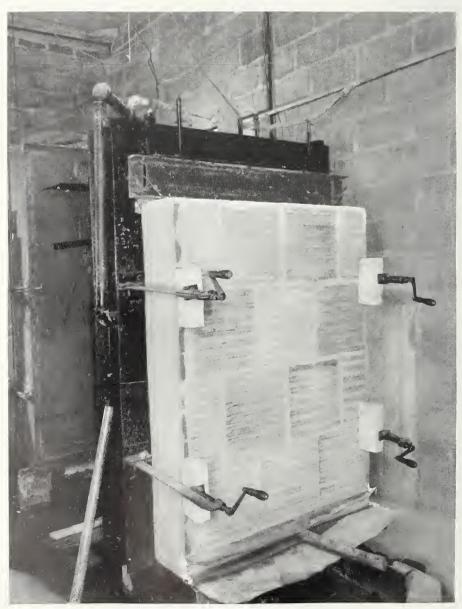
FIGURE 15.—Water-permeability test chamber. Wall similar to B127-j8A2 in position for test. Back of wall not whitewashed (preliminary test).
