REPORT BMS95

Tests of Cement-Water Paints
and Other Waterproofings for
Unit-Masonry Walls

CYRUS C. FISHBURN

and DOUGLAS E. PARSONS

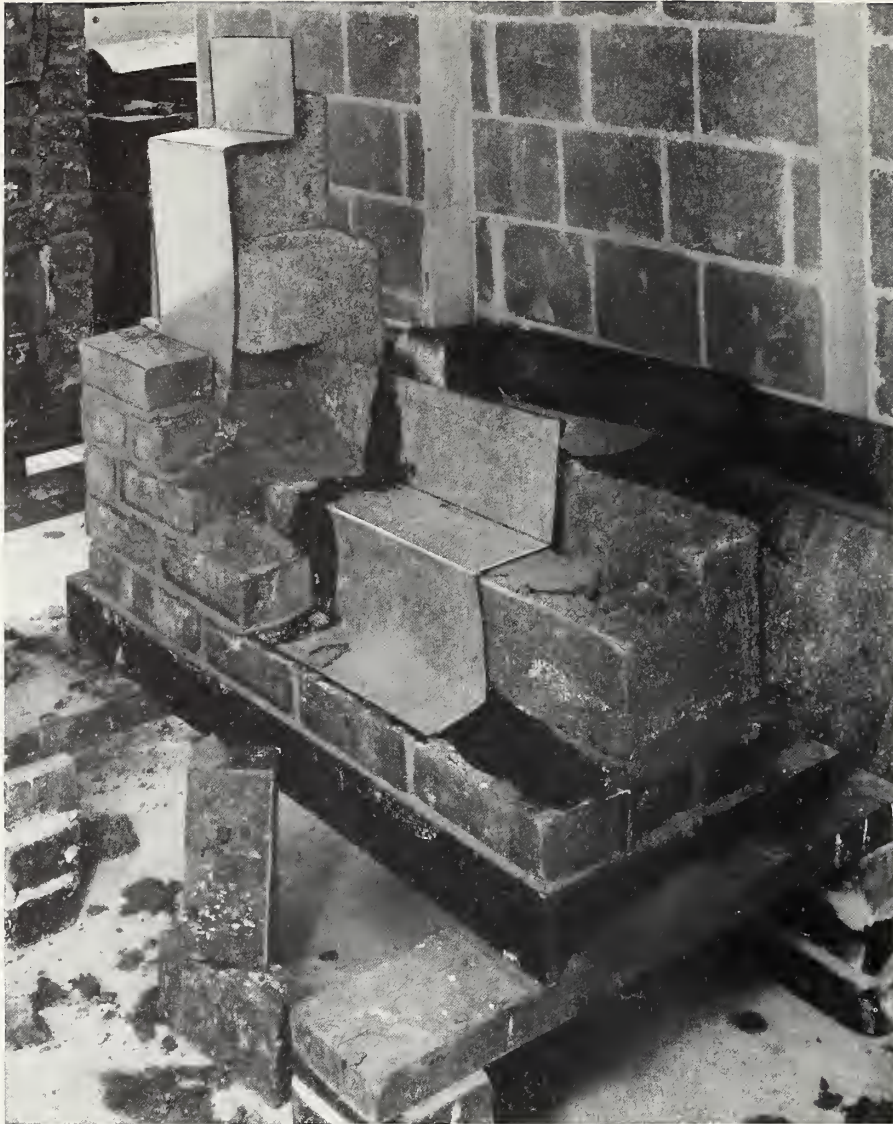
FIGURE 4.—Wall B236 during construction.

The lower membrane is bonded to the copper flashing.

The waterproofing units were made of heavy asphalt-impregnated felt or paper dusted with mica. They were preformed to fit the brick and course dimensions, and were lapped and sealed at the ends to form a series of waterproof membranes, as shown in figures 4, 5, 6, and 7. The vertical joints between the units were lapped 4 in. and sealed with an asphalt plastic cement of troweling consistency, which contained cut-back asphalt and asbestos fiber. The walls were laid in common American bond, starting with three stretcher courses. They were constructed in two groups, differing from each other in the extent and method of filling the interior of the vertical joints with mortar. The membrane waterproofings, placed in some of the walls of each group, were similar.

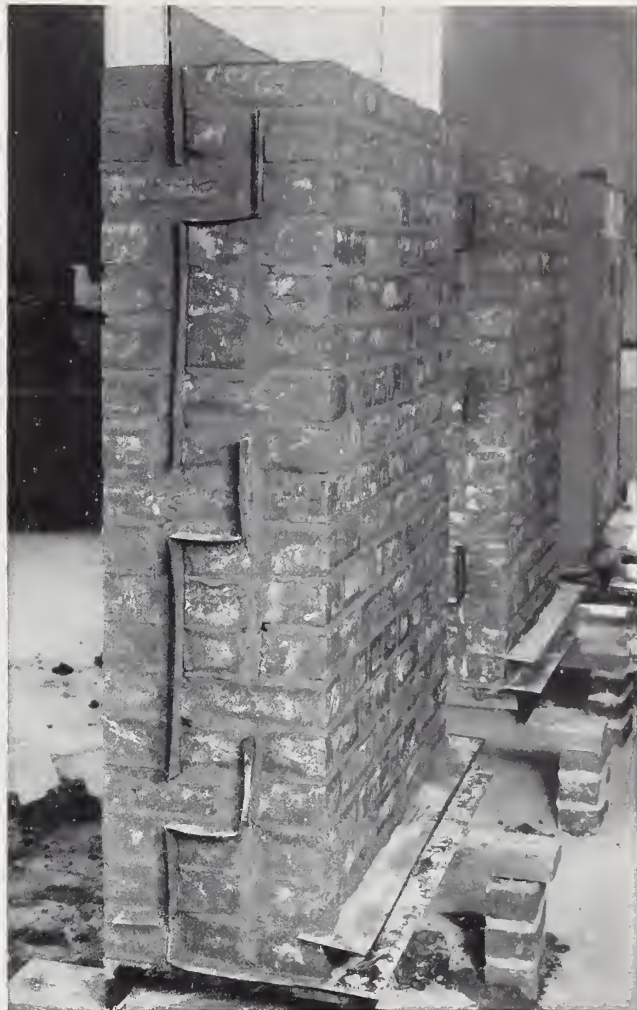
FIGURE 5.—*Brick wall containing membrane waterproofing.*

Brick Waterproofing Co., series 1.
