REPORT BMS73

Indentation Characteristics  
of Floor Coverings

PERCY A. SIGLER

MYRTLE B. WOODWARD

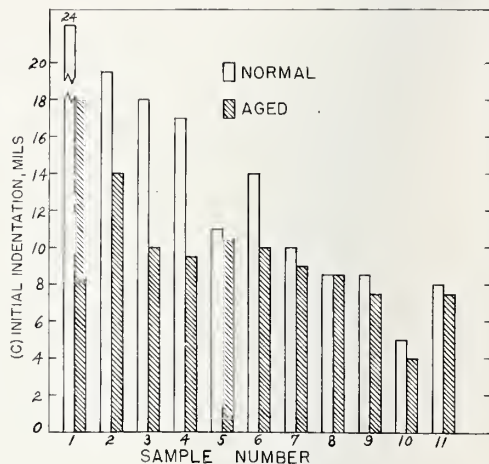
FIGURE 2.—Sheet linoleums.  
*C*, initial indentation in mils for load of 25 lb. (An approximate measure of the relative comfort value)

The results of the indentation and recovery determinations on the 64 floor coverings are summarized and shown graphically in figures 2 to 13, inclusive. The values reported represent the average of separate determinations on at least three specimens. The quantity *C* is the initial indentation (30 seconds after application of the load) in mils for a load of 25 lb on the 1/4-in. flat-ended indenting tool, and is used as an approximate measure of the relative

comfort value of the floor coverings with respect to the physical fatigue of occupants. The quantity *I* is the residual indentation in mils 120 minutes after the removal of a load of 100 lb which has been applied for 30 minutes, and is used to show the relative extent to which the floor coverings are permanently indented by a severe load. The unshaded blocks show the

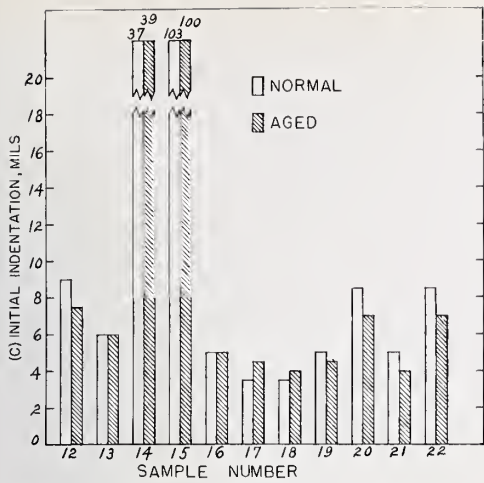
FIGURE 4.—Linoleum tile, cork composition tile, cork tiles, rubber tiles, and sheet rubber.

C, initial indentation in mils for load of 25 lb. (An approximate measure of the relative comfort value)

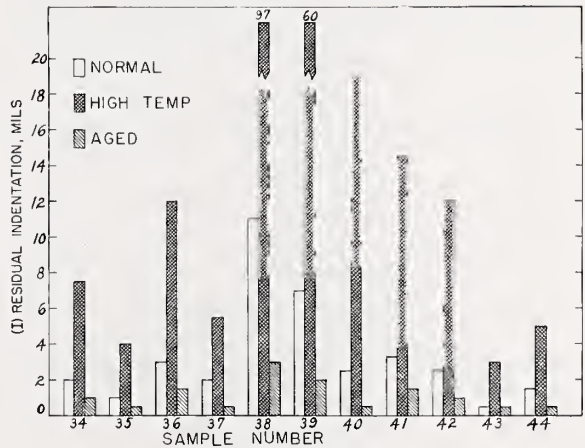
FIGURE 9.—Asphalt tiles.

I, residual indentation in mils 120 minutes after removal of load of 100 lb. (The extent to which the surface is permanently indented by a severe load)

If resistance to severe loads or abusive treatment is essential, a floor covering with a very low *I* value would be the least damaged or marred in such service. The oak and maple wood floors, pressed fiberboard, magnesium oxychloride floors, and the cement-mortar topping had a very low *I* value. Some of the asphalt tiles had a low *I* value under normal conditions. However, their *I* value was appreciably increased at an elevated temperature or by prolonged exposure to a concentrated load (see fig. 9 and table 1).

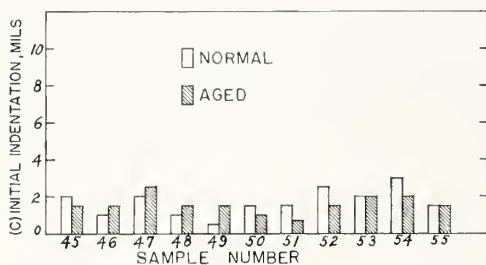
FIGURE 10.—Woods.

C, initial indentation in mills for load of 25 lb. (An approximate measure of the relative comfort value)

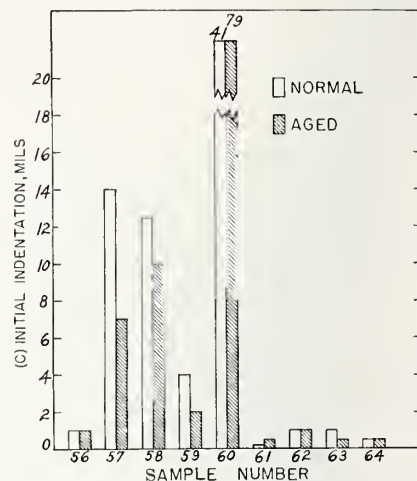
FIGURE 12.—Fiberboards and monolithic compositions.

C, initial indentation in mills for load of 25 lb. (An approximate measure of the relative comfort value)
