# HIGH RELIABILITY SHEATHED, BERYLLIA INSULATED, TUNGSTEN-RHENIUM ALLOY THERMOCOUPLE ASSEMBLIES— THEIR FABRICATION AND EMF STABILITY

G. W. Burns, W. S. Hurst and M. G. Scroger

1. Report No. NASA CR-134549	2. Government Accession No.	3. Recipient's Catalog No.	
4. Title and Subtitle HIGH RELIABILITY SHEATHED, BERYLLIA INSULATED, TUNGSTEN-RHENIUM ALLOY THERMOCOUPLE ASSEMBLIES - THEIR FABRICATION AND EMF STABILITY		5. Report Date June, 1974

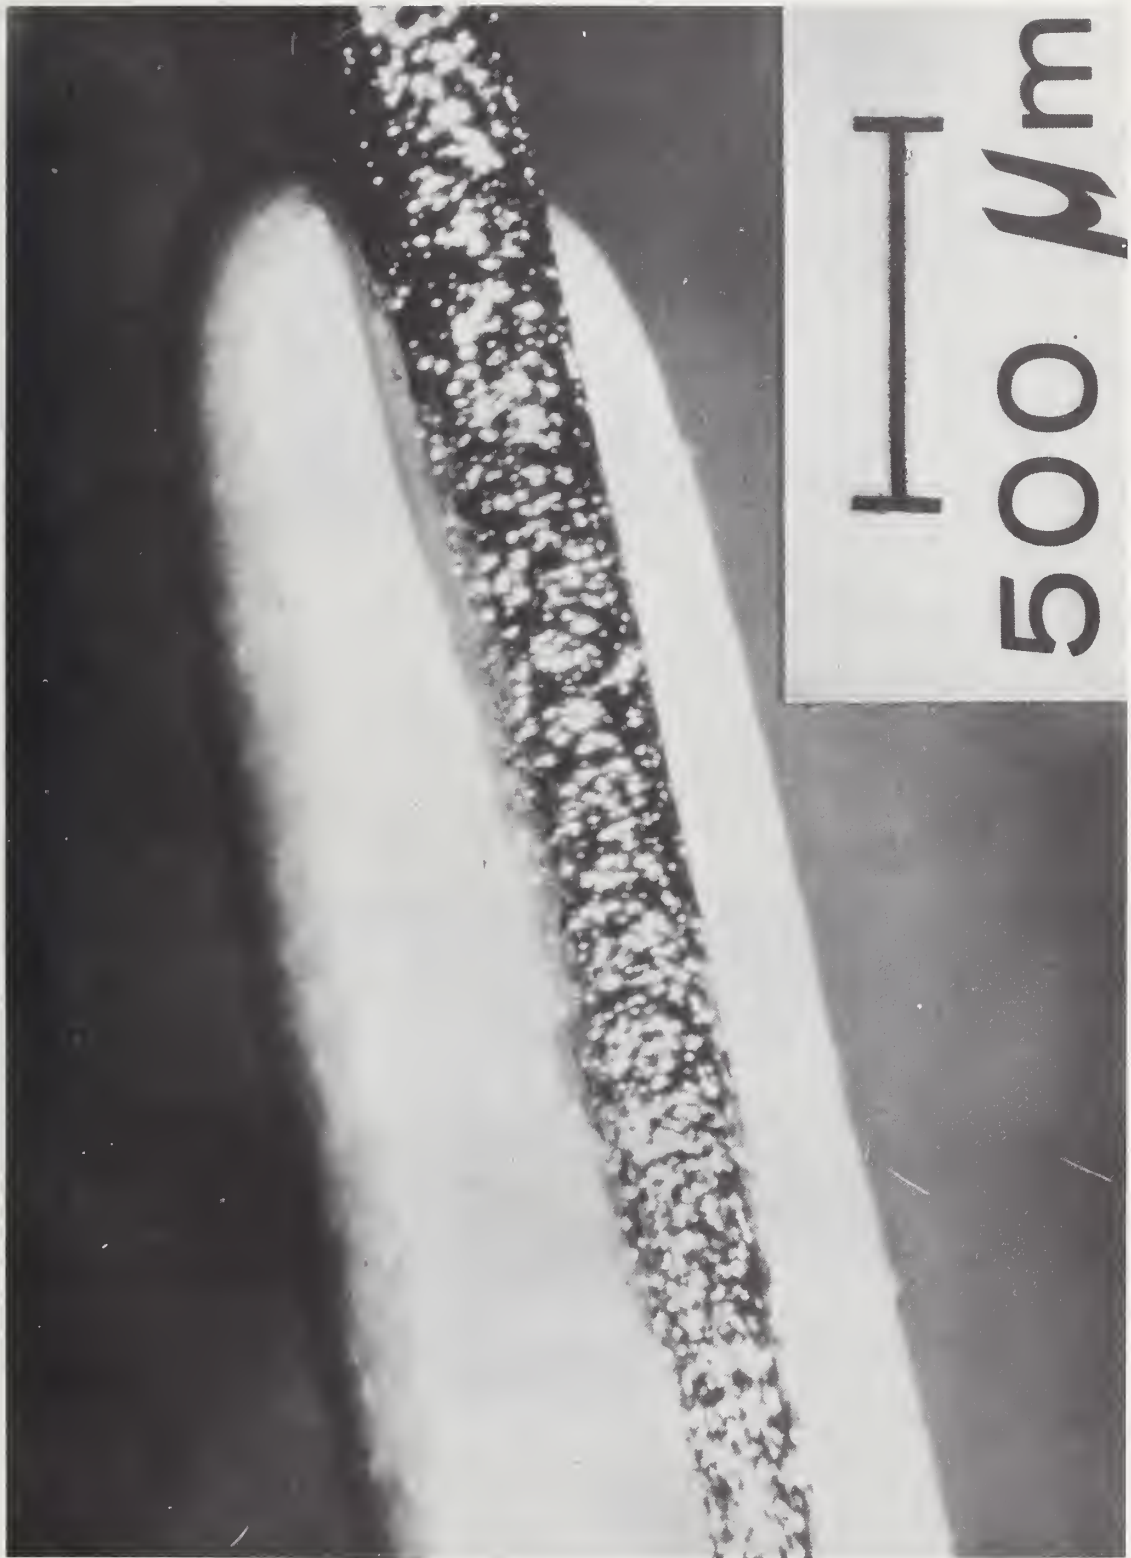
Figure 13. Photomicrograph showing the erosion of the BeO insulator near the measuring junction of an unsheathed thermocouple that was exposed within a tantalum blackbody enclosure for 307 hours at 2400 K in argon.
