## CHAPTER XVI

# THE BUILDING AS COMPLETED, FROM WALTER'S DESIGNS

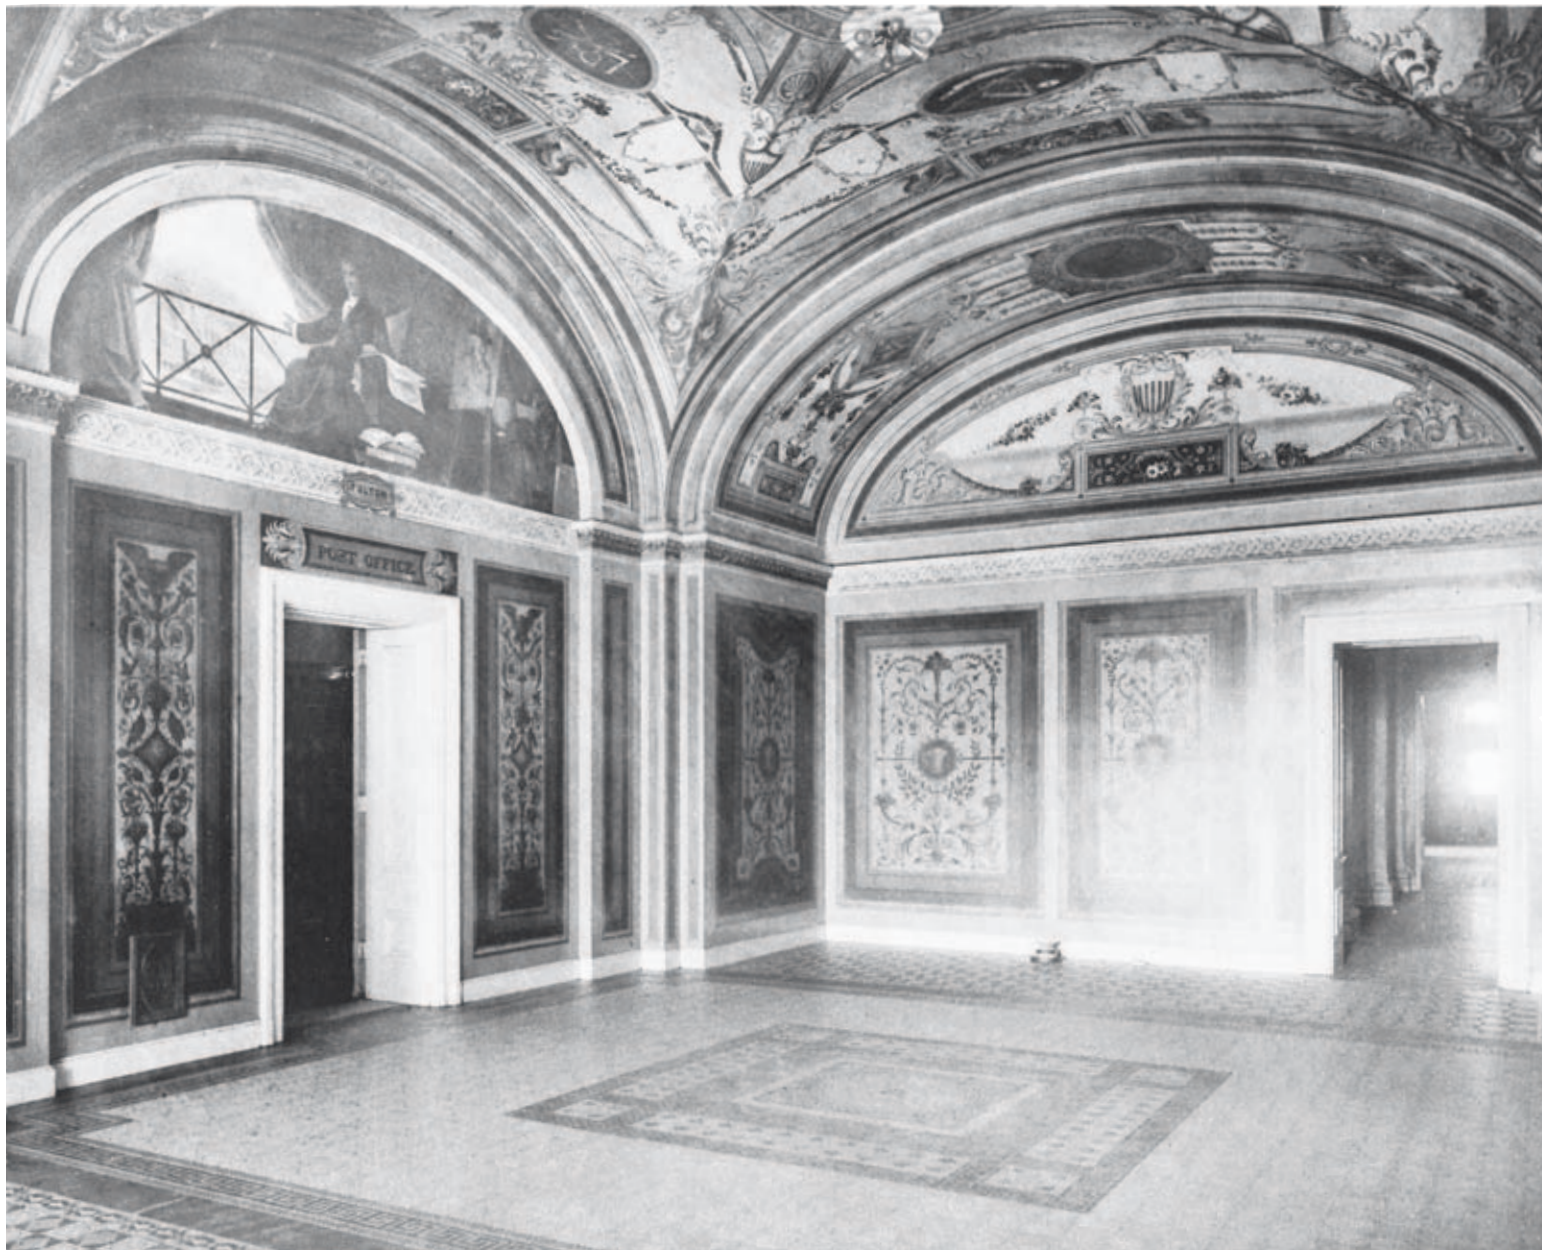
PUBLIC ROOM, NORTH WING, BASEMENT.

The Patent Corridor, one of the Brumidi Corridors, outside the entrance to S-116.

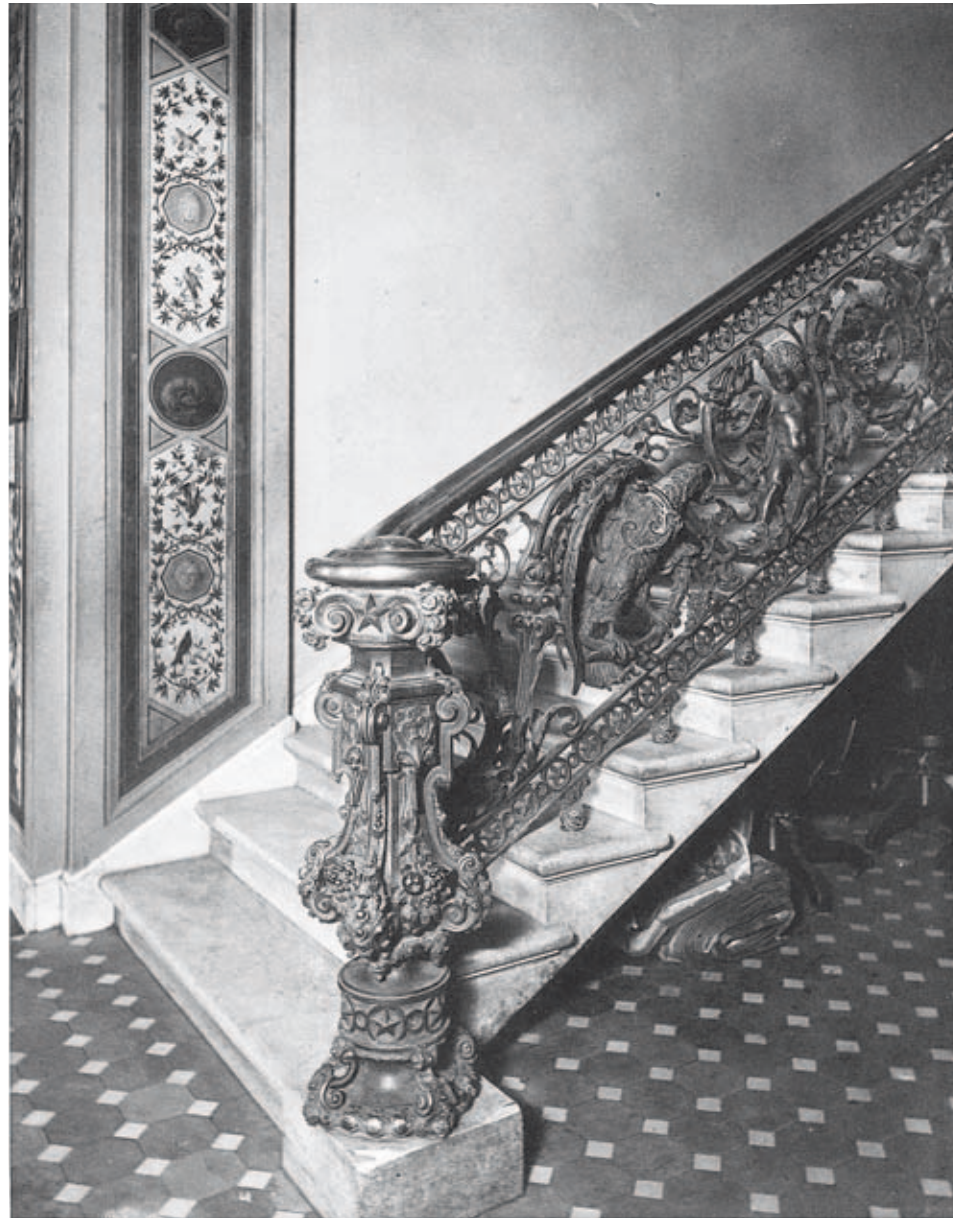
SENATORS PRIVATE BRONZE STAIRWAY, NORTH WING,—T. U. WALTER ARCHITECT.  
Designed by Constantino Brumidi, modeled by Edmond Baudin, and cast by Archer, Warner,  
Miskey and Co. of Philadelphia, 1857–59 (related drawing, plate 213).

At the east and west ends of the Senate Chamber are private stairways, with marble steps and elaborate, well modeled, and effective bronze railings, for the use of Senators [Plate 229]. On the south of the basement vestibule is an entrance to one of the principal public stairways. The design of this stairway is similar to the one used on the east and west of the House wing (see Plate 244), and there is a corresponding stairway on the east side of the Senate. In the Senate wing white marble is used in the steps, balustrades, columns, and cornices, as well as in the ceilings over the landings, while on the House side Tennessee marble is used, with bronze capitals to the columns. On the principal floor corridors with arched and vaulted ceilings surround the Senate Chamber on the south, east, and west; these corridors have simply

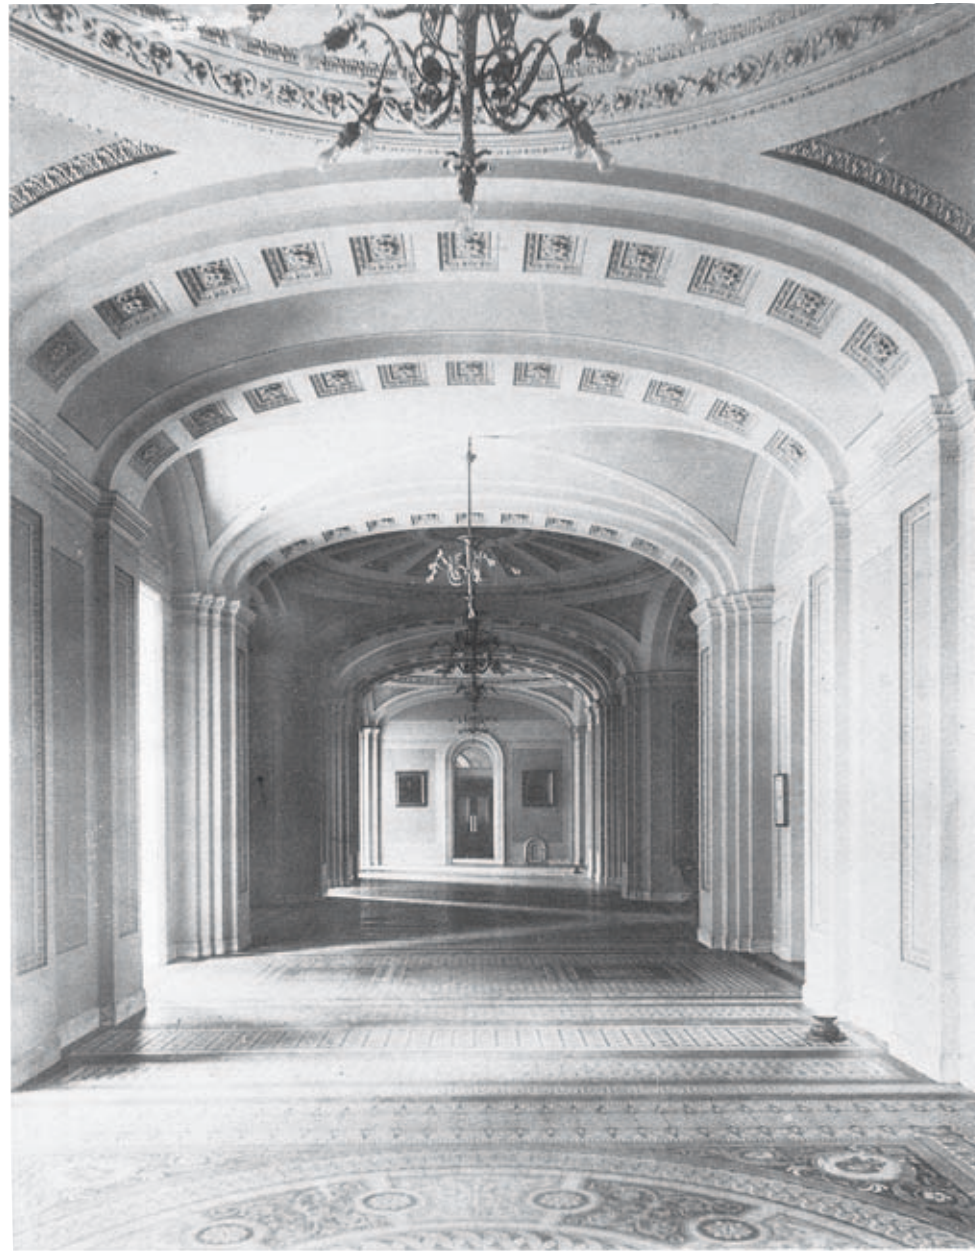
SENATE CORRIDOR, PRINCIPAL FLOOR.

View to the west toward S-224.

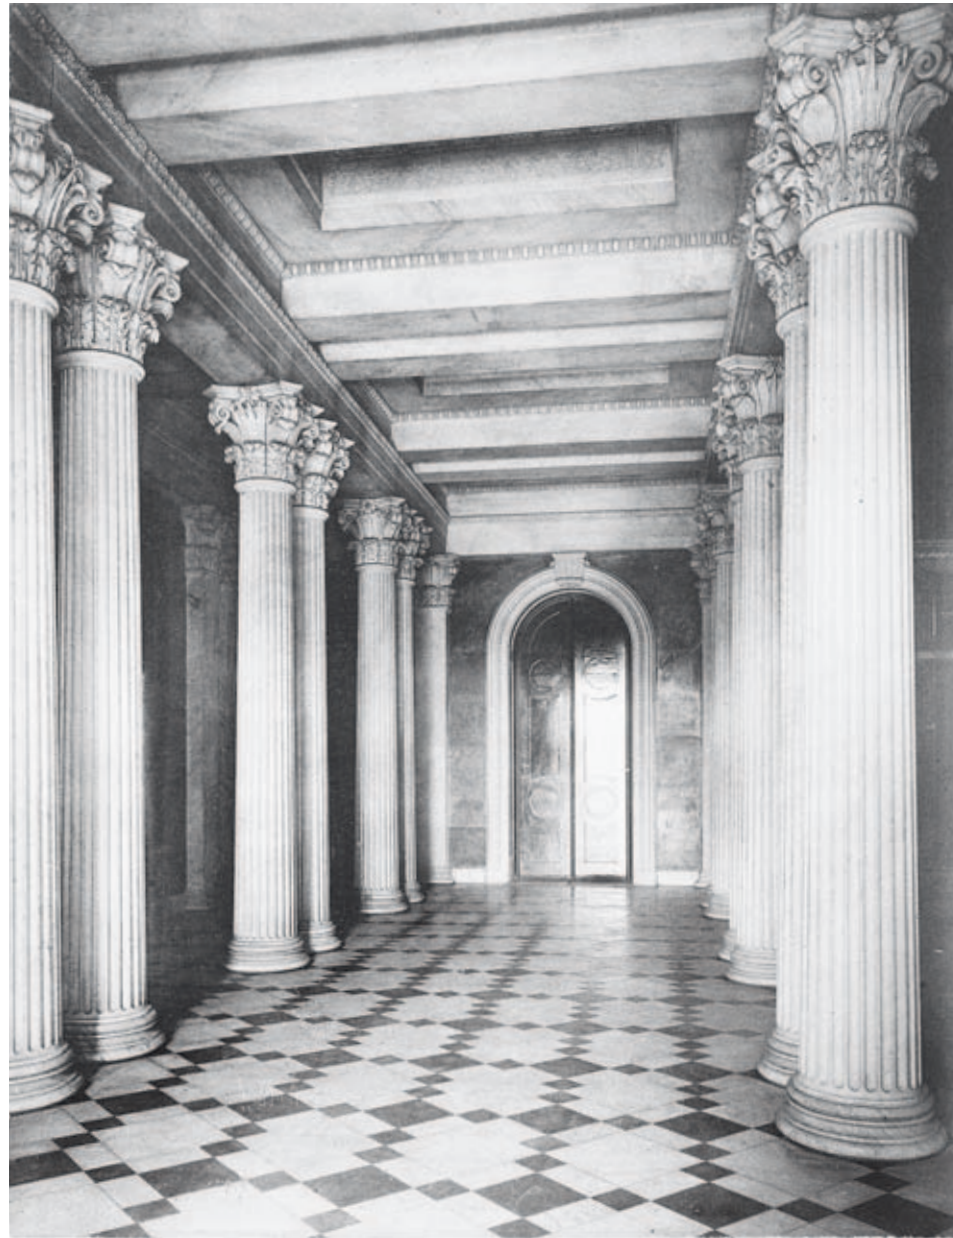
SENATE CORRIDOR, PRINCIPAL STORY.

View to the west, Senate Chamber doors. The space behind the screen of columns has been infilled with elevators (related drawing, plate 208).

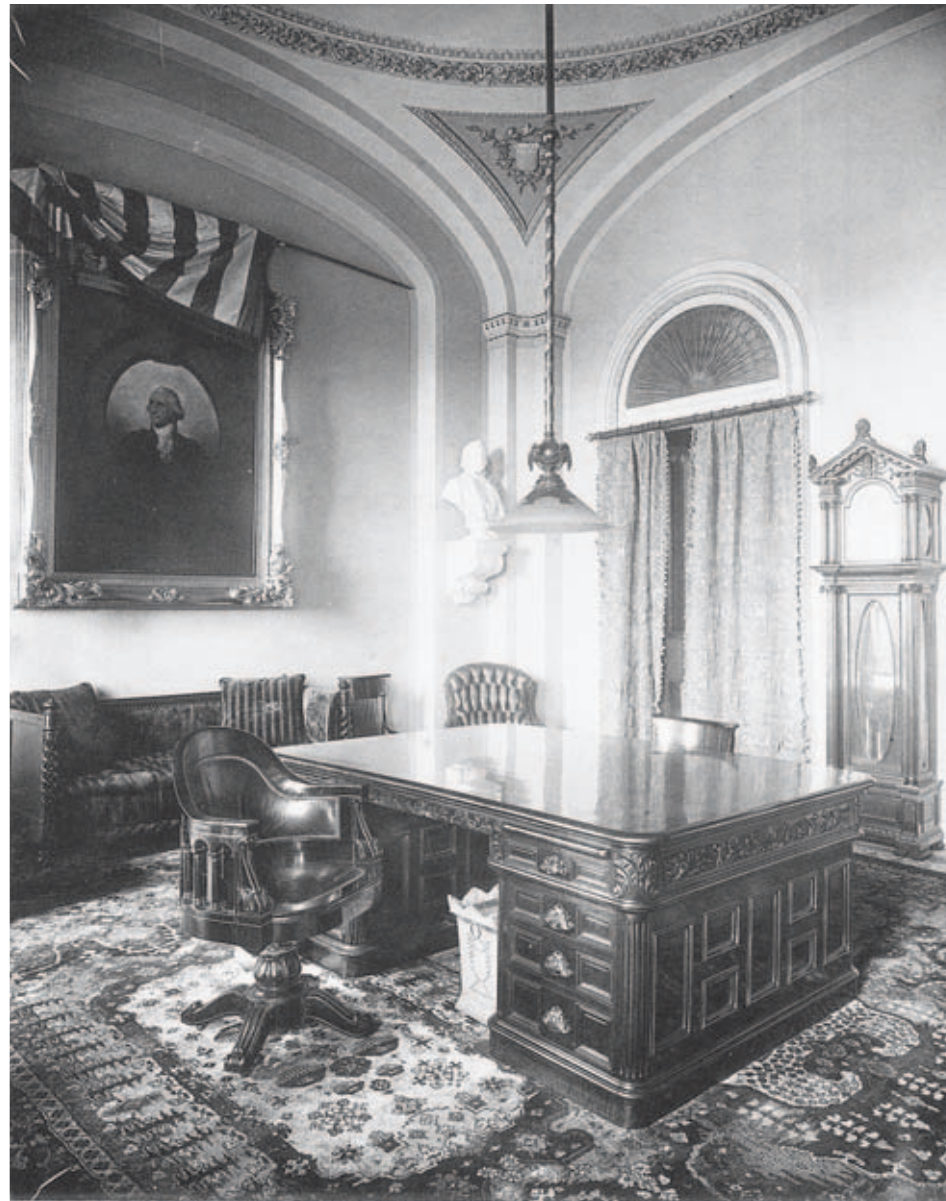
THE VICE PRESIDENT'S ROOM, NORTH WING.

S-214, now the formal Office of the Vice President. The painting of Washington has been moved to the restored Old Senate Chamber.

The room of the Vice-President [Plate 235] is on the east of the Senators' private room. This room has a domical ceiling resting upon flat elliptical arches, and in it hangs the noted painting of Washington by Rembrandt Peale.<sup>6</sup> The walls and ceilings are simply tinted.

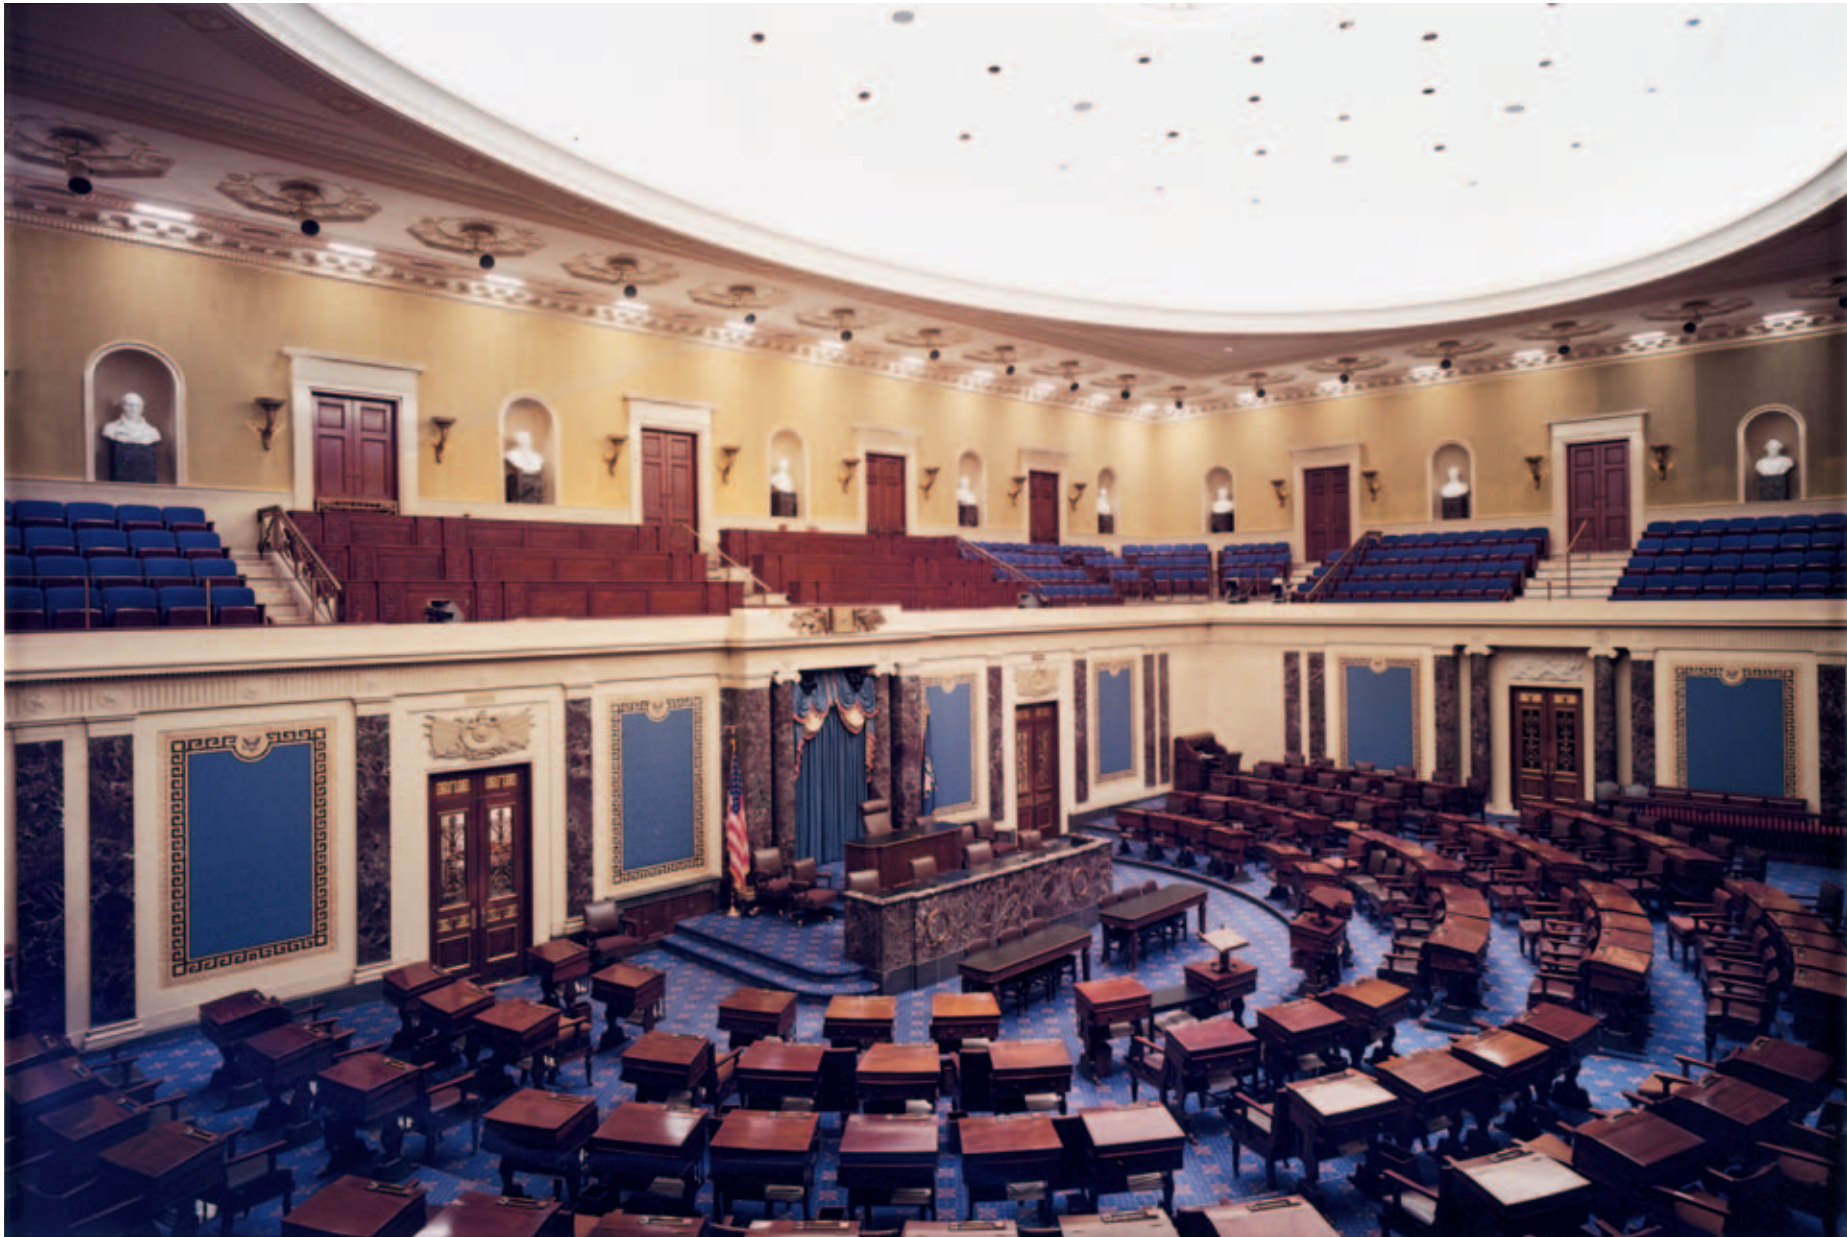
The Senate Chamber at the end of the twentieth century.

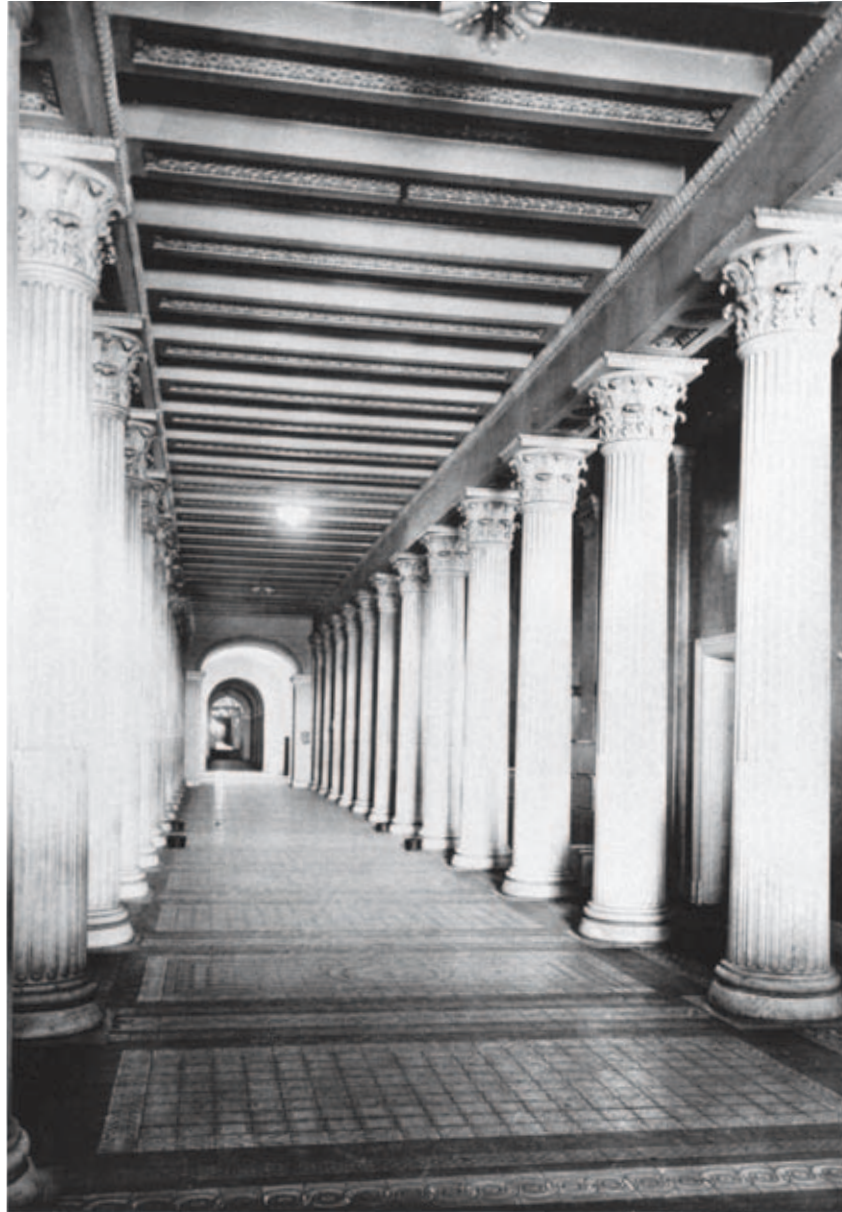
BASEMENT HALL, SOUTH WING.

The Hall of Columns (related drawings, plates 205 and 207).  
The Mindon tiles have been replaced with marble.

The principal difference in the basement story of the House wing consists in the colonnaded hallway running through this wing from north to south [Plate 241]. This hall has a long colonnade of columns

with marble side walls and ceiling in the form of lintels and panels.<sup>10</sup> The capitals are modeled from the capitals of the Temple of the Winds, Athens, the tobacco plant being utilized in the second row of leaves. The entrances to the basement of the south wing are on the east, west, and south, as well as one from the Rotunda on the north. North of the east and west entrances are located the principal stairways, similar in design to those in the Senate wing, which give the public access to the principal corridors. The private stairways [Plate 229] of the members are located in the south corridor.

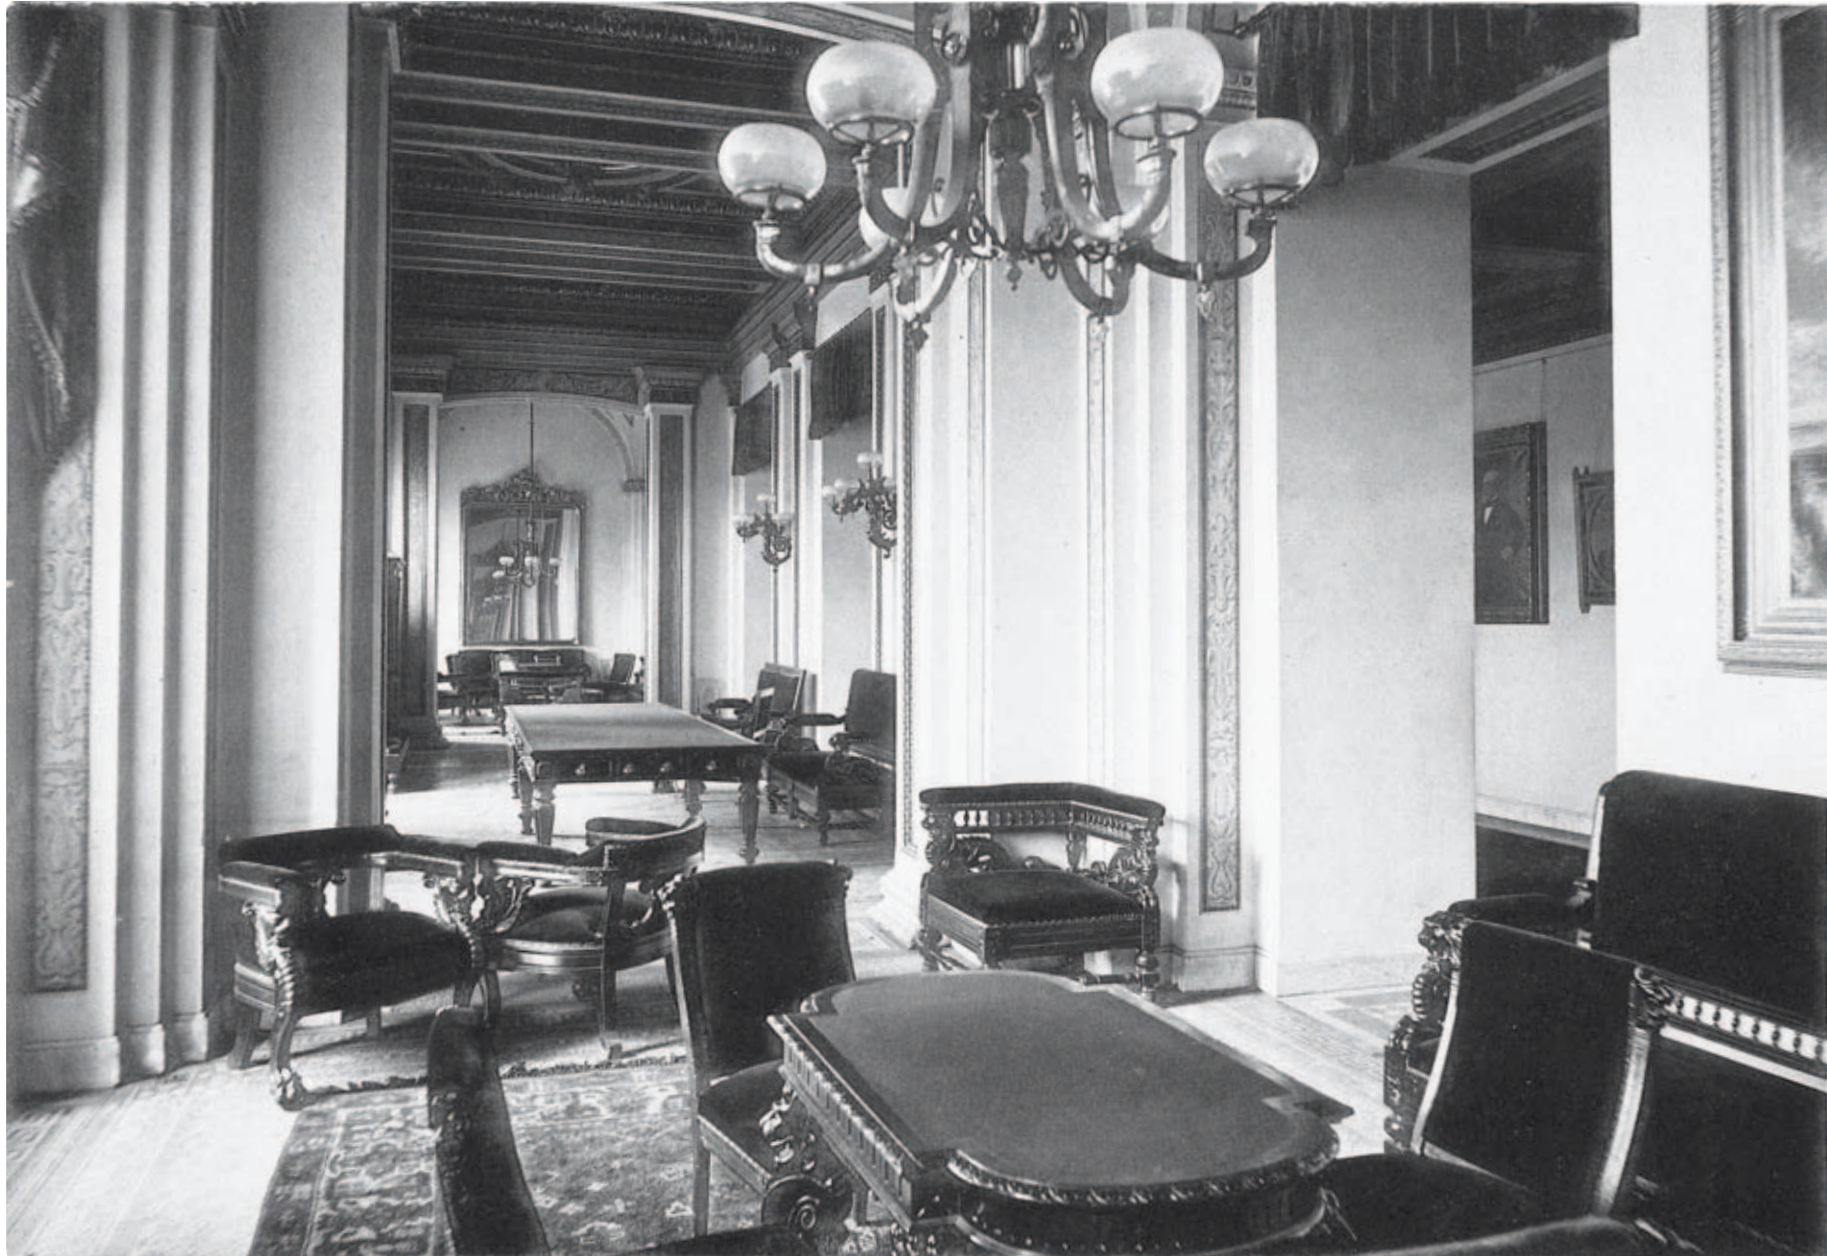
LOBBY OR CORRIDOR, SOUTH OF HOUSE OF REPRESENTATIVES.

H-212, 213, and 214, Member's Retiring Room. The center space was the original Speaker's office.

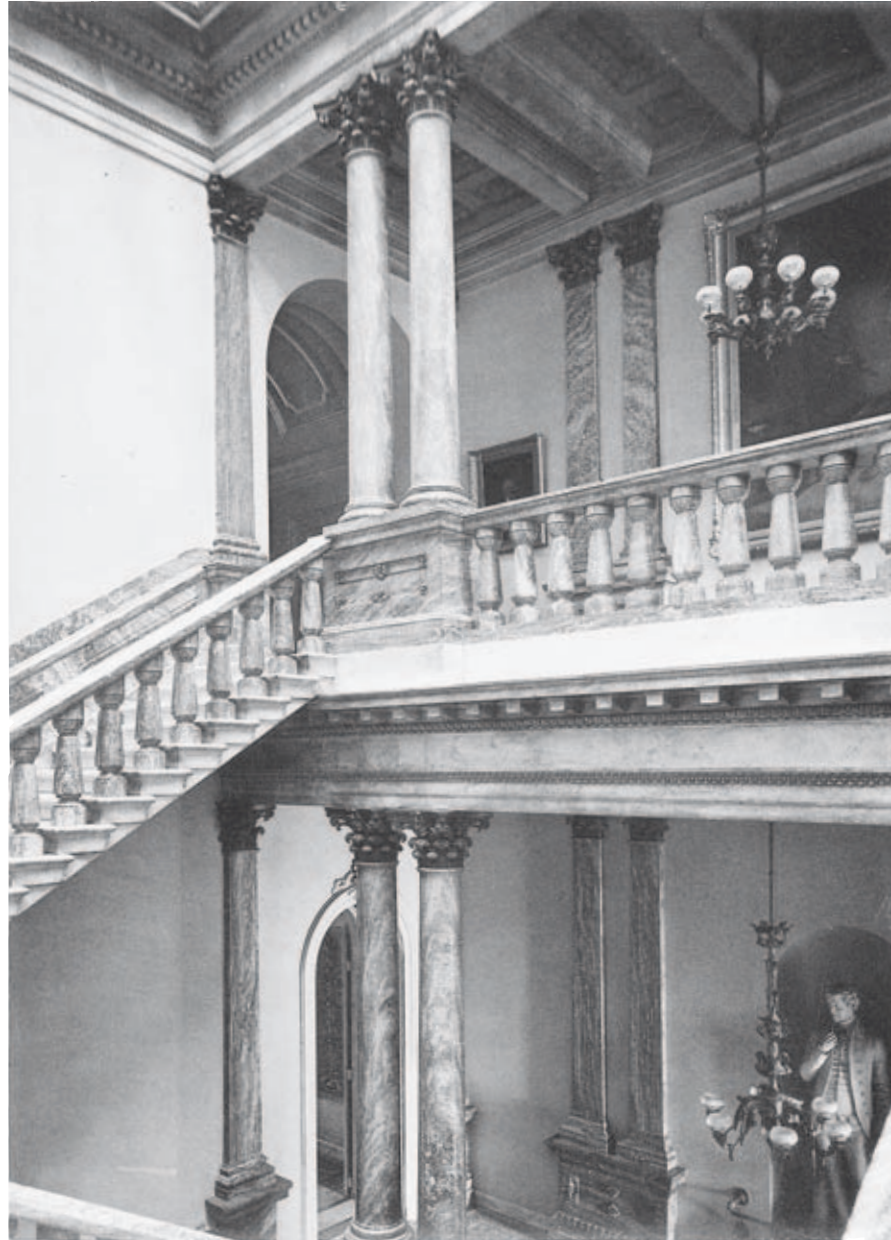
FOUR PRINCIPAL STAIRWAYS, SIMILAR IN DESIGN ON HOUSE AND SENATE WING.  
This marble staircase is located on the east side of the House wing between the second and third floors.

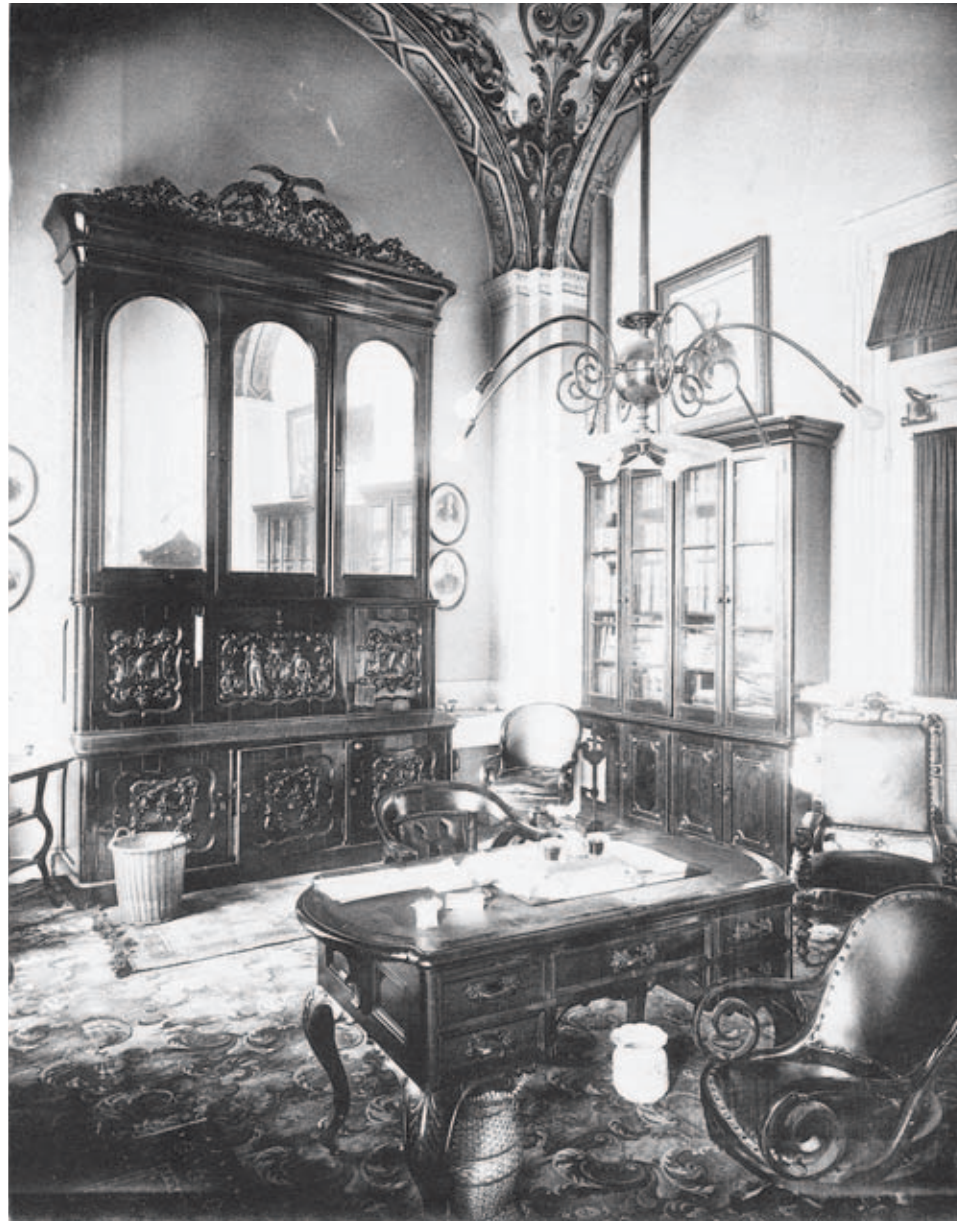
ROOM OF SPEAKER OF THE HOUSE OF REPRESENTATIVES.  
H-211, now the Parliamentarian's office.

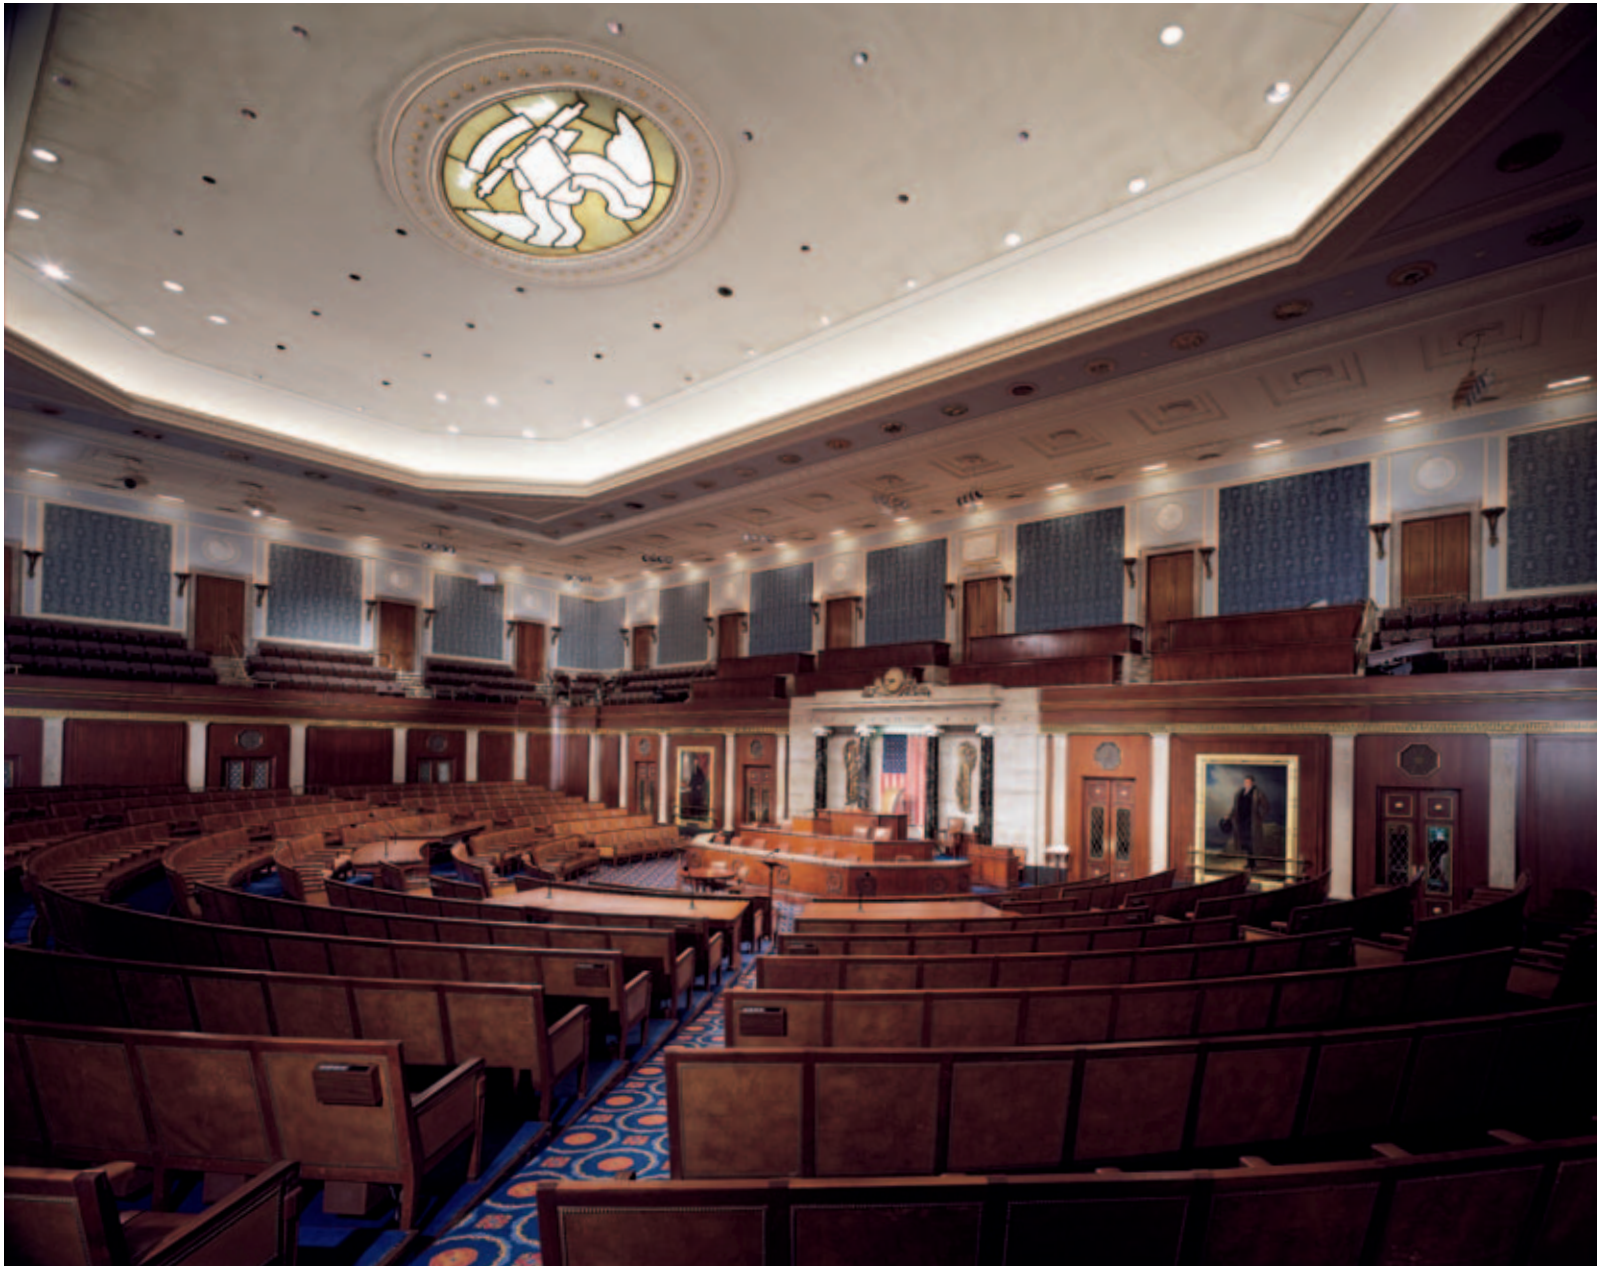
The House of Representatives Chamber at the end of the twentieth century.

The Hall of the House of Representatives [Plate 250] occupies the central portion of the south wing, being surrounded by a gallery—three sides being used by the public and the south side for private and press galleries. The room is 139 feet in length, 93 feet in width, and 36 feet in height. The ceiling is paneled with glass similar to the ceiling [Plate 192] of the Senate Chamber, the decorations consisting of stained-glass medallions depicting the coats of arms of the various States and Territories of the Union.<sup>13</sup> The cloakrooms are under the gallery, with doors opening into the Hall of the House of Representatives. The Speaker's desk [Plate 214] is on the south side of the room and below it is the desk for the reading clerk and official stenographers. The Members' desks are placed in semicircular rows, of which the Speaker's desk forms the center. The space beneath the galleries is utilized for private retiring rooms. The attic story of this portion of the building contains committee rooms, press rooms, and, to the north, the House document room.

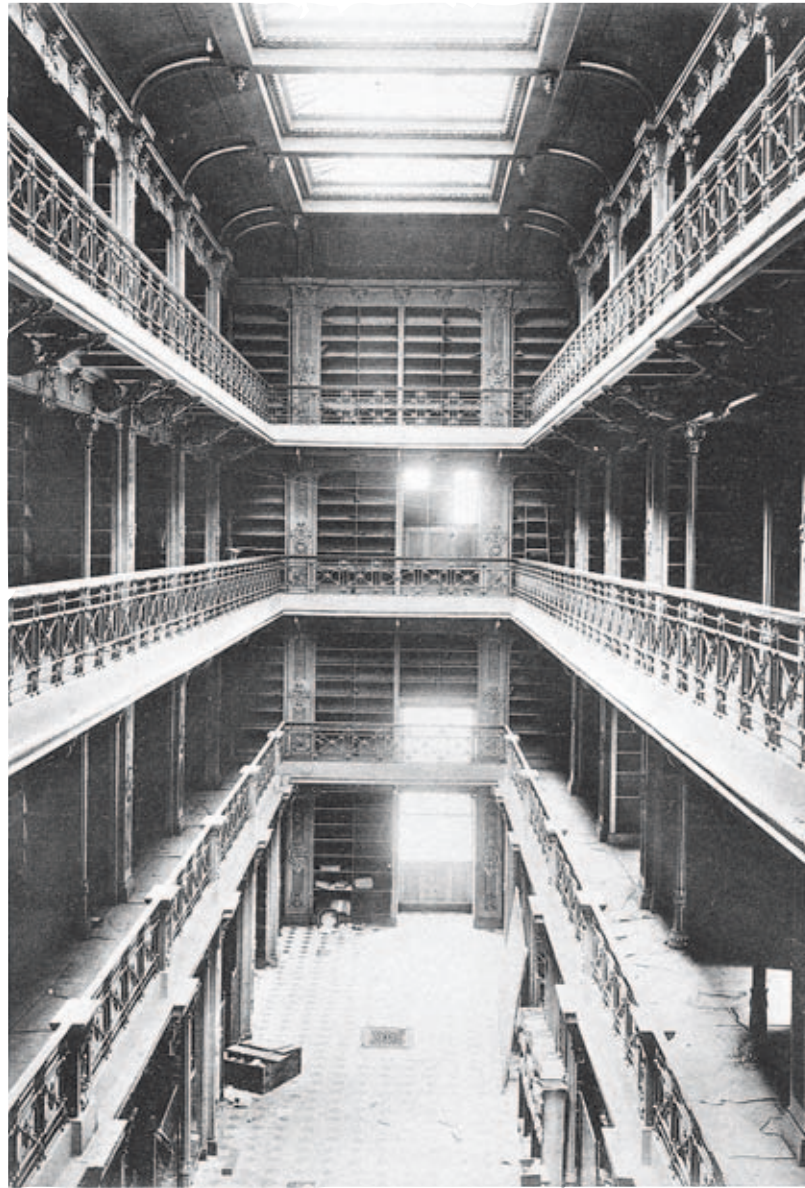
NORTH AND SOUTH HALLS, OLD CONGRESSIONAL LIBRARY,—T. U. WALTER, ARCHITECT.

These sections of the library space, photographed during the Library's demolition in 1900, were originally built under the direction of Edward Clark in 1865–66.

and two tiers of galleries from which opened book alcoves. The western hall of the Library, which was first completed [Plate 251], was 34 feet in width and 92 feet in length. The north and south sections were completed at a later date [Plate 252]. The detailing shows clearly the character and method of construction [Plates 253, 253a]. The books were removed from the Capitol July 31, 1897, when the new Congressional Library building was completed and ready to receive them.

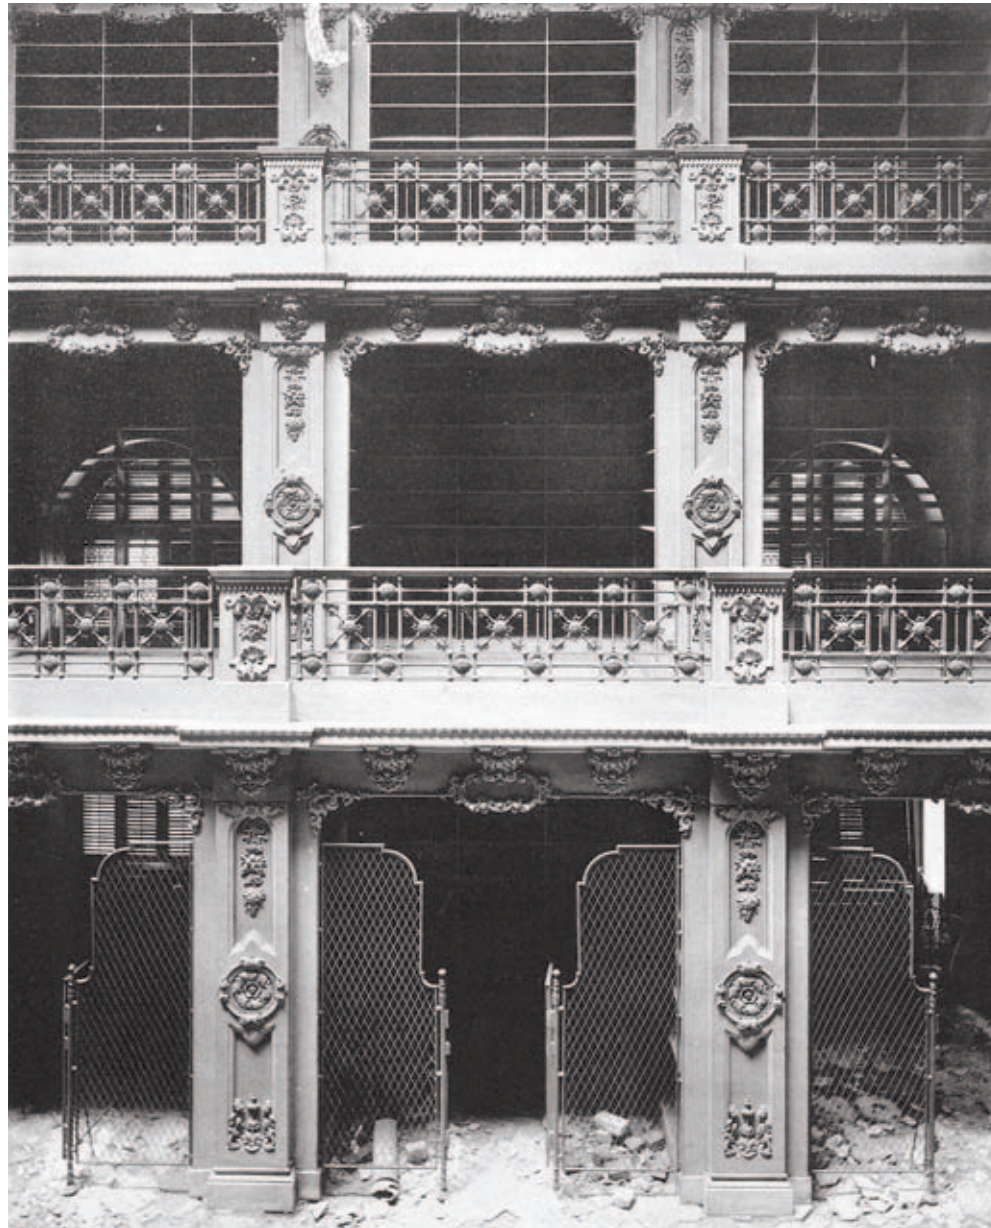
DETAIL OF IRON WORK IN OLD CONGRESSIONAL LIBRARY,—T. U. WALTER, ARCHITECT.  
Photograph taken to record this work before demolition in 1900.

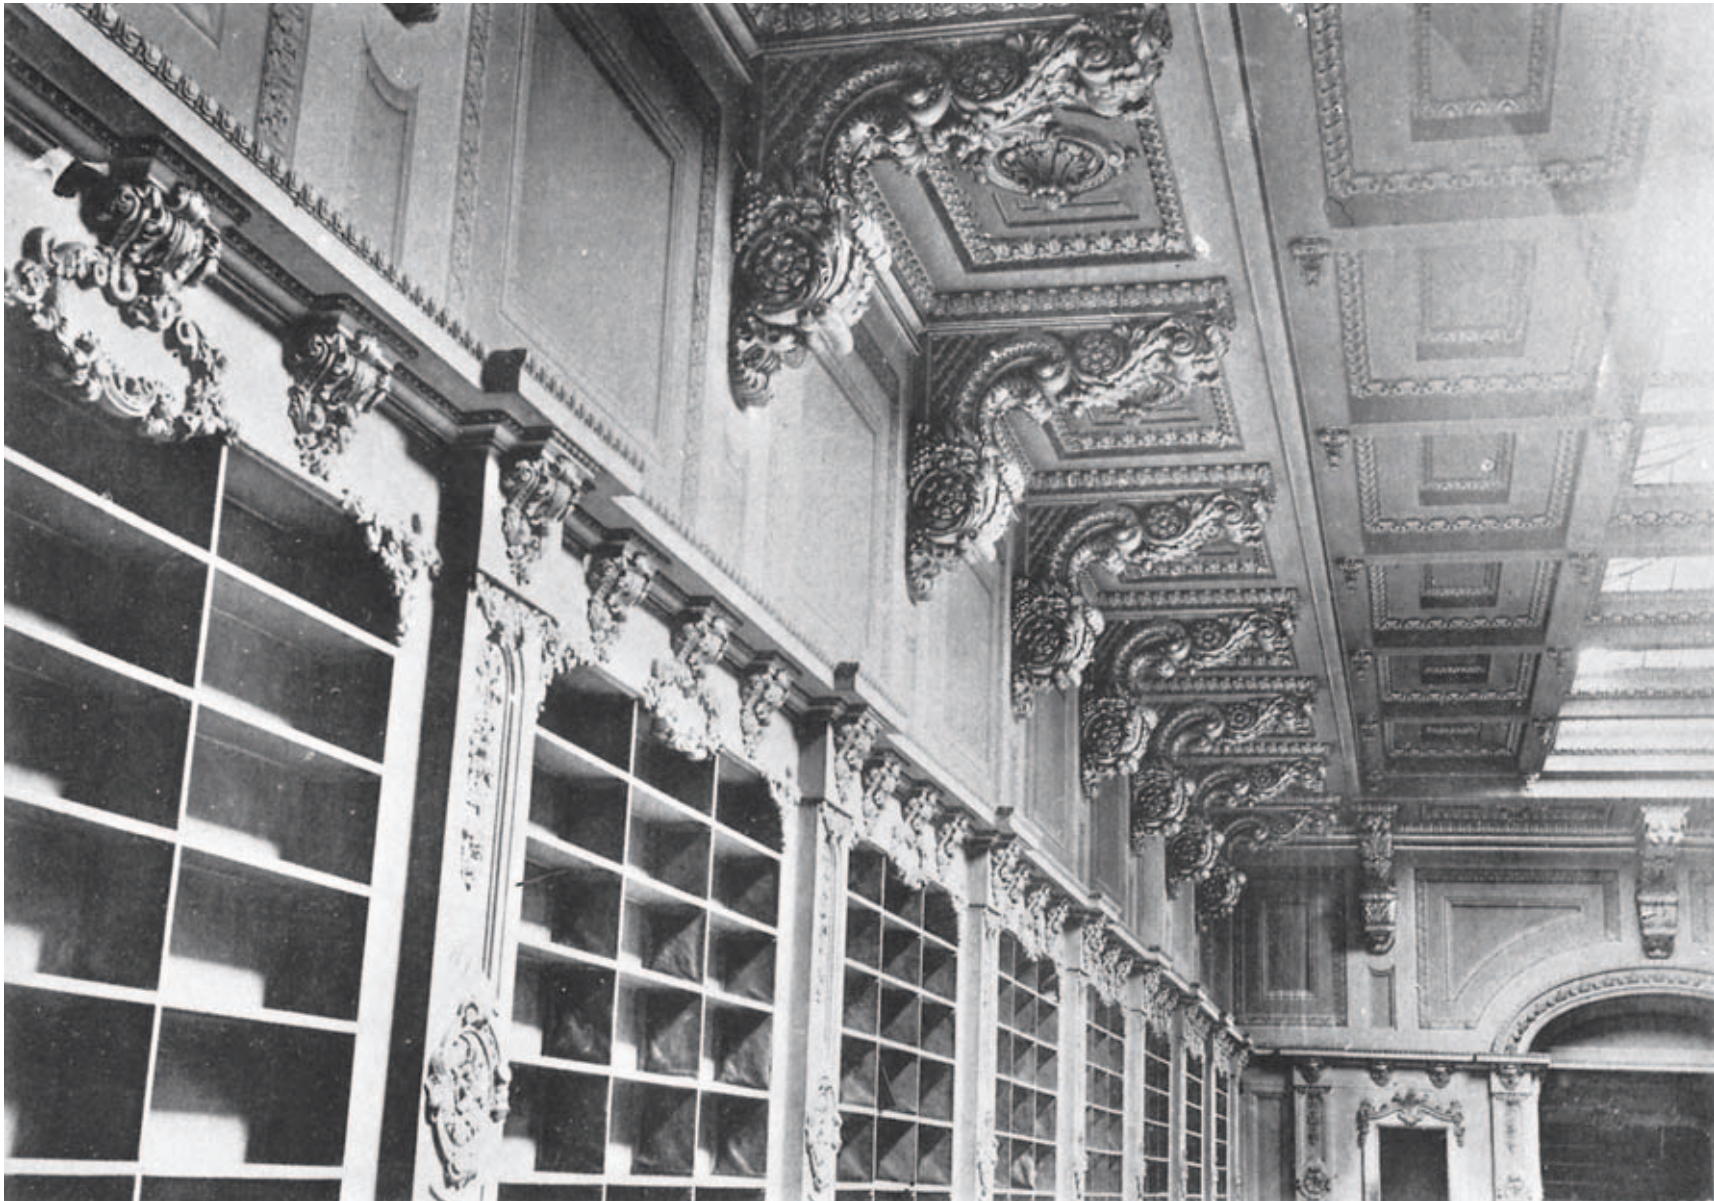
CEILING OF WEST HALL, OLD CONGRESSIONAL LIBRARY,—T. U. WALTER, ARCHITECT.

This photograph was taken to record the design of the ceiling and consoles, but it also shows the empty bookshelves in the abandoned library just before demolition in 1900 (related drawing, plate 210).
